SHOREWALL INSPECTION PROGRAM

Lagoon City, Township of Ramara

Inspection Report – Phase 1
2016

Lagoon City Parks and Waterways Commission

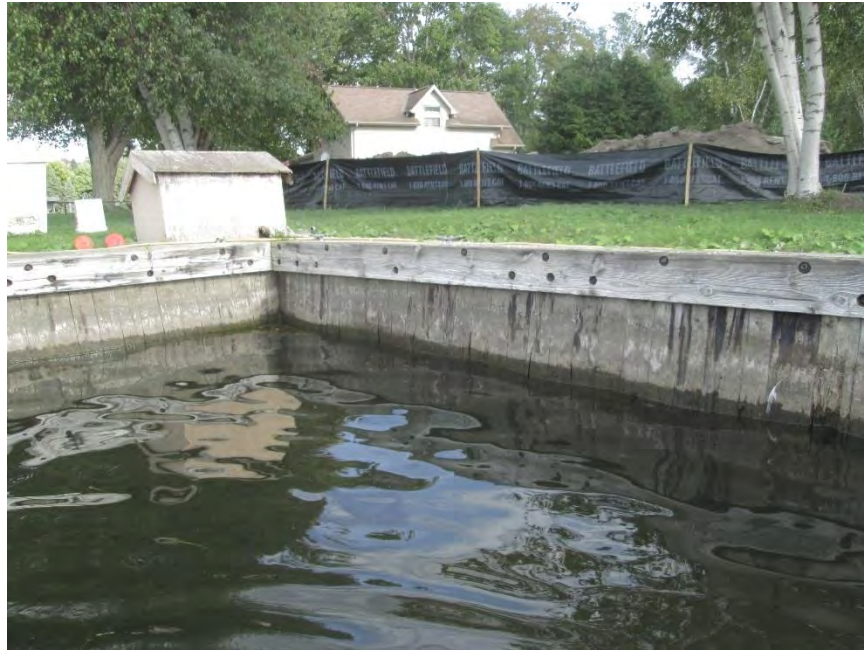
Photograph No. 1
Typical wood plank shorewall.

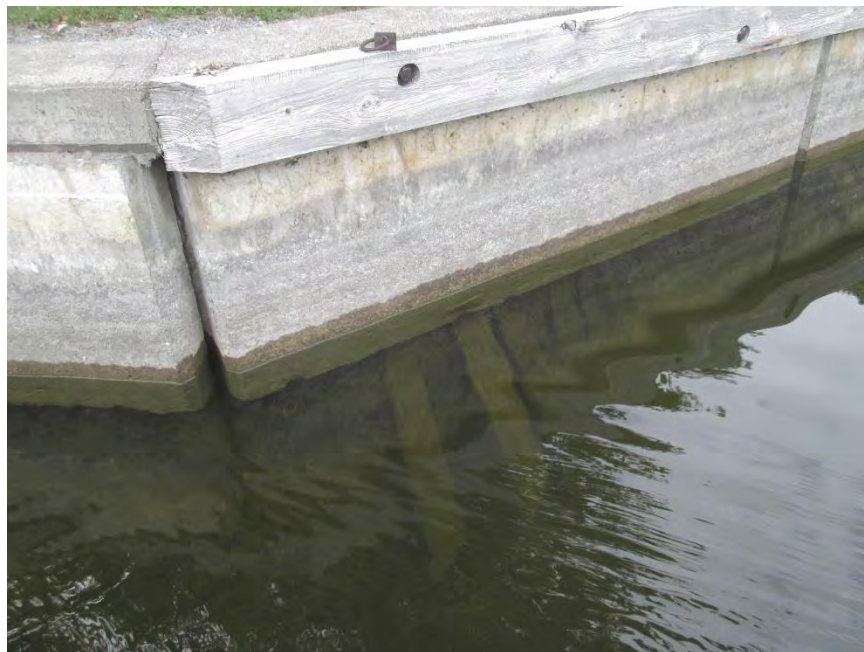
- at concrete fascia shorewalls, it was apparent the wood planks behind have deteriorated and become dislodged, effectively minimizing their soil retention capabilities (refer to Photograph No. 2 of Appendix C);

Photograph No. 2
Typical concrete fascia wall with wood planks behind.

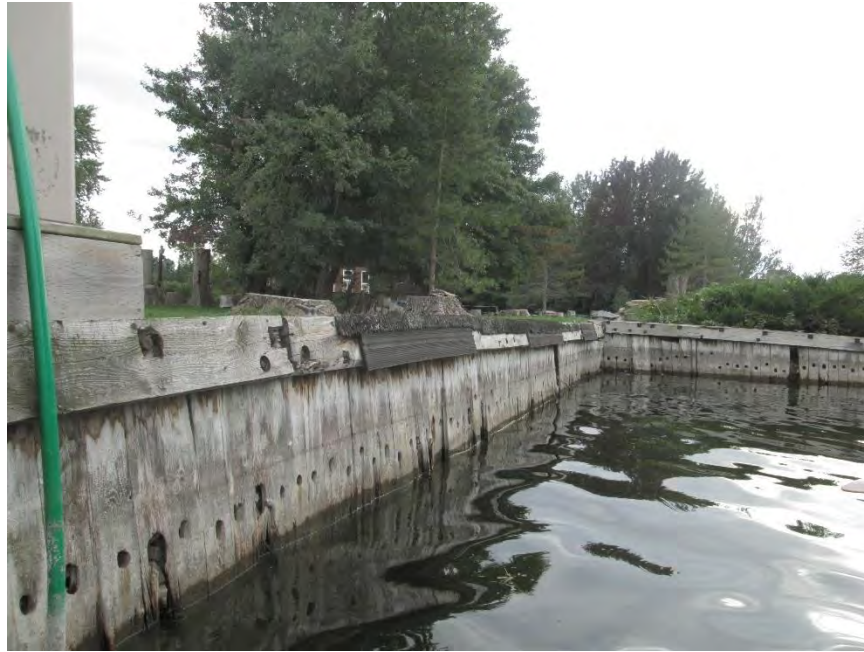
- at wood shorewalls, bowing and warping was evident as well as outward deflection of the lower end of the wood planks, likely due to inadequate resistance to lateral earth pressures and poor embedment of the plank bases into the channel bottom (refer to Photograph No. 3);

Photograph No. 3
Leaning/bowing/splitting of wood planks.

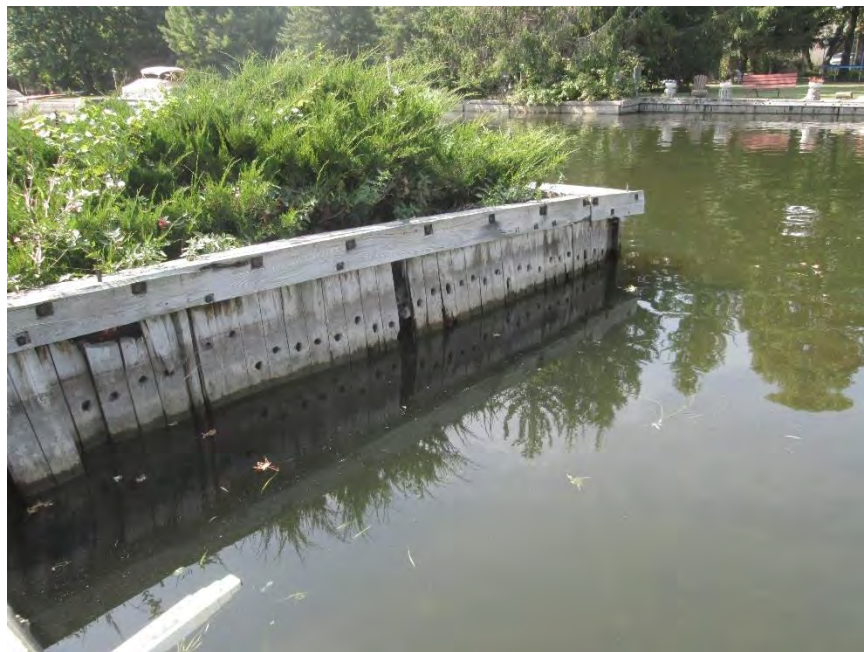
- damaged and/or missing wood planks leading to exposure of the granular fill behind (refer to Photograph No. 4). This was further evident from the granular fill deposits noted at the base of the walls within the canal;

Photograph No. 4
Missing planks and exposed granular fill.

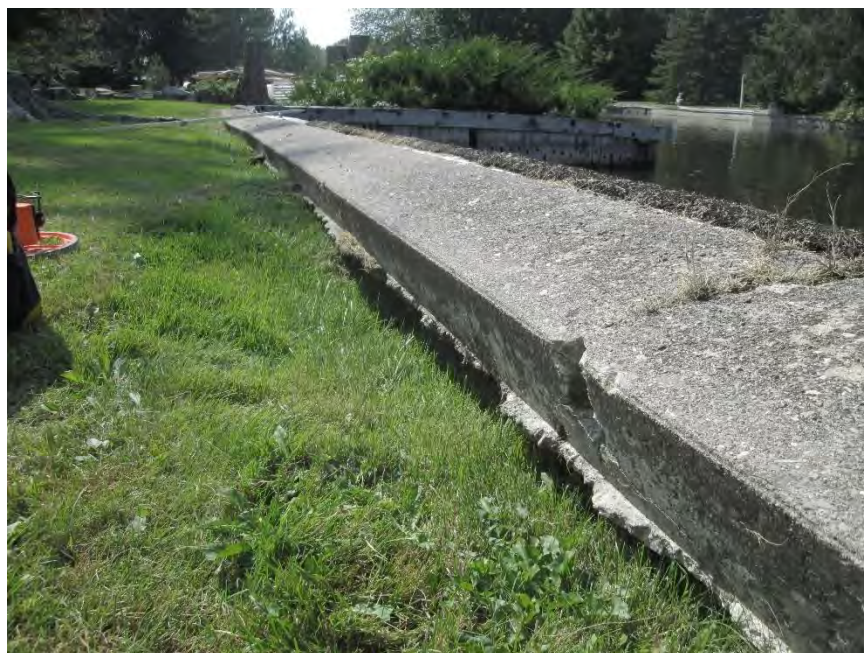
Photograph No. 5
Erosion and sloping of grade towards wall. Top cap tipping away from canal.

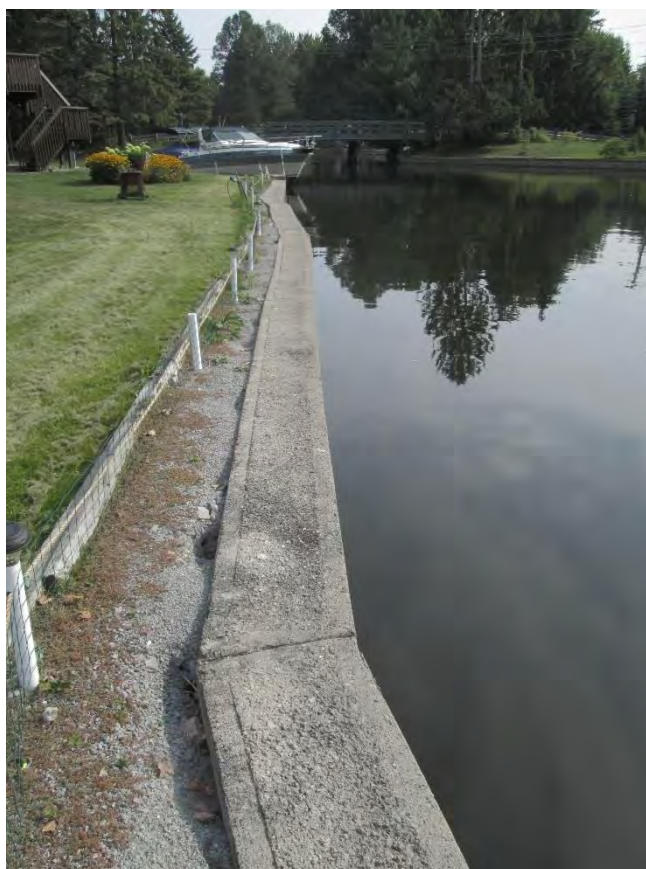
Photograph No. 6
Minor erosion (isolated spillways) behind wall.

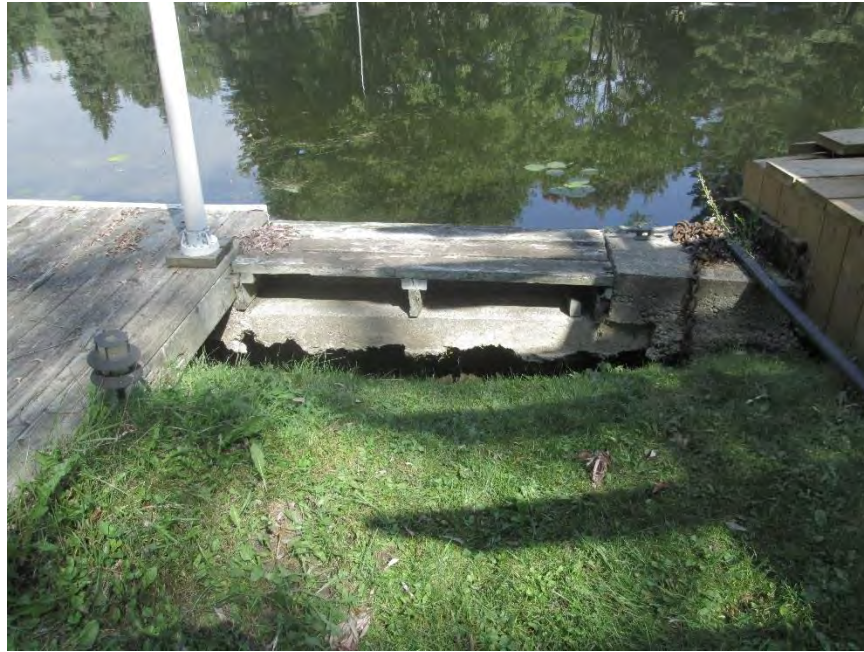
Photograph No. 7
Severe erosion at swale outlet. Swale blocked by constructed boardwalk.

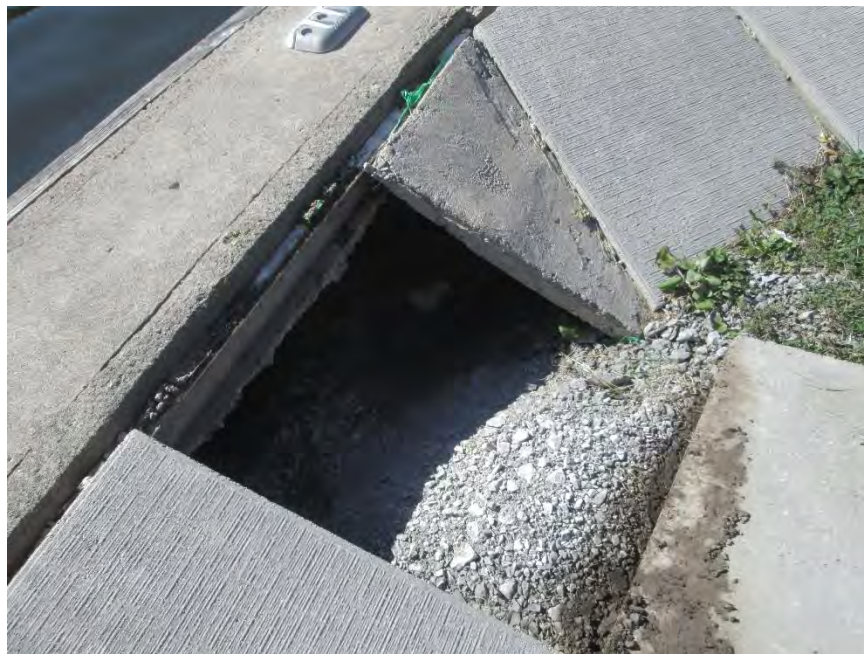
Photograph No. 8
Severe erosion behind wall – settlement of patio stones.

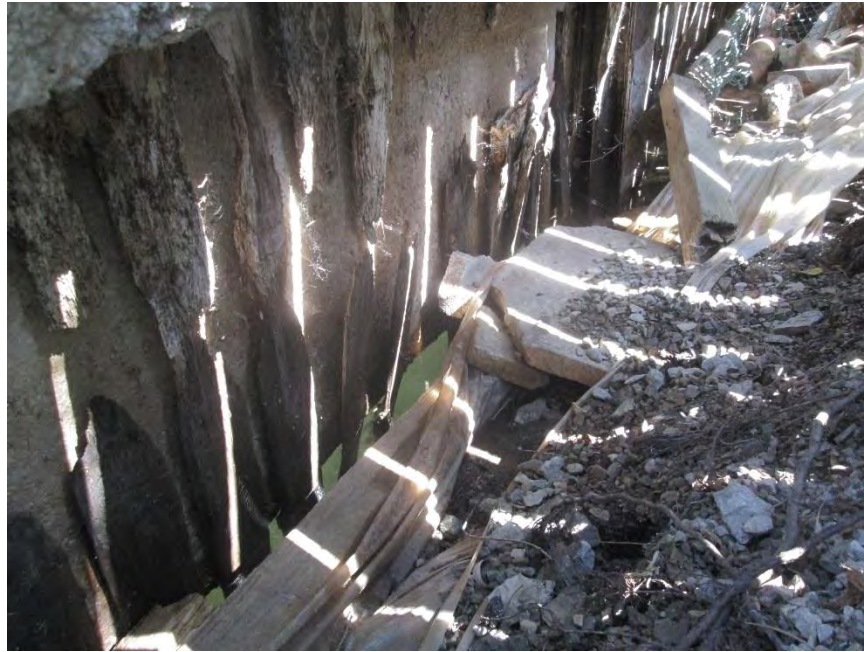
Photograph No. 9

Severe erosion behind wall – deteriorated wood planks, exposed piles and tiebacks.

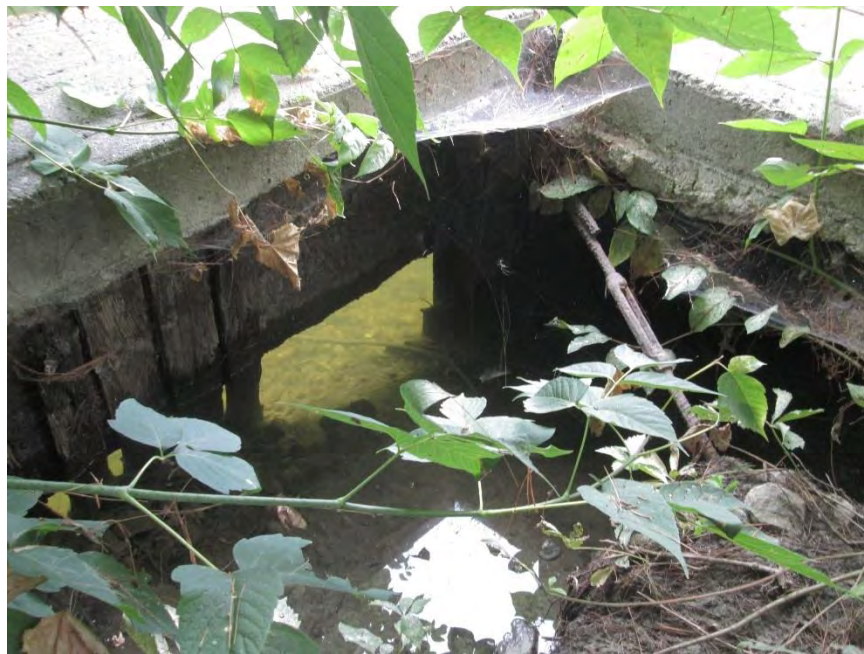
Photograph No. 10

Severe erosion behind wall – deteriorated wood planks, exposed piles and tiebacks.

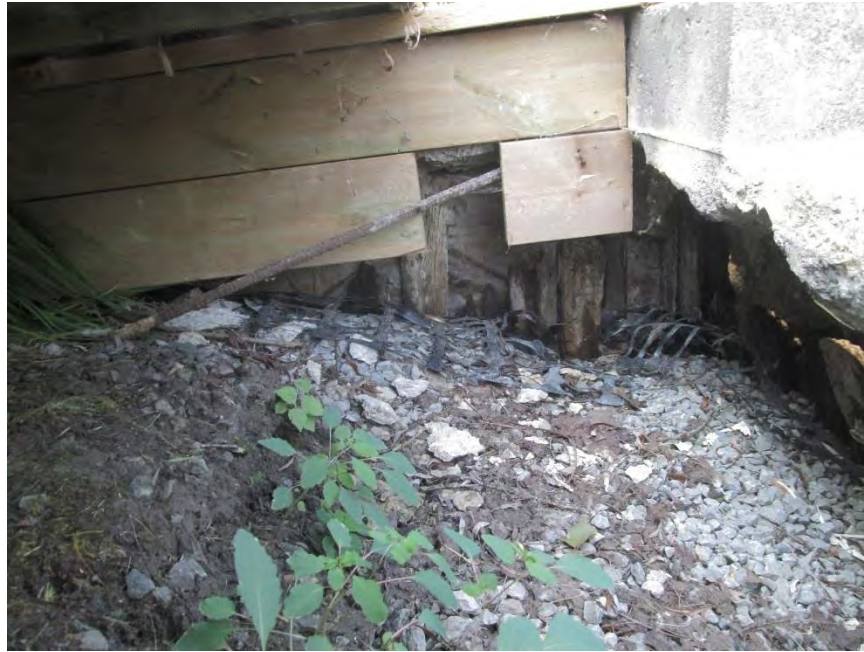
Photograph No. 11
Severe erosion behind wall – exposed piles and tiebacks.

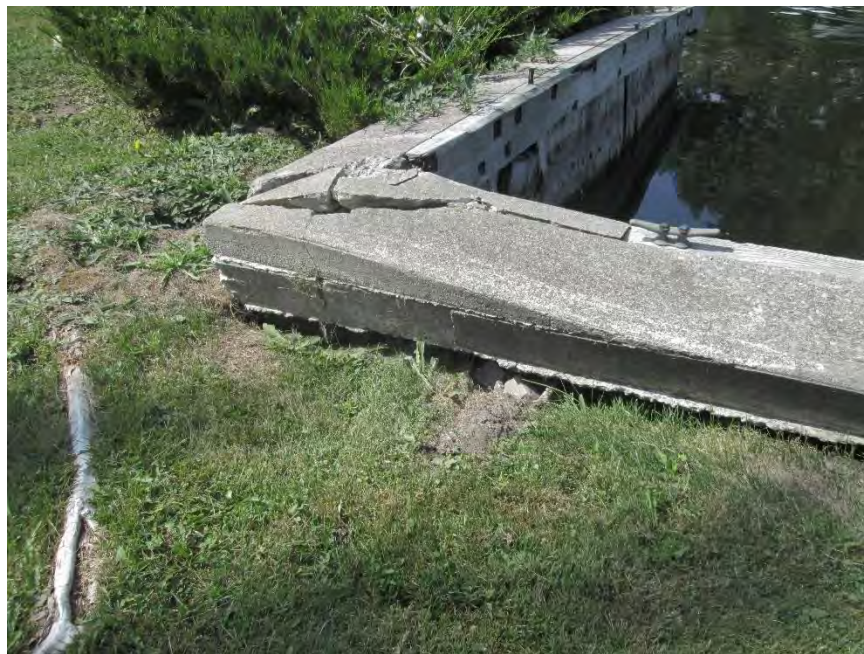
Photograph No. 12
Damaged top cap and erosion behind wall.

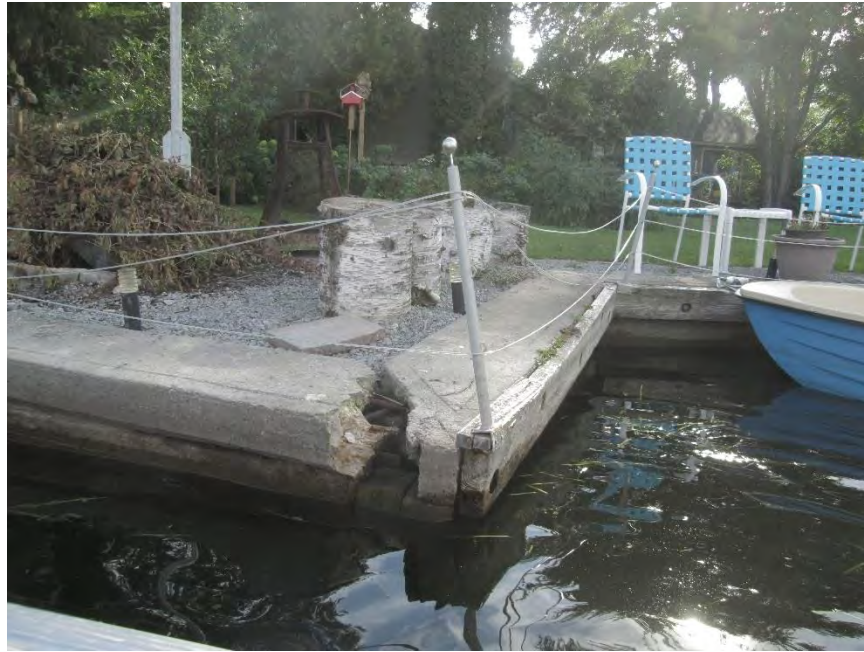
Photograph No. 13
Damaged top cap, exposed rebar and pile – settlement of wall.

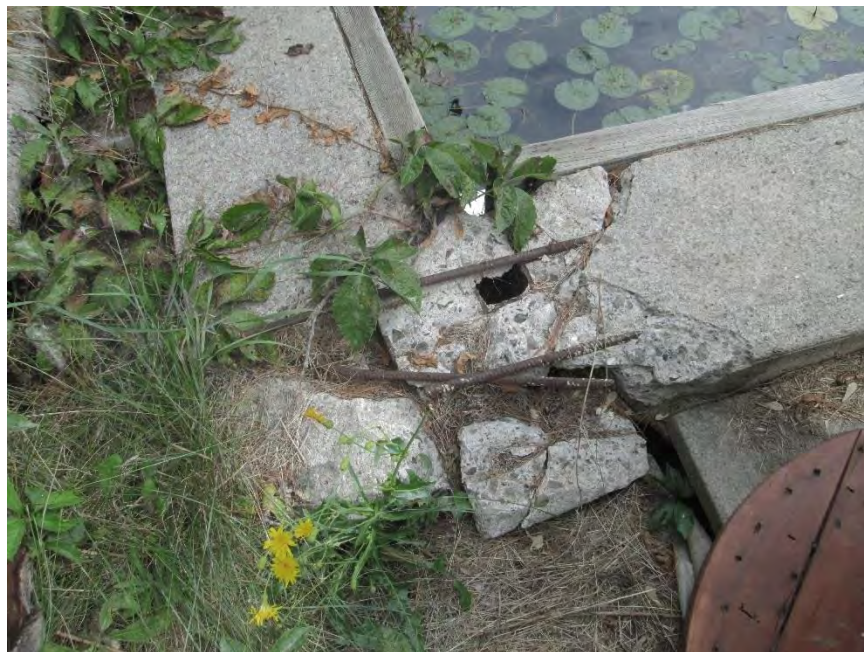
Photograph No. 14
Damaged top cap, exposed rebar and pile.

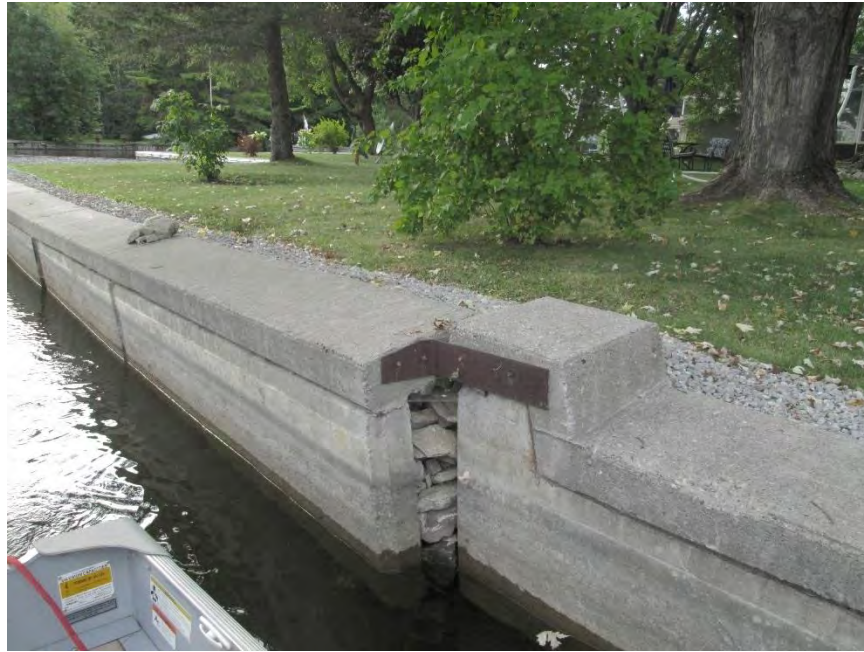
Photograph No. 15
Lateral movement in wall and repair detail.

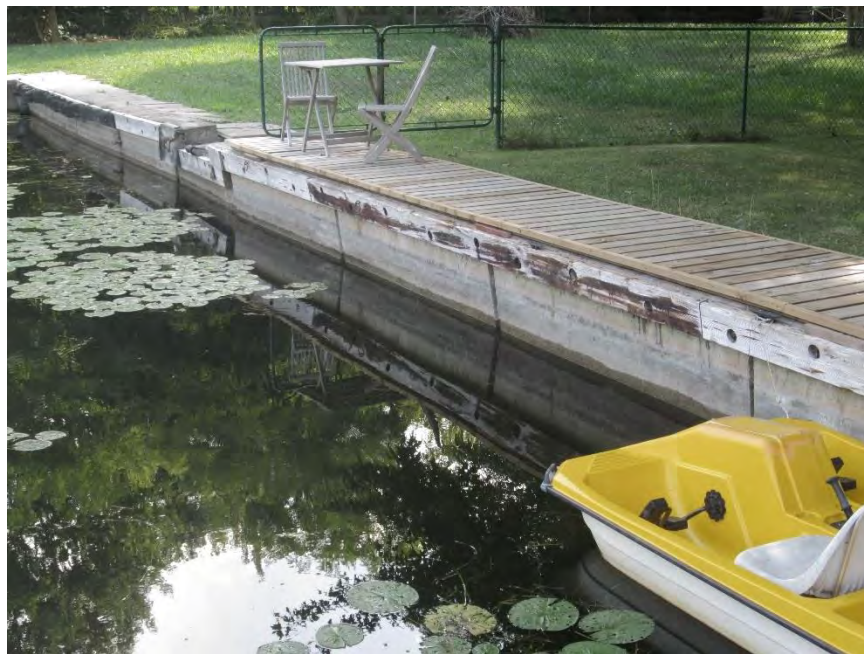
Photograph No. 16
Slight lean in top of wall towards canal.

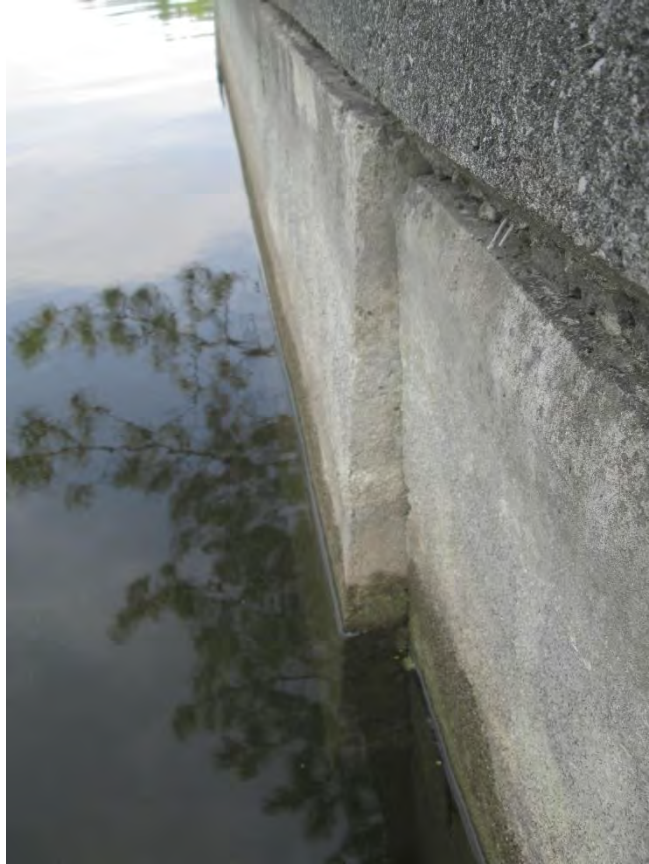
Photograph No. 17
Differential lateral movement of concrete fascia panels.

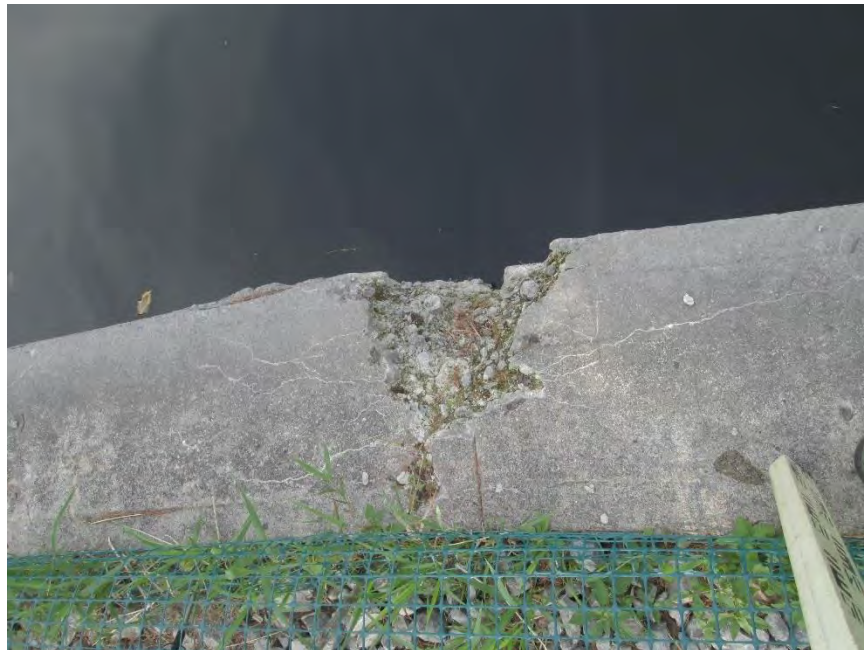
Photograph No. 18
Spalling of concrete cap with exposed rebar.

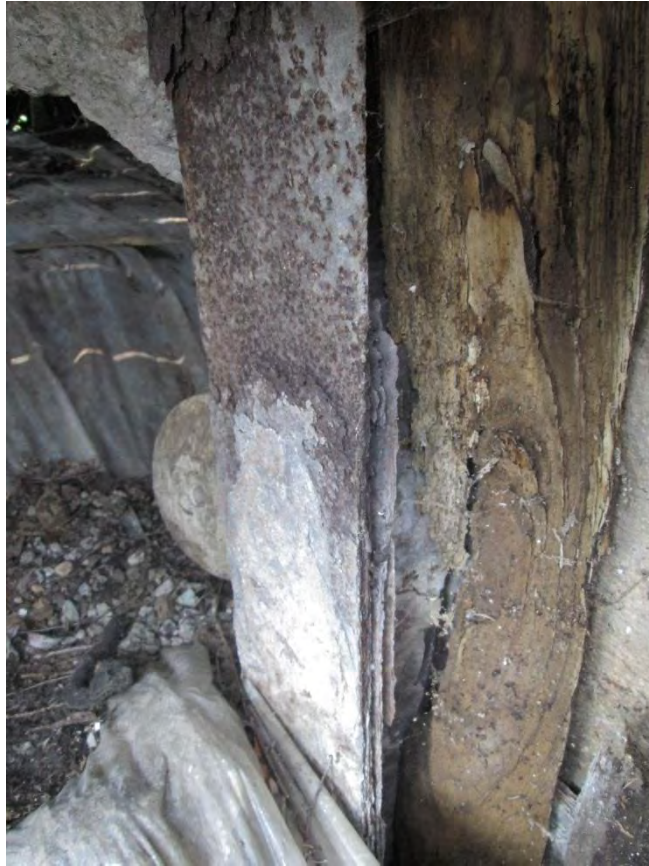
Nos. 19 & 20	Severe corrosion on exposed tieback and pile.
No. 21	Exposed tiebacks at grade with minor (surface) corrosion.
Nos. 22 to 24	Typical structures built within the restricted area (25' setback) . In most cases, the wooden decks appeared to be used to span over severe erosion on backside of wall.

Photograph No. 19
Severe corrosion (flaking) of pile flange.

- due to the corrosive nature of the existing soil, we recommend that a provision be included as part of the standard design for the protection of all exposed steel elements via a rust inhibitive coating or galvanization. During the Phase 1 inspection program, significant corrosion (flaking) was consistently observed on exposed steel elements close to the waterline;

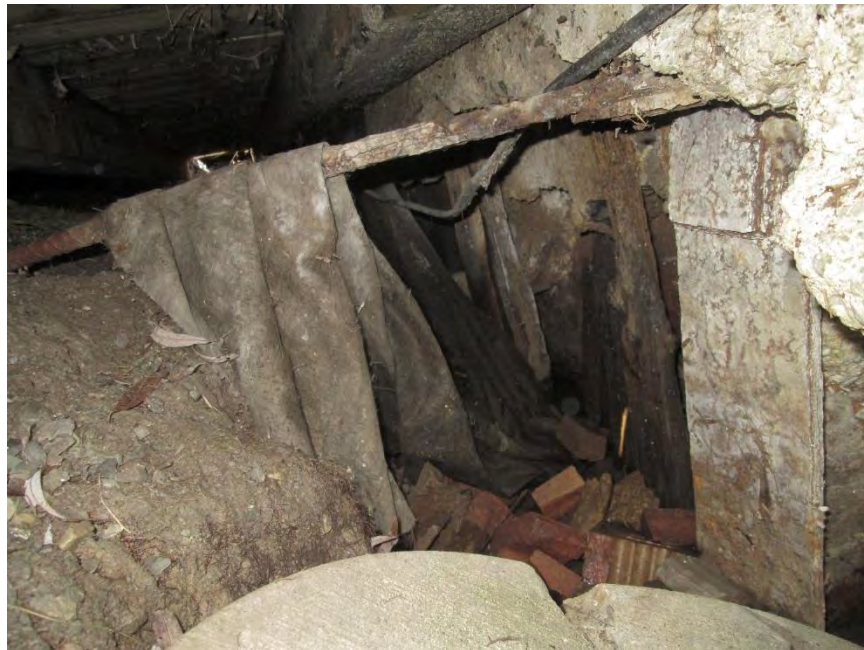
Photograph No. 20
Severe corrosion (flaking) of pile flange and tieback.

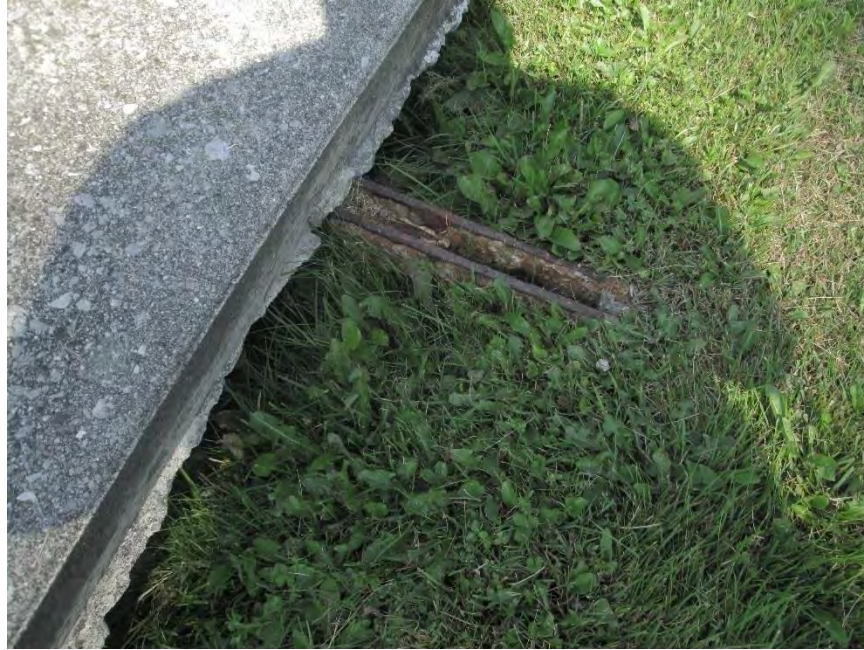
Photograph No. 21
Exposed tieback at grade with minor (surface) corrosion.

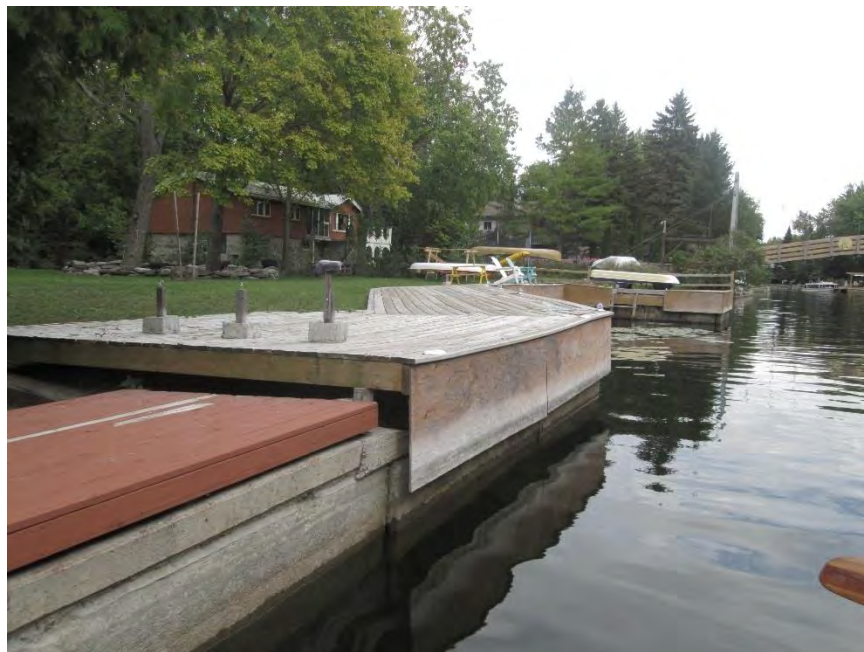
Photograph No. 22
Deck structure built within restricted area (**25' setback**).

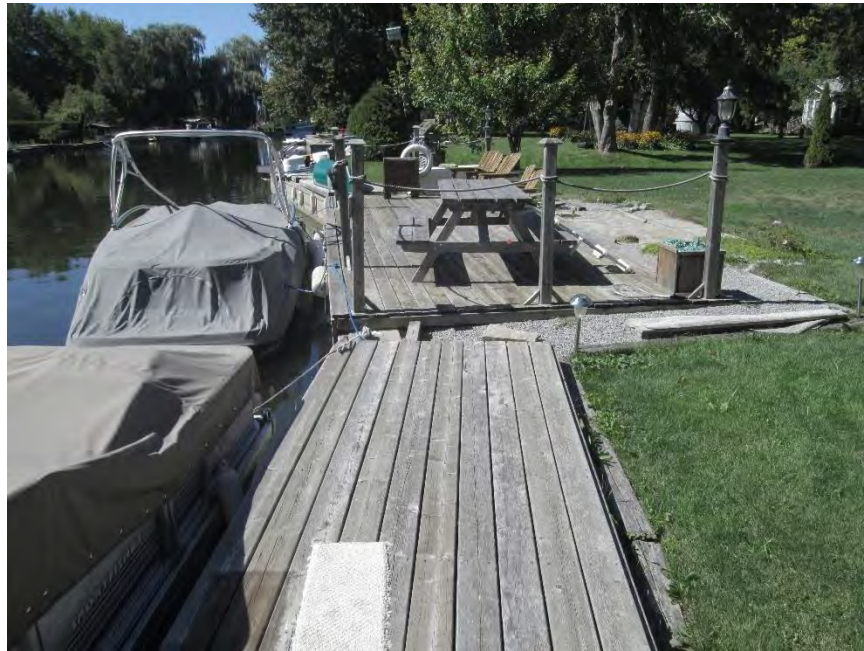
Photograph No. 23
Deck structure built within restricted area (25' setback).

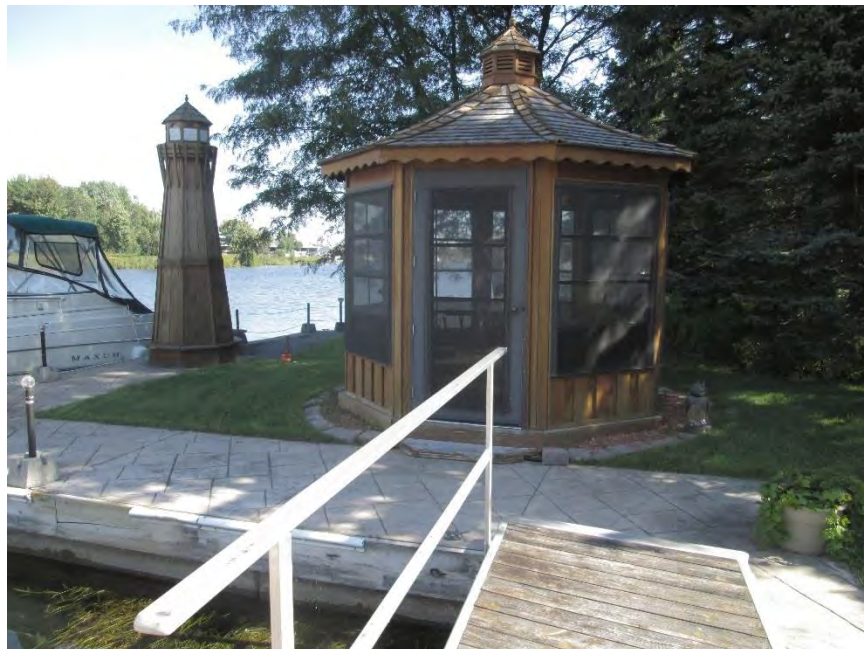
Photograph No. 24
Gazebo structure built within restricted area (25' setback).
