Bayshore Village Sewage Works

Annual Wastewater Performance Report

Prepared For: The Township of Ramara

Reporting Period of January 1st – December 31st, 2022

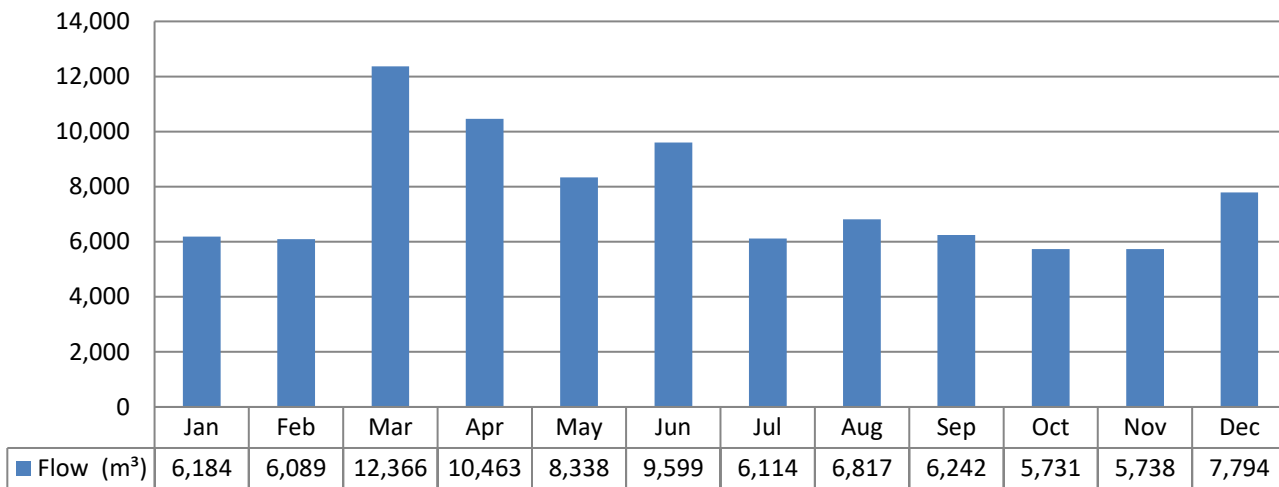
Graph 1: 2022 Influent Flow Monthly Totals

Note: The above flows are calculated based upon manual flow meter readings and was averaged.

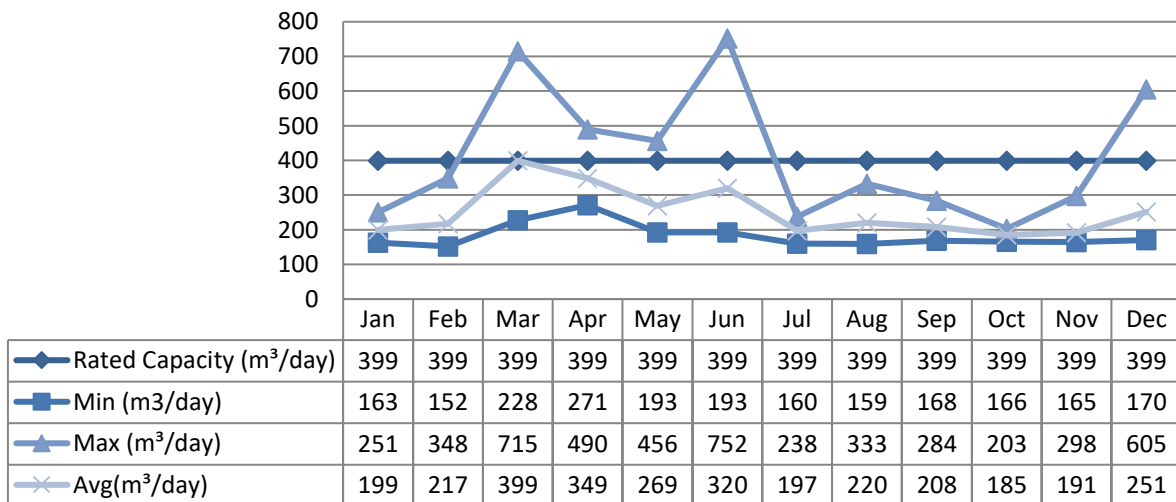
Graph 2: 2022 Influent Daily Minimum, Maximum and Average Flows

Note: Seasonally a significant fluctuation in flow trends shows higher sewage flows which indicates there is ongoing infiltration into the sewer systems. The Ontario Clean Water Agency has maintenance schedules/programs to inspect service laterals, new connections and manholes.

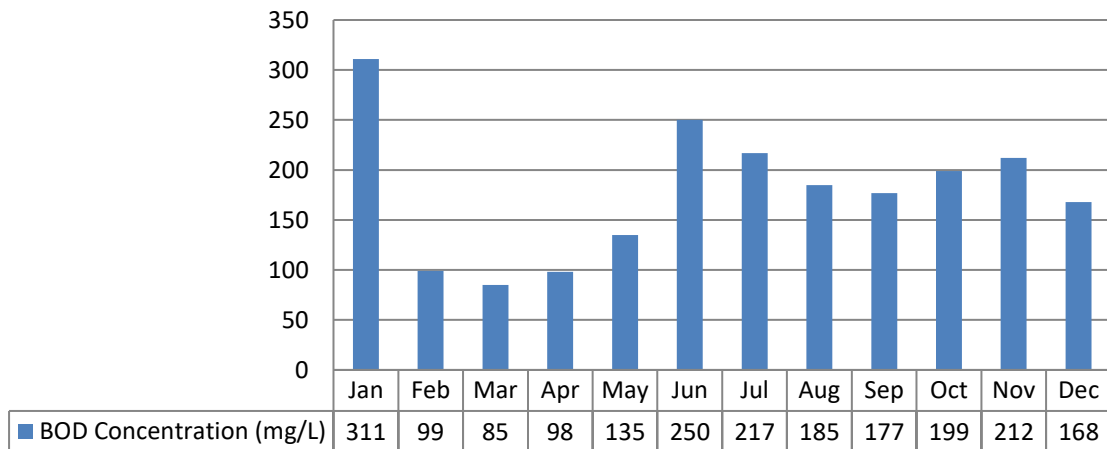
Graph 3: 2022 Monthly BOD5 Raw Sewage Concentration

BOD5 Monthly Average Concentration

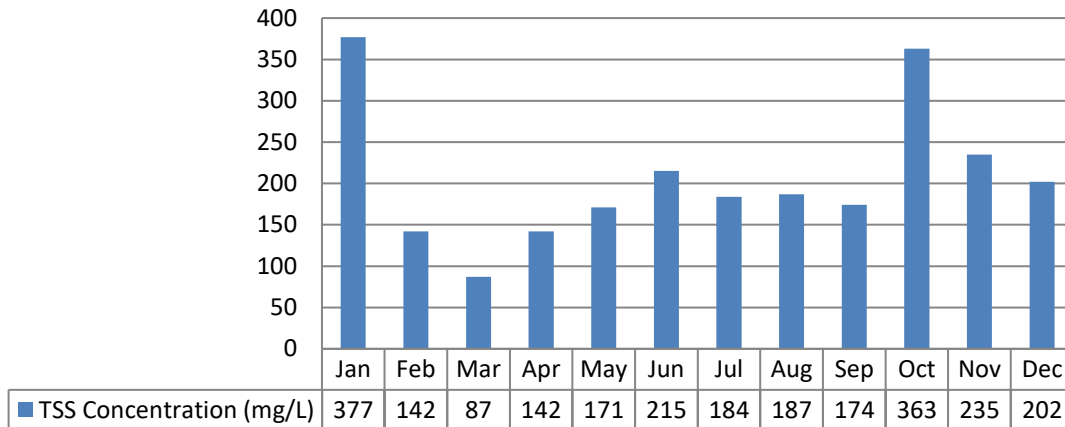
Graph 4: 2022 Monthly TSS Raw Sewage Concentration

Total Suspended Solids Monthly Average Concentration

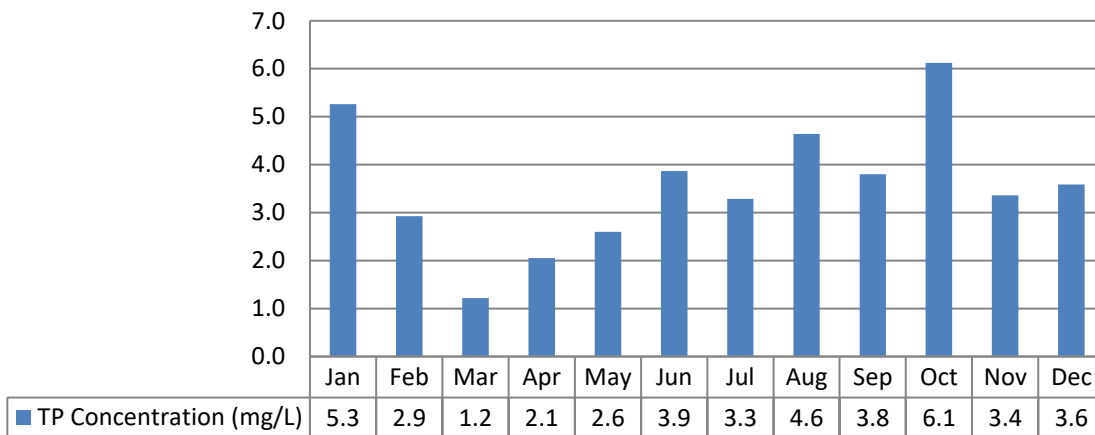
Graph 5: 2022 Monthly Total Phosphorus Raw Sewage Concentration

Total Phosphorus Monthly Average Concentration

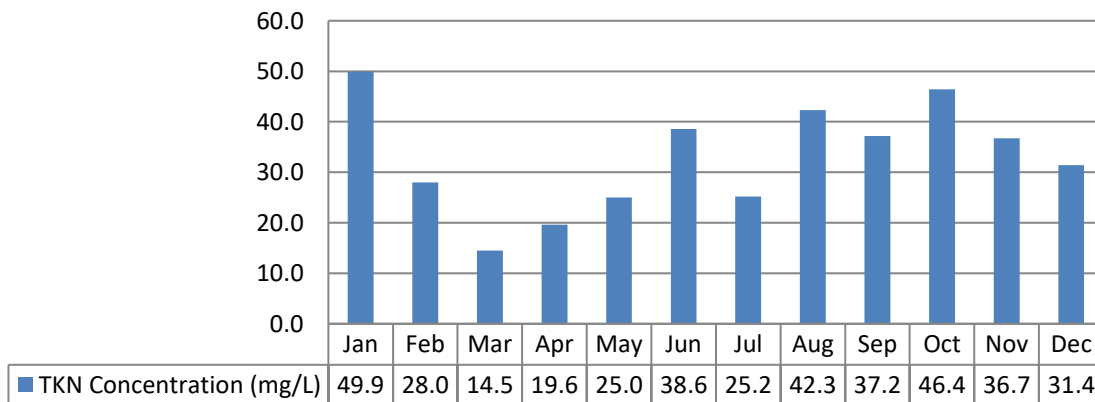
Graph 6: 2022 Monthly Total Kjeldahl Nitrogen (TKN) Monthly Raw Sewage Concentration Comparison

Total Kjeldahl Nitrogen (TKN) Monthly Raw Average Concentration
