#### Re: 2020 Performance Report for Bayshore Village Sewage Works

### **Bayshore Village Sewage Works**

### **Annual Wastewater Performance Report**

Reporting Period of January 1<sup>st</sup> – December 31<sup>st</sup>, 2020

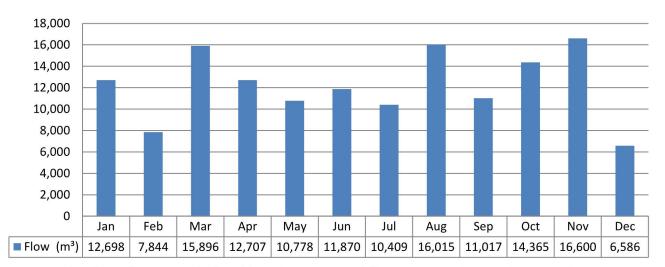
**Graph 1: 2020 Influent Flow Monthly Totals**

Note: The above flows are calculated based upon manual flow meter readings and averaged.

Condition 1.1 of the (C of A) No. 3-1337-81-968 indicates "The Owner Shall ensure that the flow of sewage into the sewage treatment plant foes not exceed the average daily flow of 399 m³/day for any part of time greater than one (1) calendar year." The annual average daily influent flow was 401 m³/day or 100.5 % of the rated capacity in 2020.

The total Influent flow in 2020 was 146 785 m<sup>3</sup>

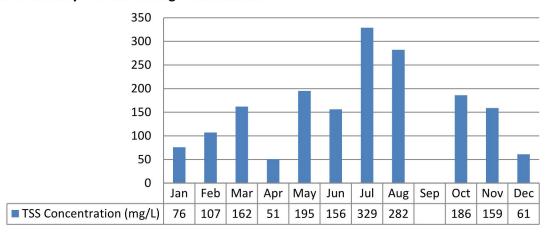
**Graph 4: 2020 Monthly TSS Raw Sewage Concentration**

Total Suspended Solids Monthly Average Concentration
