Bayshore Village Sewage Works

Annual Wastewater Performance Report

Prepared For: The Township of Ramara

Reporting Period of January 1st – December 31st, 2024

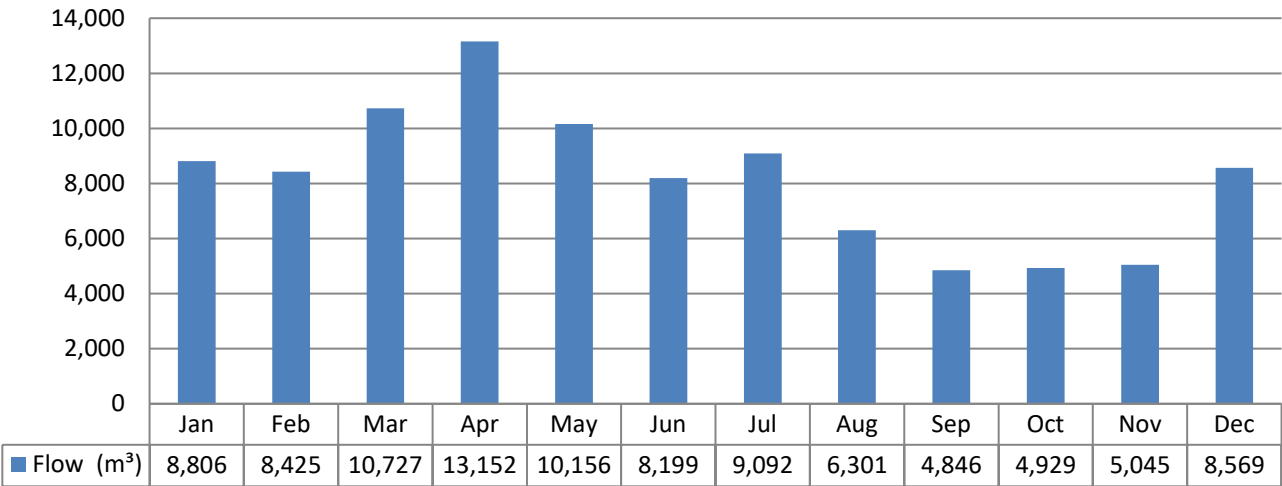
Graph 1: 2024 Influent Flow Monthly Totals

Note: The above flows are calculated based upon manual flow meter readings and was averaged.

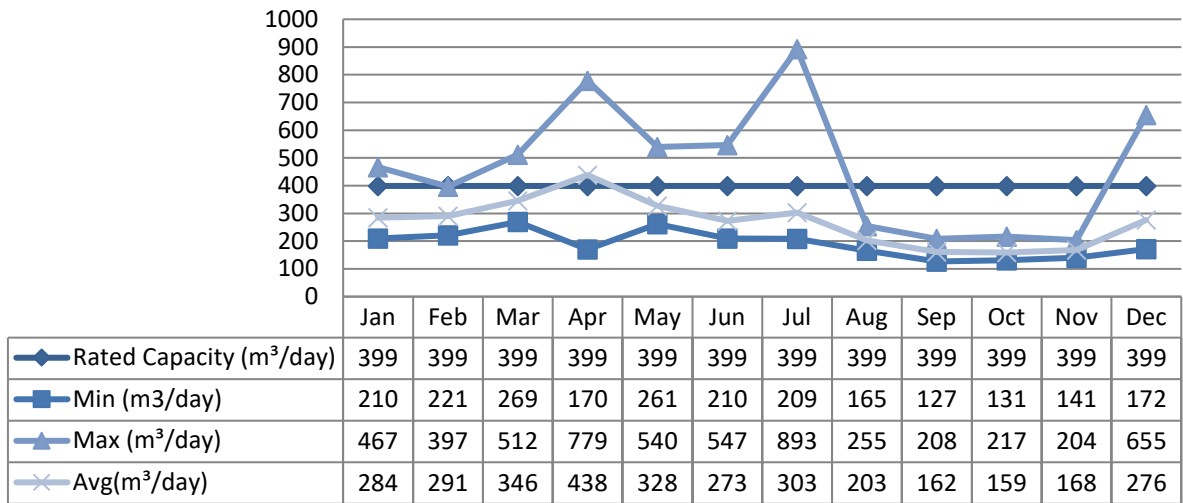
Graph 2: Influent Daily Minimum, Maximum and Average Flows

Note: Seasonally a significant fluctuation in flow trends shows higher sewage flows which indicates there is ongoing infiltration into the sewer systems. The Ontario Clean Water Agency has maintenance schedules/programs to inspect service laterals, new connections and manholes.
