WWTP-202

WASTEWATER SYSTEM # 120002264

LAGOONS/SPRAY IRRIGATION

ANNUAL WASTEWATER REPORT

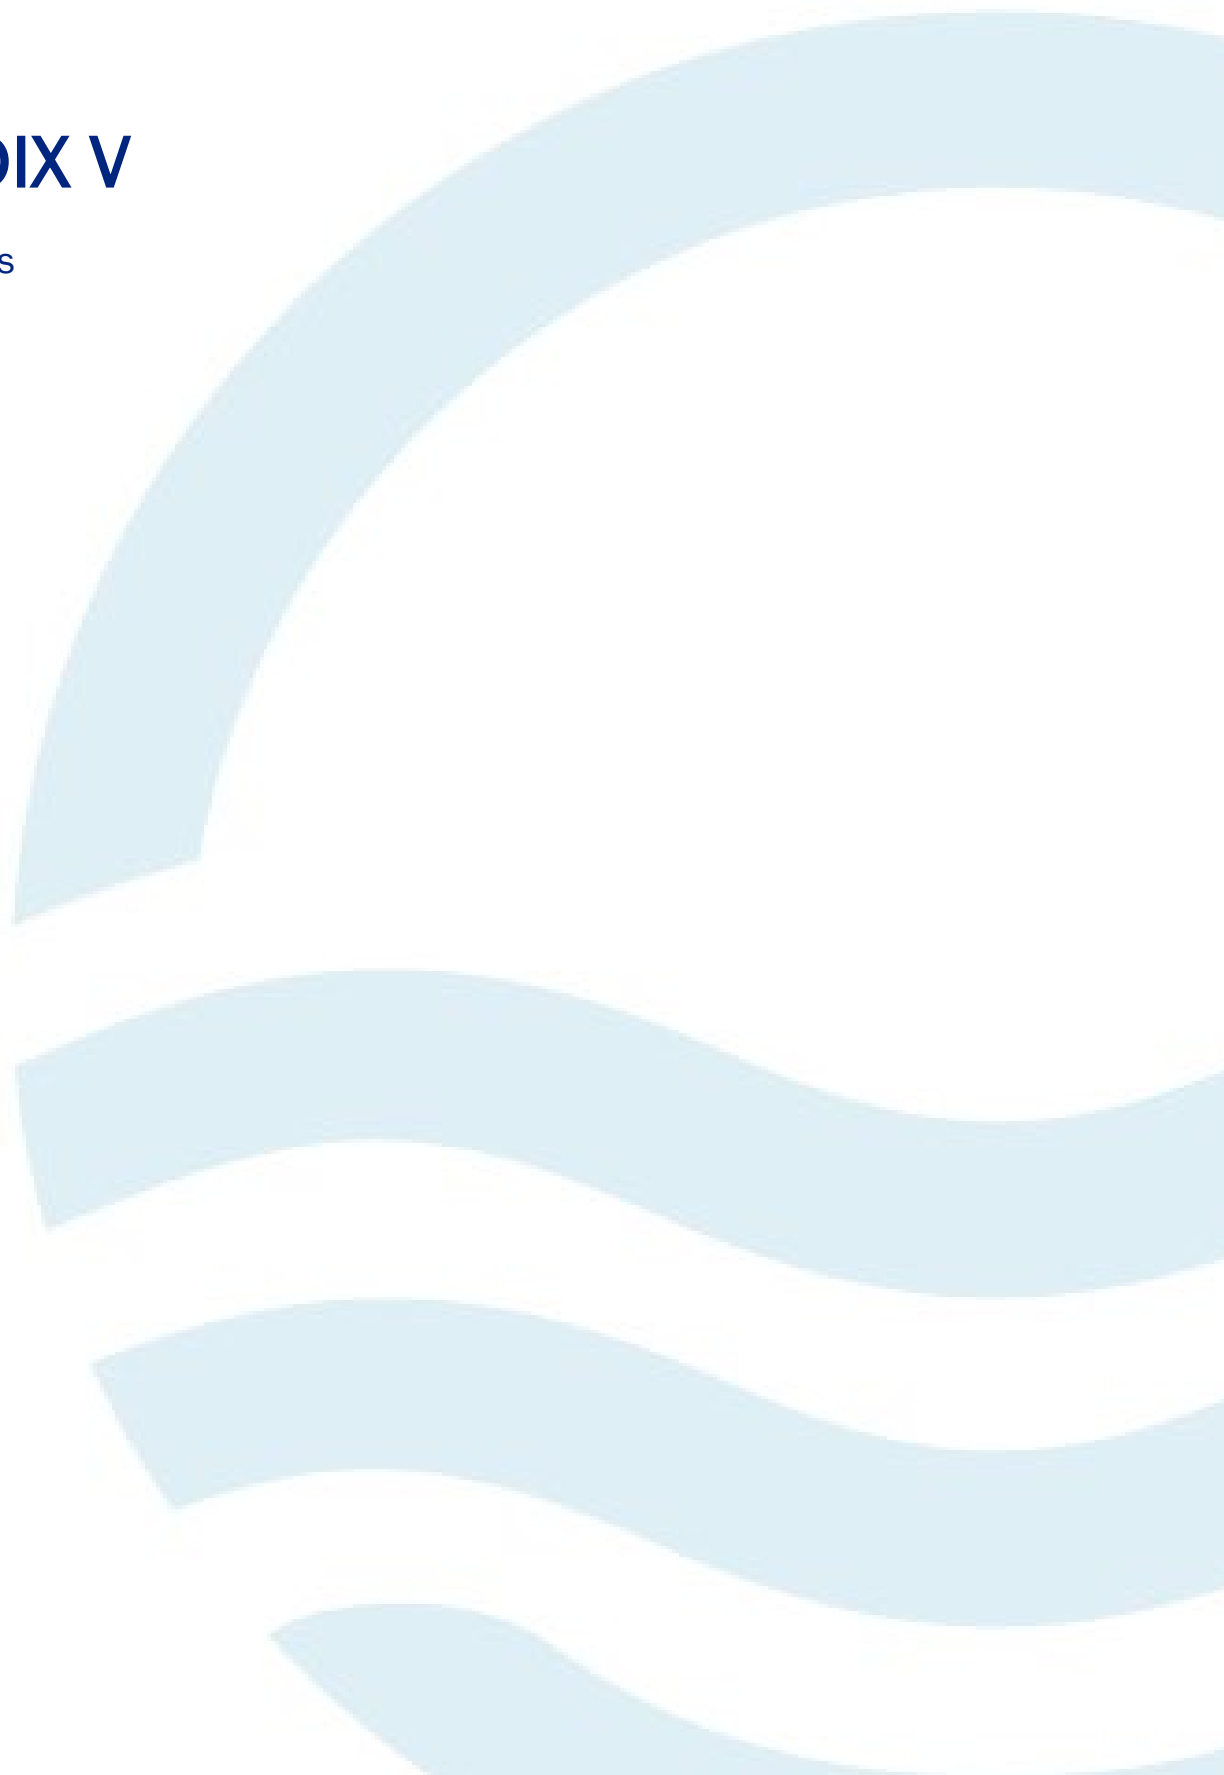
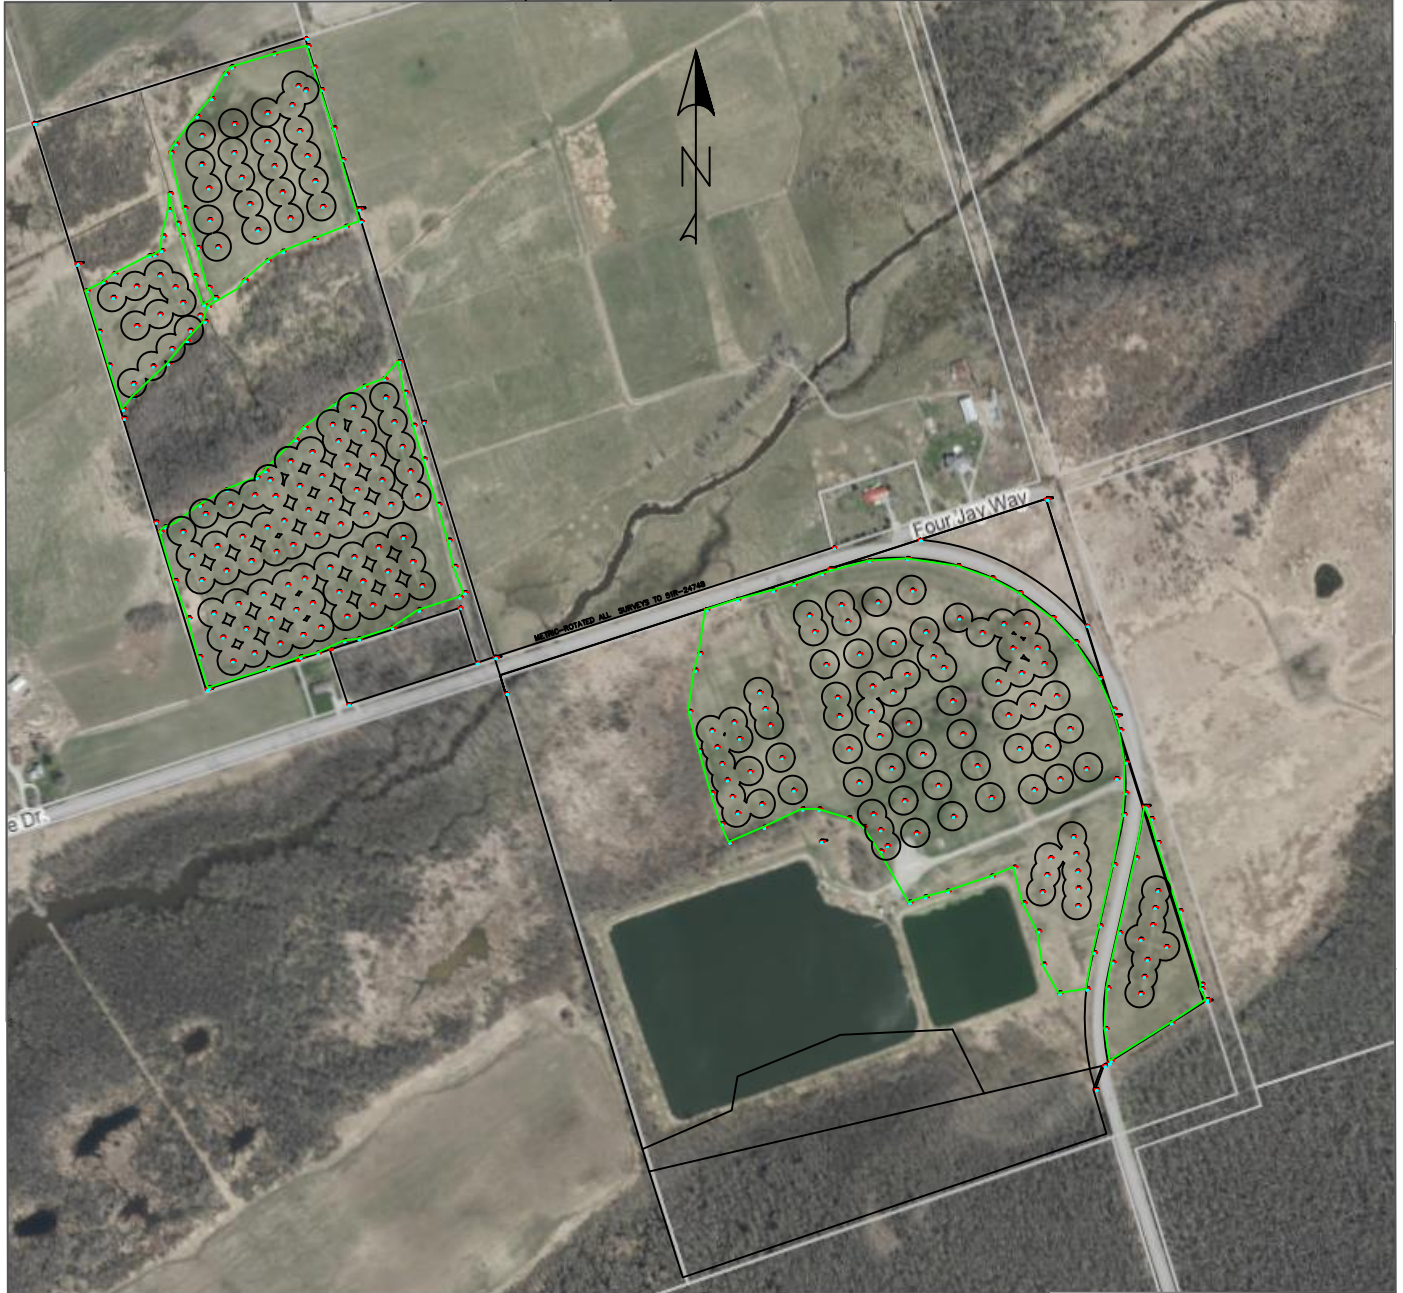
EFFLUENT SPRAY IRRIGATION FIELDS OVERALL PLAN

NORTH FIELD
 99 SPRINKLER HEADS AS OF OCT 2025
 TOTAL SPRAY IRRIGATION FIELD SIZE 107,889 m² (10.79 HA)

SOUTH FIELD
 84 SPRINKLER HEADS AS OF OCT 2025
 TOTAL SPRAY IRRIGATION FIELD SIZE 146,048 m² (14.60 HA)

The Class Environmental Assessment Final Report recommended that a survey be conducted of the piping and spigot layout, along with determining the extent of spray irrigation areas. The survey, completed in the fall, supported efforts to address concerns associated with past system operations while the Township proceeded with the design, approval, and construction of the effluent disposal bed. The survey confirmed that the North Irrigation Field has an area of 10.79 hectares and the South Irrigation Field has an area of 14.60 hectares.
