SHOREWALL INSPECTION PROGRAM

Lagoon City, Township of Ramara

Inspection Report – Phase 1
2016

Lagoon City Parks and Waterways Commission

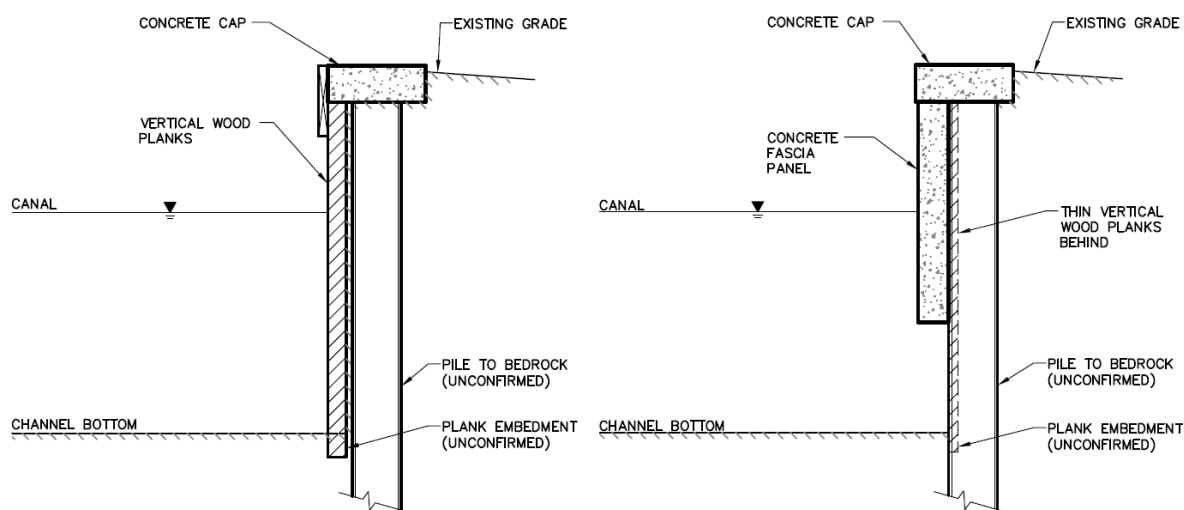
Figure 2: Typical Shorewall Construction: a) Wood Plank; b) Concrete Fascia

During our inspections, we found most of the shorewalls are constructed of either 3" thick vertical wood planks or a single concrete fascia panel with thin vertical wood planks behind as depicted in Figure 2 and Photograph Nos. 1 and 2 of Appendix C. In several instances, a mix of each wall type was installed on an individual property, typically transitioning from concrete along the main canal to wood-only within the boat slips. These wall specifications contravene those specified in the By-laws, however we believe construction of most of the shorewalls inspected during Phase 1 of the program pre-date implementation of the By-laws. Wall repairs have been completed at several properties involving the use of steel sheeting either as the main structural system or as a back-up behind the concrete fascia panel. A breakdown of the wall types constructed on each property have been provided in both Appendices D and E.
