Road, Bridge and Stormwater Networks

ASSET MANAGEMENT PLAN

2022

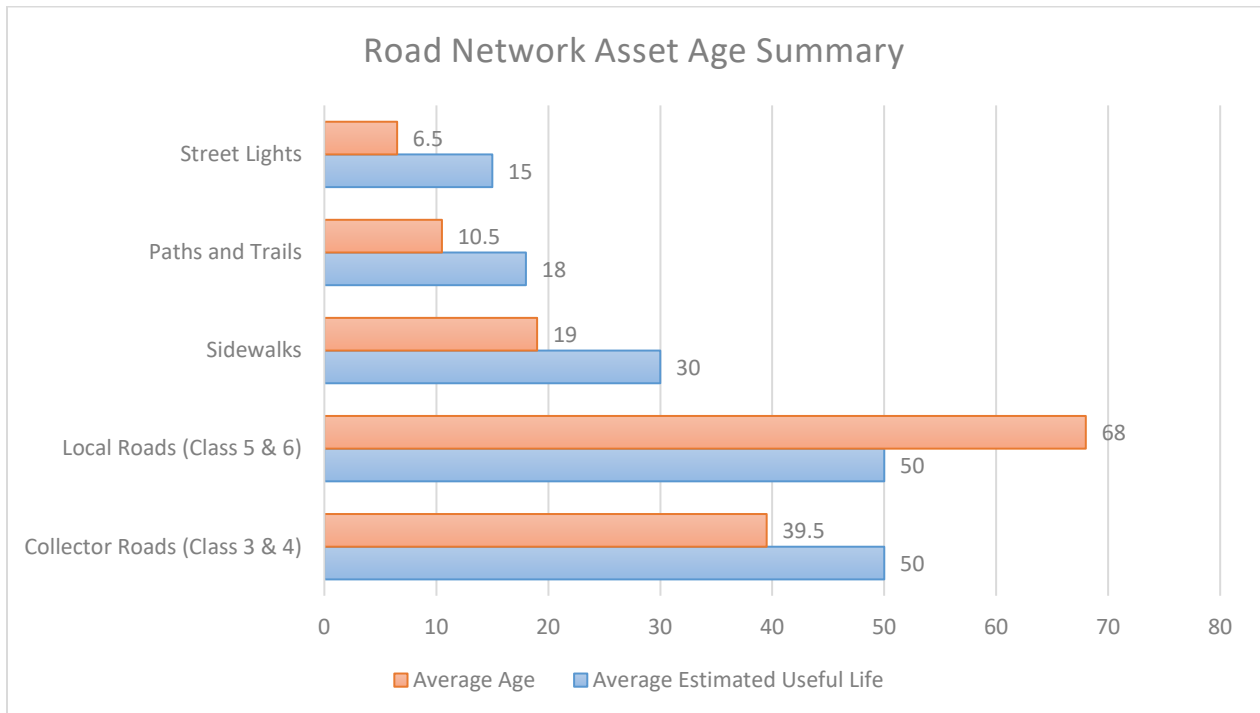
Figure 3.2: Road Network Asset Age Summary

A summary of the asset age for the Road Network Assets is shown in [Figure 3.2](#). Streetlights, sidewalks, paths and trails are in the middle range of their Estimated Useful Life. The average collector roads age will reach the end of their Estimated Useful Life within the next ten years, where the average local road age exceeds the Estimated Useful Life by 18 years.

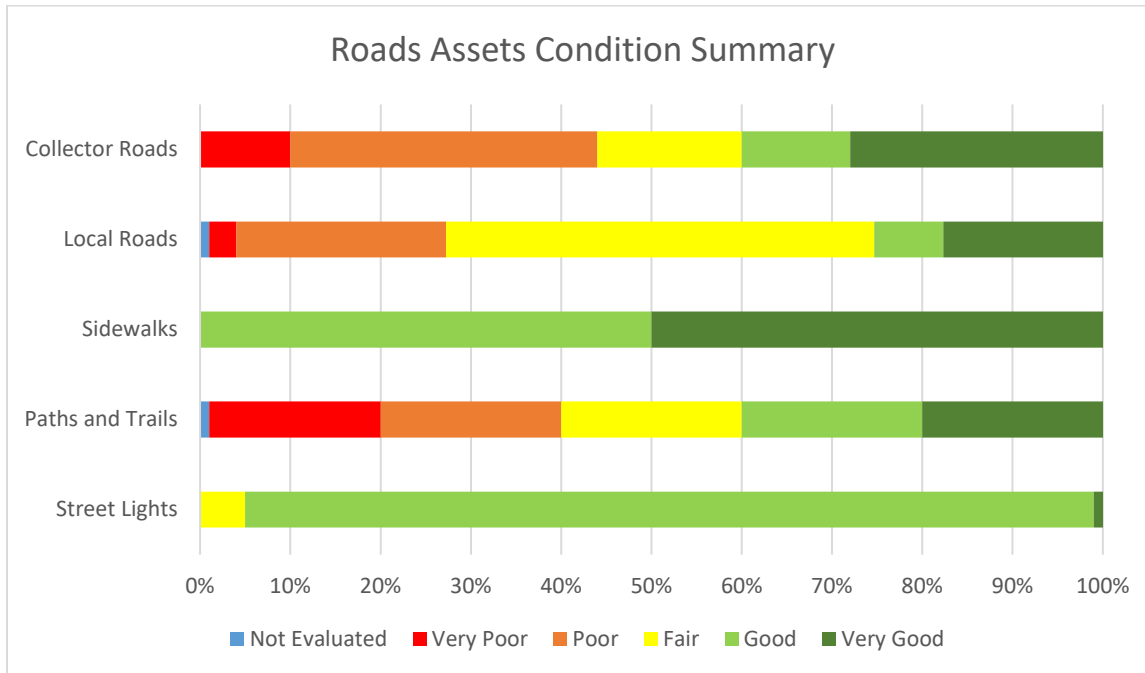
Figure 3.3 Road Network Asset Condition Summary

Figure 3.3 shows the overall condition assessments for the assets within the Road Network

Road evaluations show **40% of Collector roads were rated as Good or Very Good**, while **26% of Local roads were graded as Good or Very Good**, with 47% of Local Roads in Fair condition.

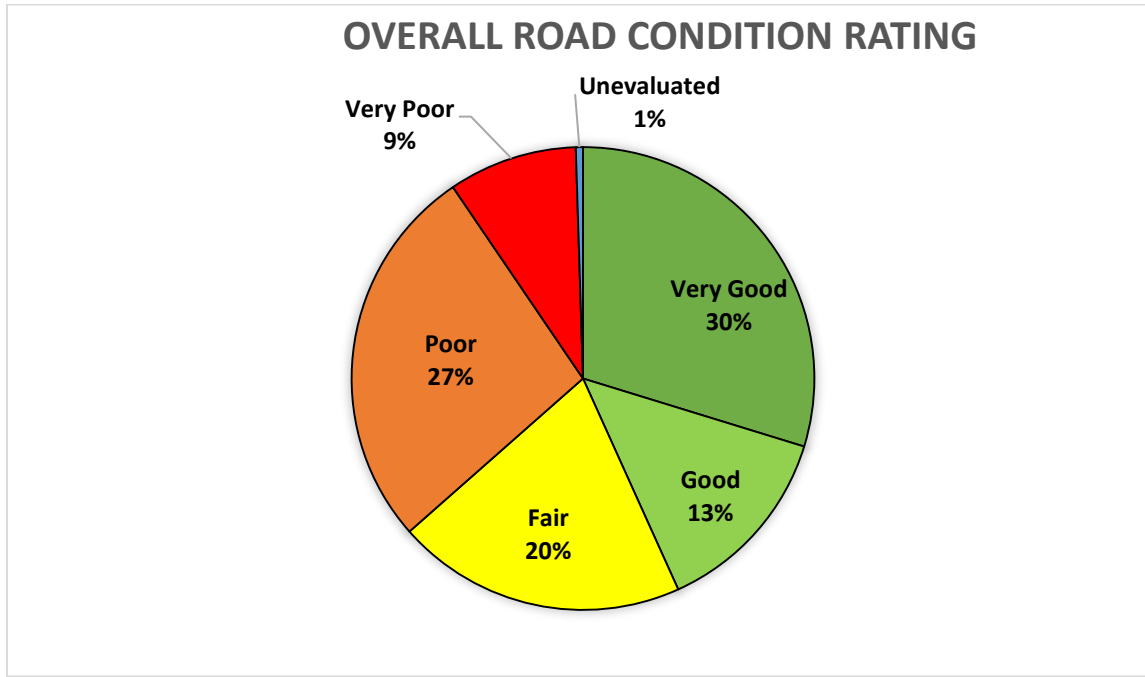
Figure 3.8: Overall Road Condition by Length

The pie chart below shows the overall road condition rating by length of road segment and its condition. 36% of all the kilometers of roads in the Township (regardless of class or surface type) are currently rated as “poor” or “very poor”.

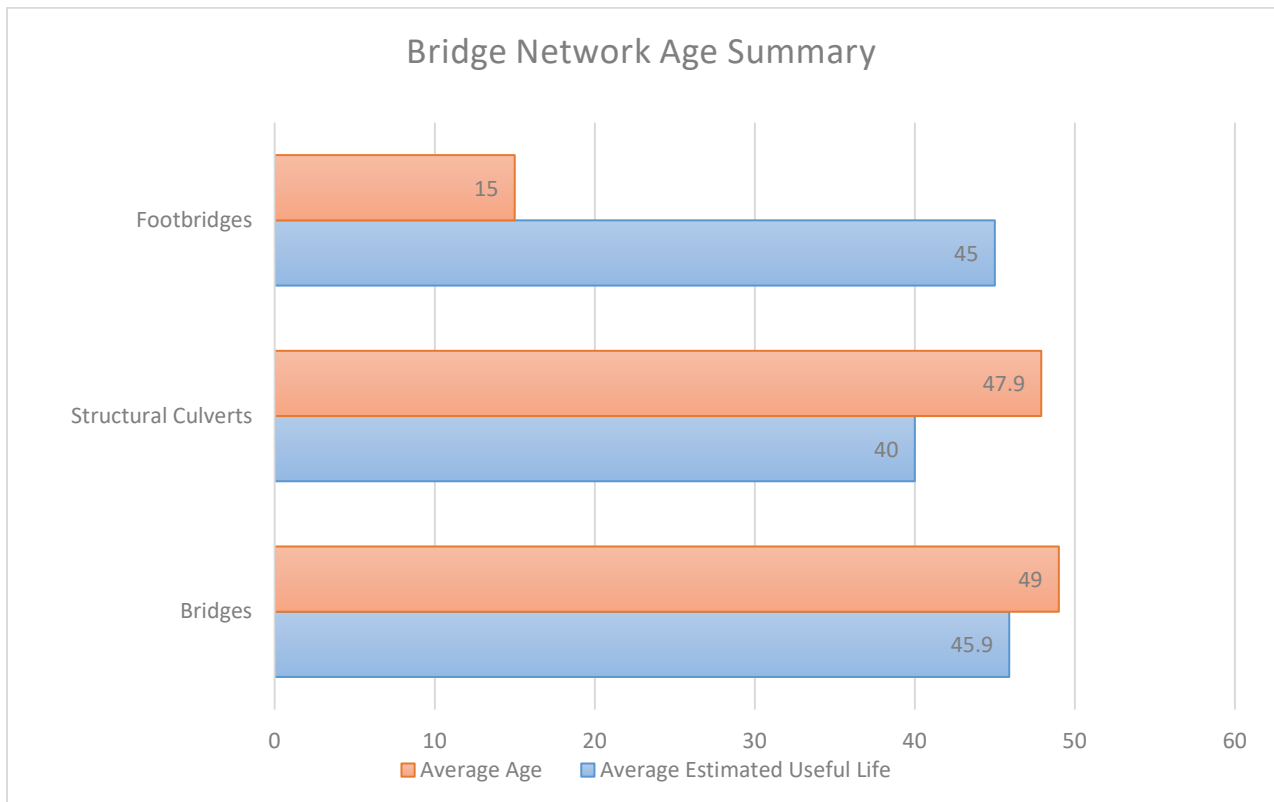
Figure 4.3: Bridge Network Age Summary

A summary of the asset age for the Bridge Network Assets is shown in Figure 4.3. The footbridges in Lagoon City are early in their estimated useful life, while the structural culverts and road bridges on average have exceeded their Estimated Useful Life. The current bridge inventory in Ramara are older bridges, in Lagoon City for example most bridges are made with timber. As bridges are replaced, the new Estimated Useful Life should be 75 years instead of the current 40-50 year lifespan.

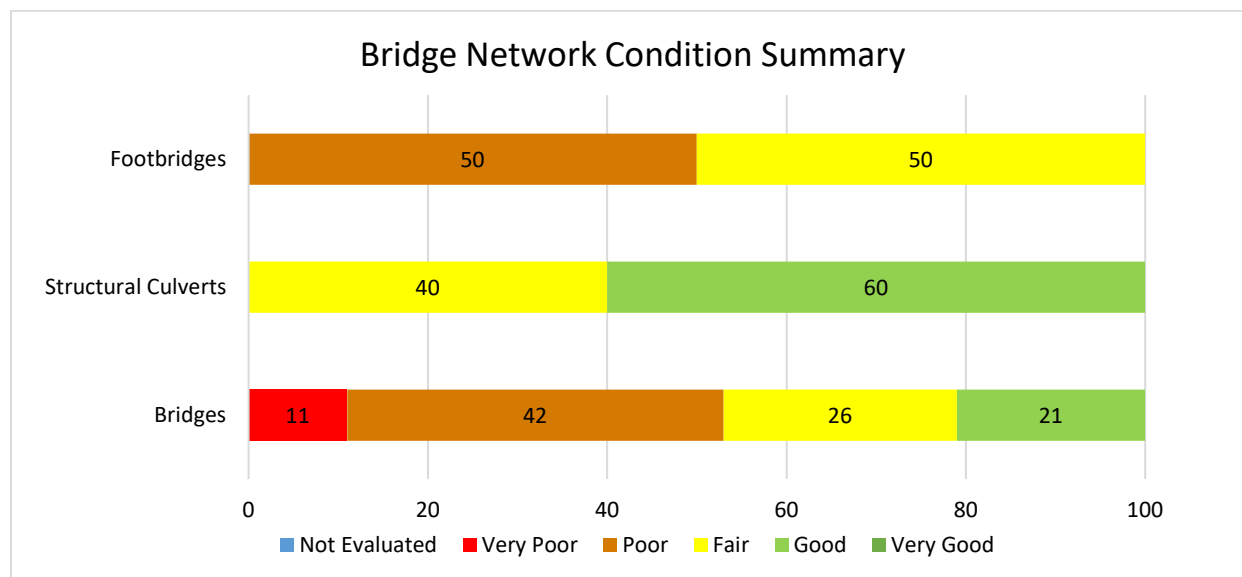
Figure 4.4: Bridge Network Asset Condition Summary (values in percentage of overall asset type)

There are two bridges (Bridges 13 & 14) on unopened road allowances, both rated as very poor. They are not planned for replacement.

60% of the structural culverts were all rated as Good overall condition with an average BCI of 74.5. Three of the five culverts had limited access due to high water and distance. It is recommended in the report that closer inspections be done on these culverts during the 2023 study.

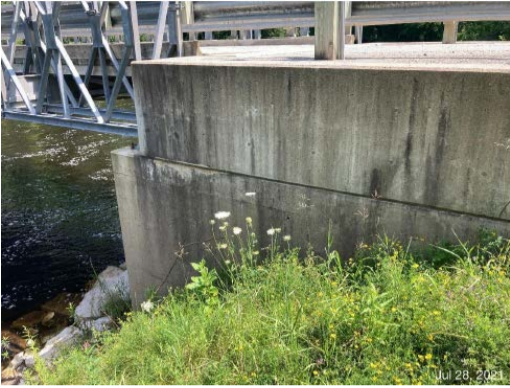
Condition	Images of the condition of bridges
<p>Very Good Condition</p> <p>No repairs needed</p>

Table 4.8: Description and Images of Bridge Condition

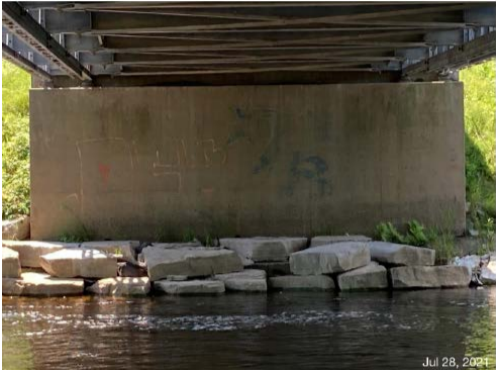
<p>Good Condition</p> <p>Minor Rehab within 1-5 years. (example, deck repairs)</p>

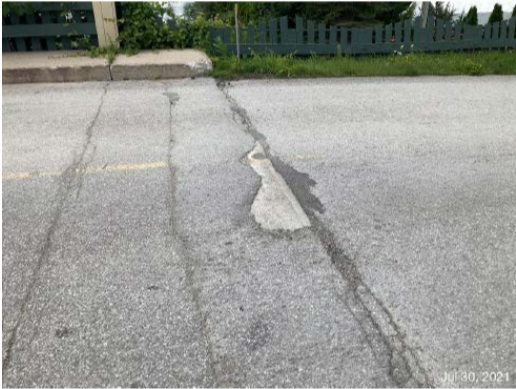
<p>Fair Condition</p> <p>Wearing surface over joint seal and approach slab</p> <p>Rehabilitation or Replacement required within 6-10 years</p>

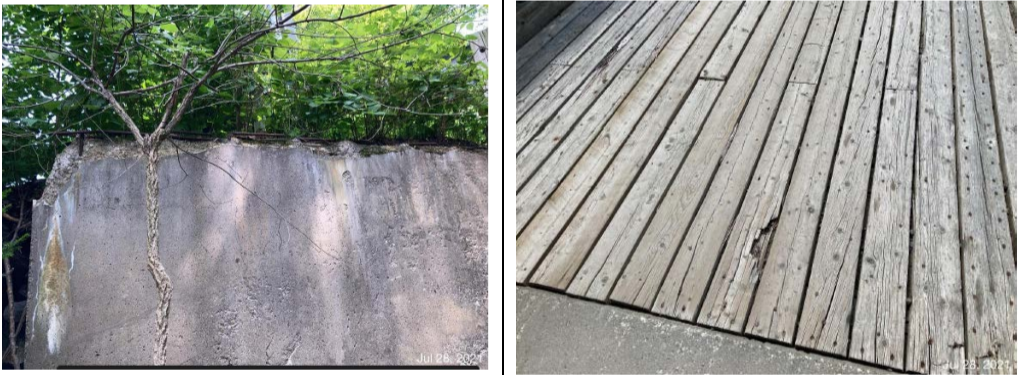
<p>Poor Condition</p> <p>Concrete loss and exposed rebar on wingwalls. Poor condition timber deck</p> <p>Rehabilitation or Replacements within 1-5 years</p>

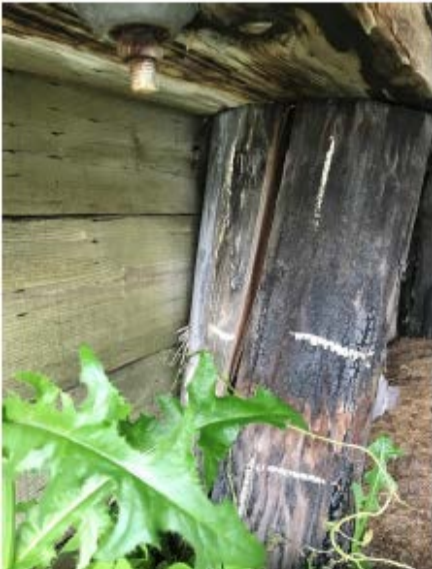
<p>Very Poor</p> <p>Decayed and crushed timber piles</p> <p>Rehabilitation or Replacement required immediately</p>

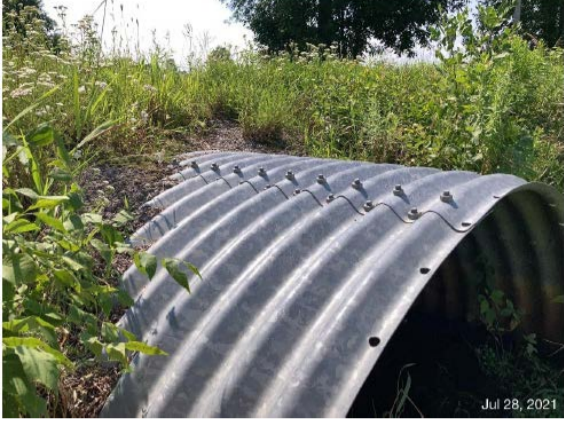
Condition	Description
<p>Very Good</p> <p>No repairs needed</p>

Table 4.9: Description and Images of Culvert Condition

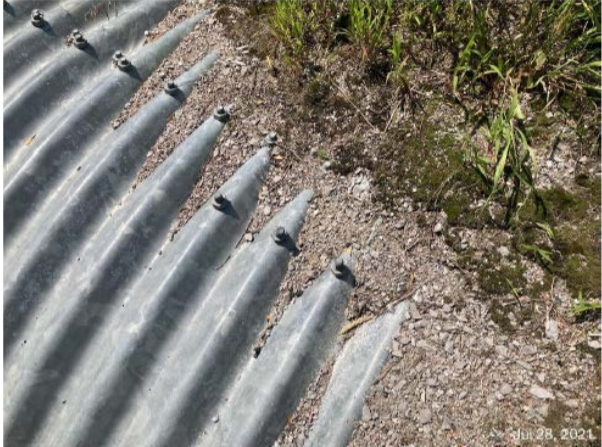
<p>Good</p> <p>Minor repairs or service such as tightening or replacement of bolts</p>

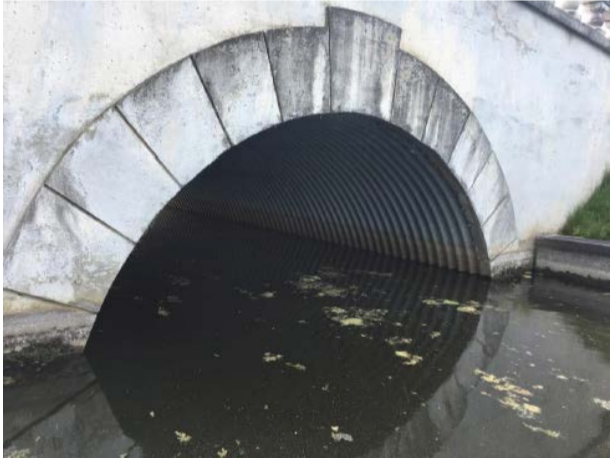
<p>Fair</p> <p>Acceptable condition and components generally functioning as intended</p> <p>Minor rehabilitation may be required within 6-10 years</p>

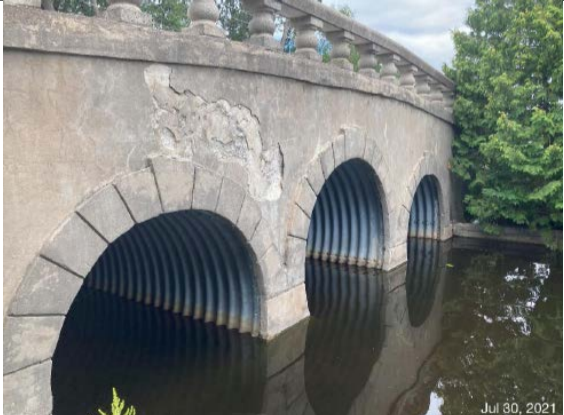
<p>Poor</p> <p>Presence of distresses or significant deterioration with components</p> <p>Rehabilitation or replacement required within 1-5 years</p>

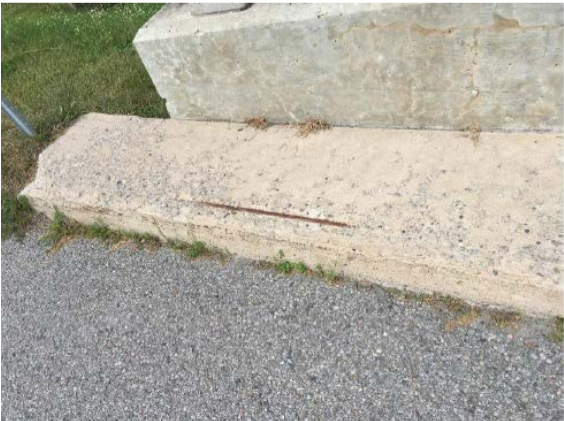
<p>Very Poor</p> <p>Structural Integrity compromised. Immediate repair required</p>

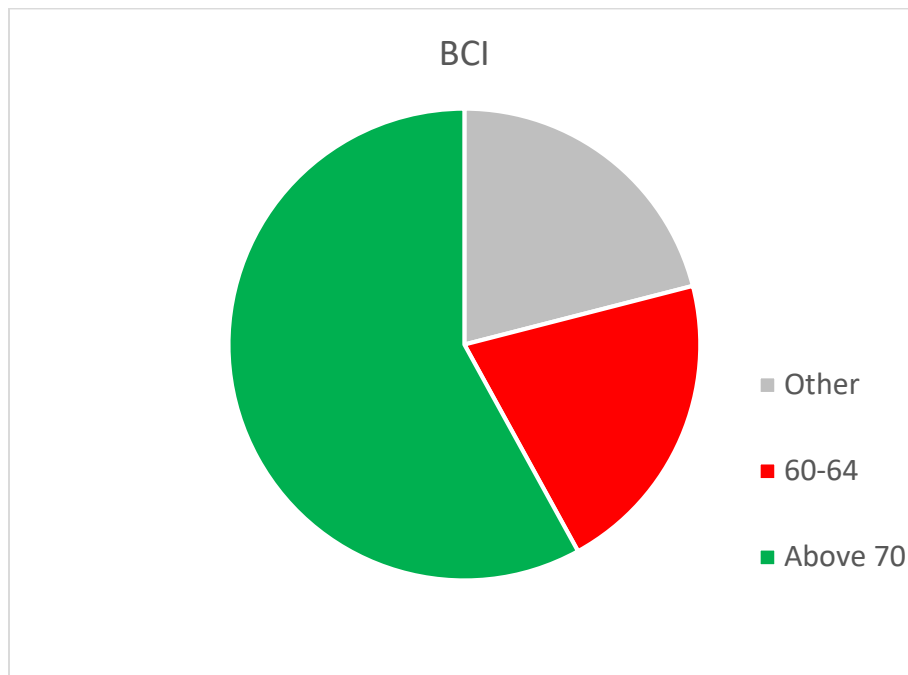
Figure 4.10 Bridge Condition Performance Measures

Figure 4.10 shows the percentage of bridges that have a BCI between 60 and 64. These bridges are more likely to have rehabilitations/repairs **within the next 5 years and require short term planning**. Conversely, the percentage of bridges with a BCI over 70 is also being highlighted as these bridges are generally in good repair with maintenance not usually required within the next 5 years.

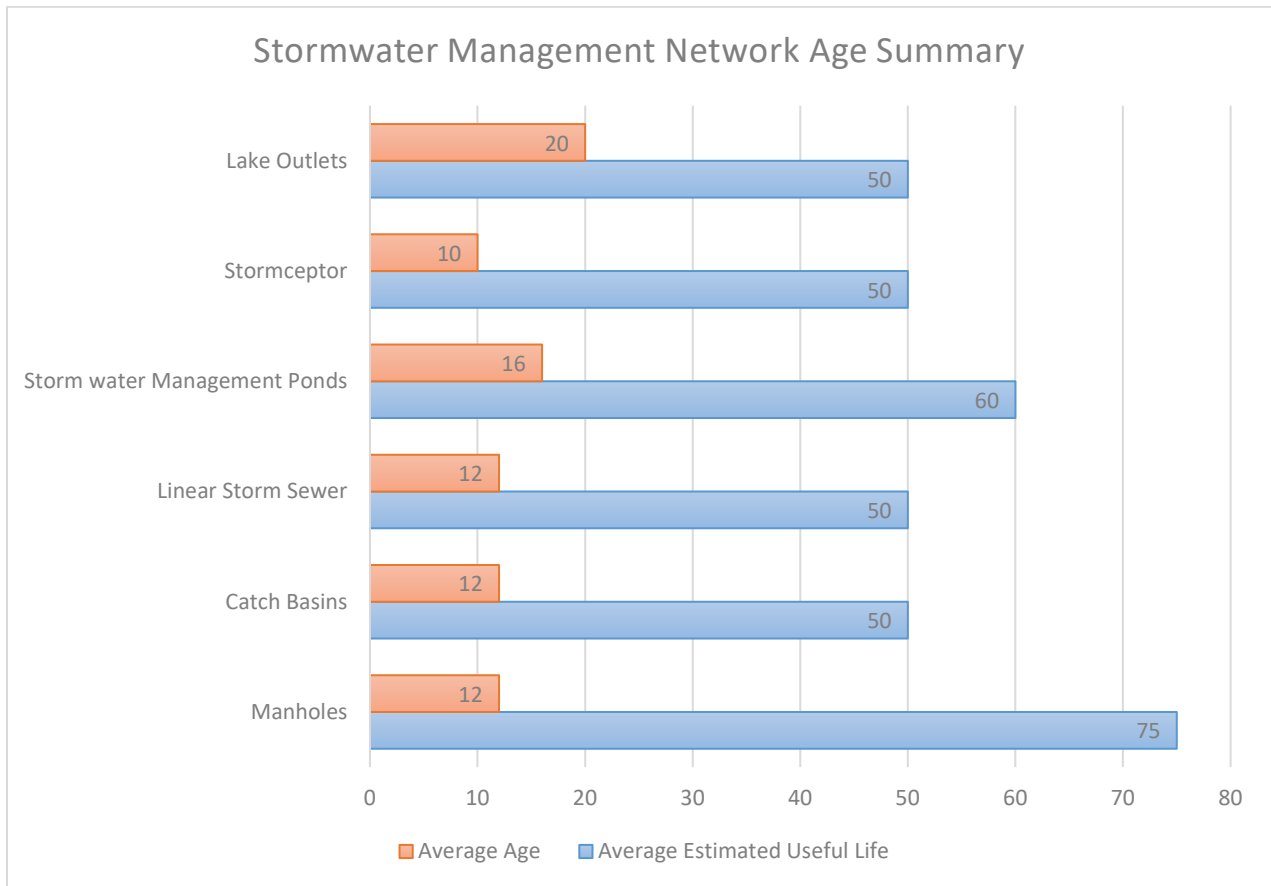
Figure 5.2 Stormwater Management Network Age Summary

A summary of the asset age for the SWM Network is shown below. Most of the storm water management assets are early in their Estimated Useful Life. The average SWM pond is 16 years old, and most manholes, catch basins and ditch inlets have been installed within the last 12 years.

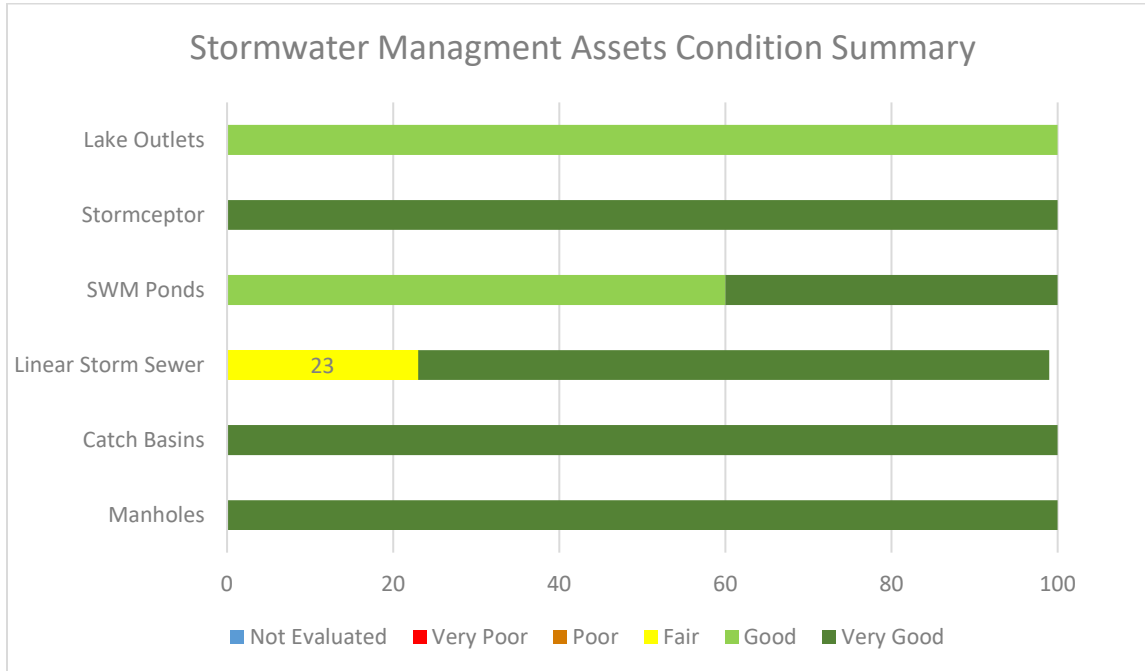
Figure 5.3 – Stormwater Management Condition

Figure 5.3 shows the overall condition assessment of the assets within the Storm Water Management Network.

The Condition assessments are based on annual or biannual inspections during maintenance and clean out procedures. Most of the Township's Stormwater Management Infrastructure is fairly young in age and is **in Good or Very Good Condition**. Any impairments on functionality are noted and the maintenance and/or rehabilitation are scheduled and completed accordingly. There has been some drainage impairment noted in the Brechin area during heavy rain fall, this section is in fair condition.
