# **Report to the Township of Ramara for Inflow and Infiltration Study**

Date: April 20, 2023  
Project No: RAMARN1616-2233  
Rev: 2

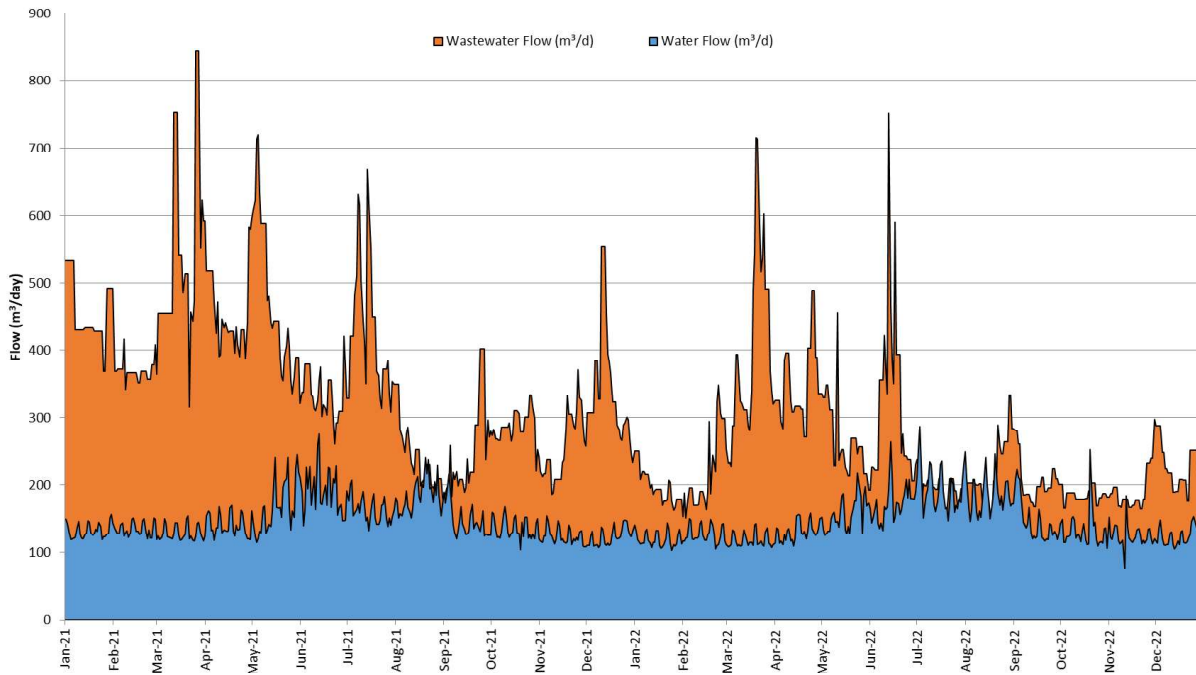
In Figure 1, the water flow data reflect typical usage patterns, higher in the summer months as lawn watering and other seasonal activities occur and lower in the winter. However, Figure 1 also shows that the Township's sanitary flows are significantly higher than the treated water flows until late May 2022 when the wastewater flows decrease.

Figure 1: Comparison of Water and Wastewater Flows (January 2021 to December 2022)

Similar to the 2022 Report, a high level analysis of flow rates from the local water and wastewater treatment facilities was conducted, however this analysis included data from 2022 as shown in Figure 1 where the Township's treated water flow (blue) is plotted with raw wastewater flow (orange). In a perfect system, the amount of treated water produced would be equal to or greater than the amount of wastewater ultimately entering the wastewater system.

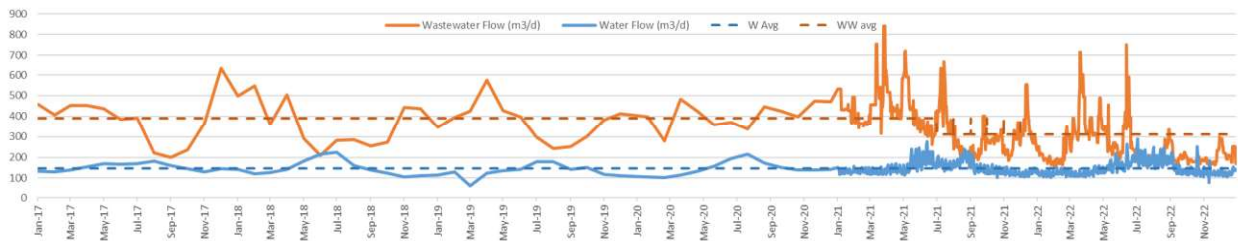
Overall, the wastewater flows appear to have decreased since the same analysis was conducted for the 2022 Report. When the full data range is plotted (Figure 2), it is apparent that although the average water supplied has remained constant at approximately 146 m<sup>3</sup>/day throughout the study period, the wastewater flows have decreased 20% from 389 m<sup>3</sup>/day (Jan 2017 to June 2021) to 310 m<sup>3</sup>/day (July 2021 to Dec 2022). This decrease could be attributed to drier weather or successful excess flow reduction efforts. In order to better determine which is true, a precipitation analysis was conducted (Sections 2.1.1 and 2.1.2).

Figure 2: Comparison of Water and Wastewater Flows (January 2017 to December 2023)

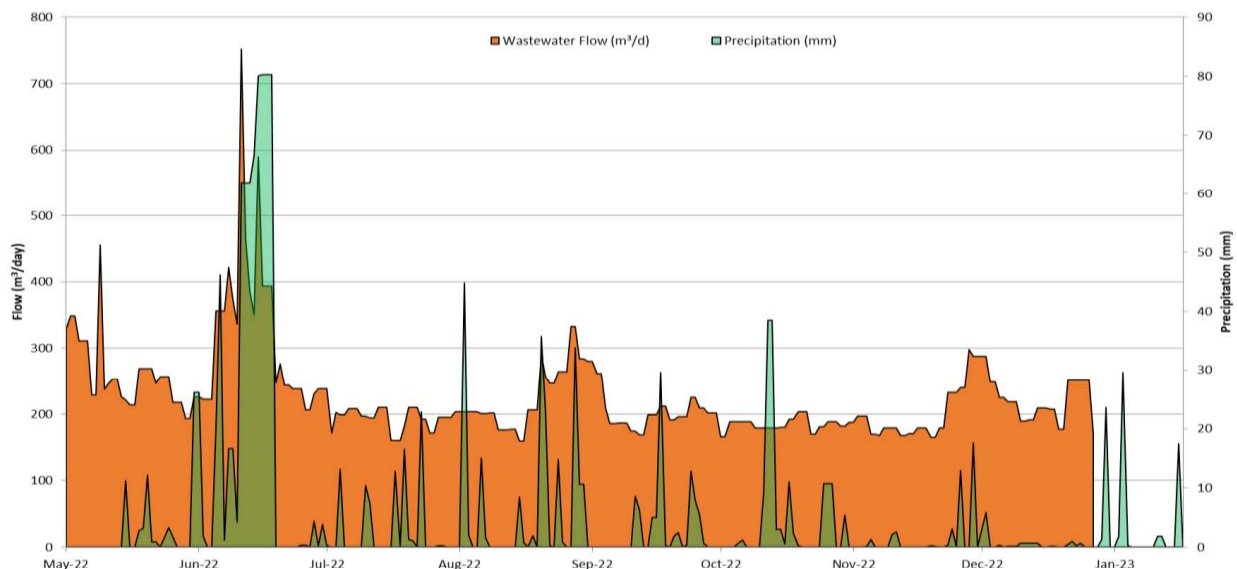
Since that report, a weather station was installed in the Bayshore area. The data collected from May 2022 to January 2023 was then compared to incoming wastewater flows (Figure 3).

Figure 3: Comparison of Wastewater flow and Local Precipitation (May 2022 – Jan 2023)

The more detailed (and localized) data in Figure 3 show that:

- Individual rain events seem to have little effect on wastewater flows. This can be seen in the rain events observed in July, early Aug, and October. This indicates that inflow (cross-connections, downspouts, etc.) are not a significant factor as inflow tends to be noticeable during/immediately following rain events.
- Continuous rain over several days will trigger an increase in wastewater flows, as seen in the June and late August events. A high frequency of rain events will saturate the ground and potentially lead to infiltration.

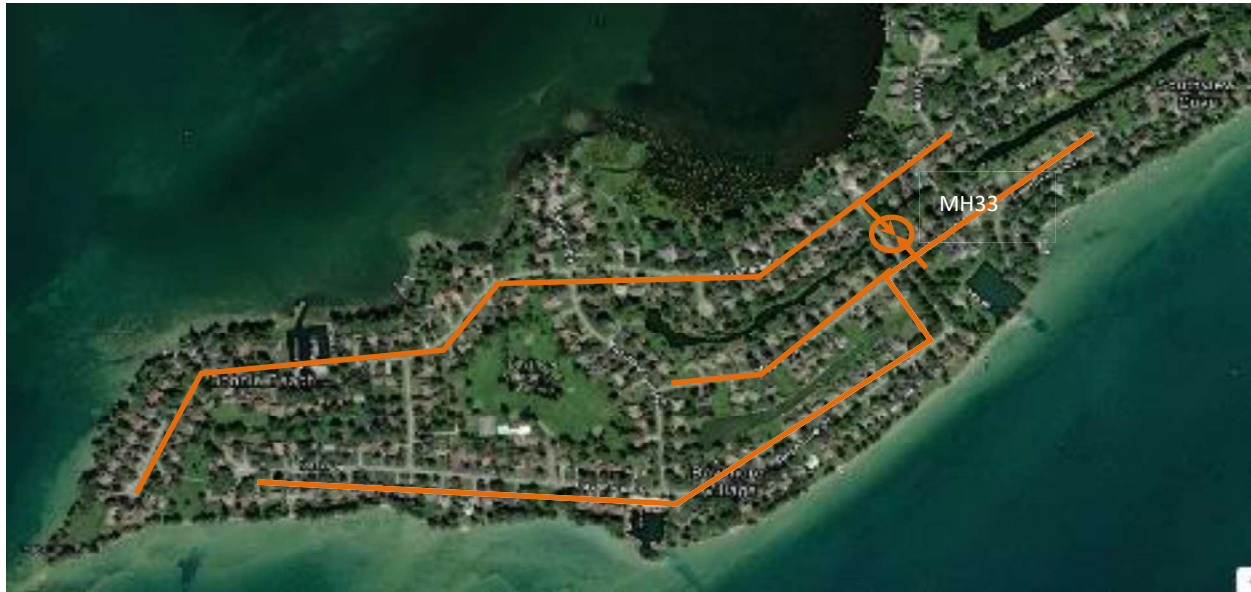
Flow monitoring was sub-contracted to Civica Infrastructure Inc. (Civica), who installed two flow meters (FM) in maintenance hole 33 (MH33), one to capture flows from the north side of the system (FM1) and one to capture flows from the south (FM2).

*Figure 4: Civica Flow Monitor Location (MH 33)*

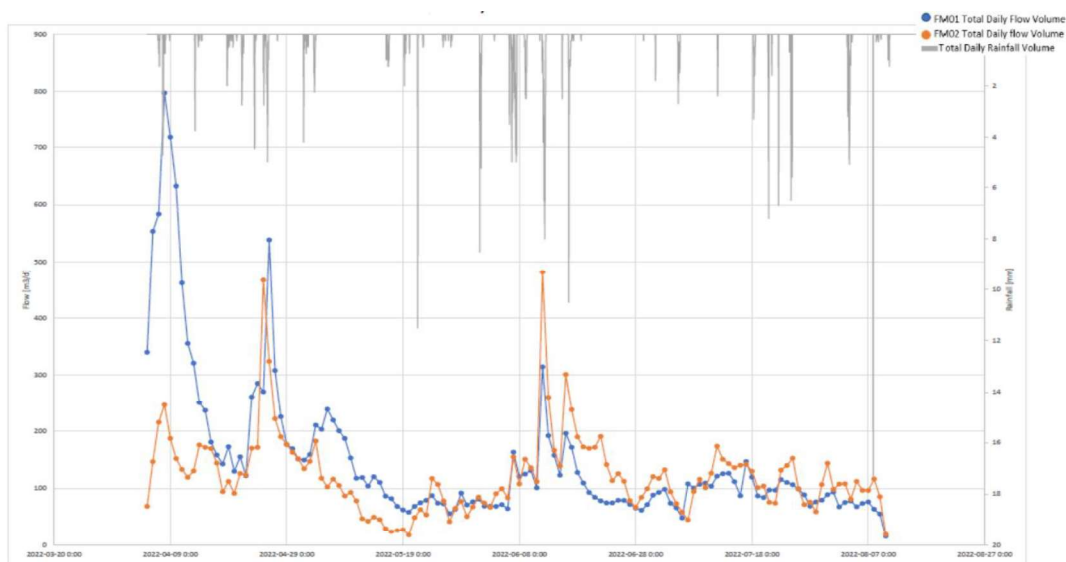
Flow and rain data were collected between April and August of 2022. Civica’s report is presented in Appendix B while Figure 5, below, shows the effect of wastewater flows with respect to rainfall. As noted in Section 3.1.1, individual rain events have little effect on wastewater flows, but frequent rainfall over a period of time as seen on June 6-8 increases wastewater flows. This is further evidence that groundwater infiltration is the predominant source of I&I in the collection system.

*Figure 5: Summary of Flow Data from Civica Daily Monitoring (May 2022 – July 2022)*

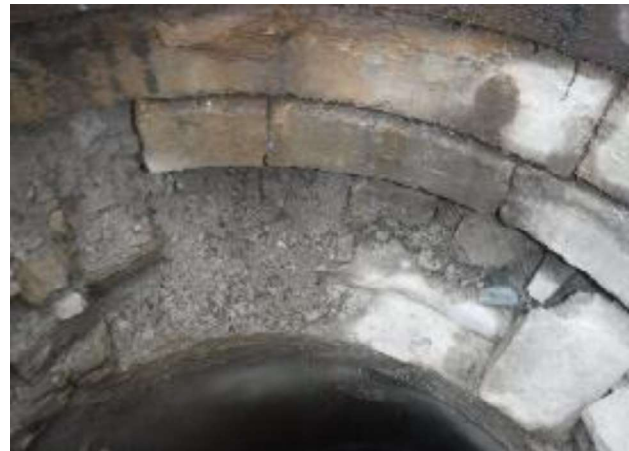
Of the 73 inspected maintenance holes, 33 had grade adjustment comprised of concrete rings and/or concrete bricks. Of these 33 MHs, 21 had some level of deterioration from cracking to broken and displaced pieces of concrete, however only 17 currently require remediation and are listed in Table 6 (Section 4.1.2).

Figure 6: Grade Adjustment in MH47

Grade adjustment is used to adjust the height of the maintenance hole so that it is flush with the road surface. When the grade adjustment is compromised, it can provide an avenue for infiltration.

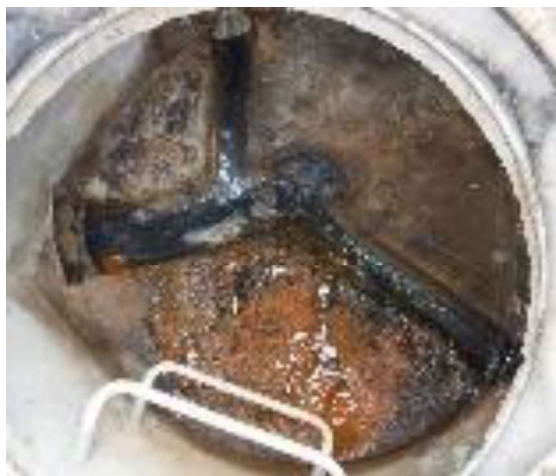
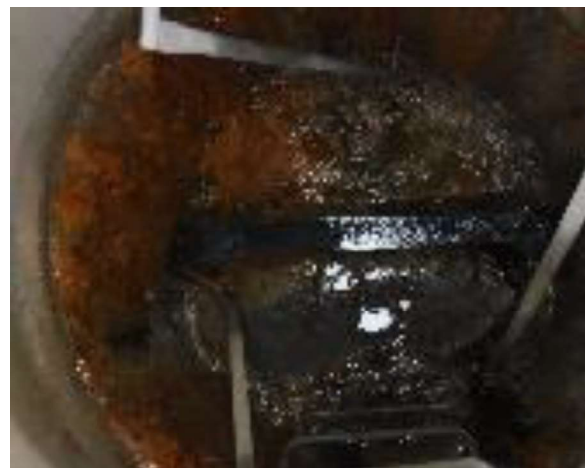
Figure 7 shows infiltration between the lower joint and benching in MH26 and significant evidence of infiltration (staining and buildup) in MH28.

Figure 7: Infiltration in MH26 (left) and MH28 (right)

The maintenance holes in the system are comprised of precast concrete sections. Shallow chambers have only one section but deeper chambers in the System have up to four sections. If the seal between sections is compromised, infiltration can occur. Active infiltration through a joint was observed in six maintenance holes while evidence of infiltration (staining or buildup) was observed in 15 maintenance holes.

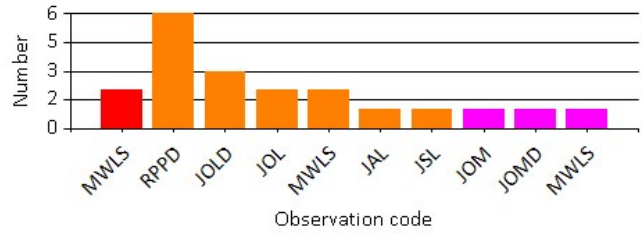
Most important structural observations (Grades 3, 4 and 5)

86 items

5 - Most significant defect grade (2 of 86 items)

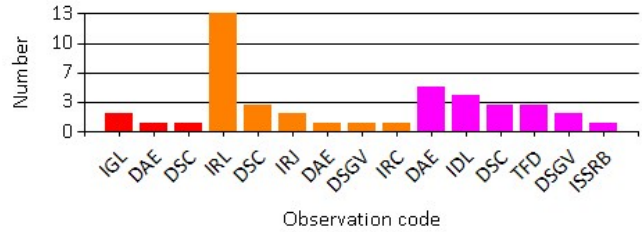
Most important operation & maintenance observations (Grades 3, 4 and 5)

86 items

5 - Most significant defect grade (4 of 86 items)

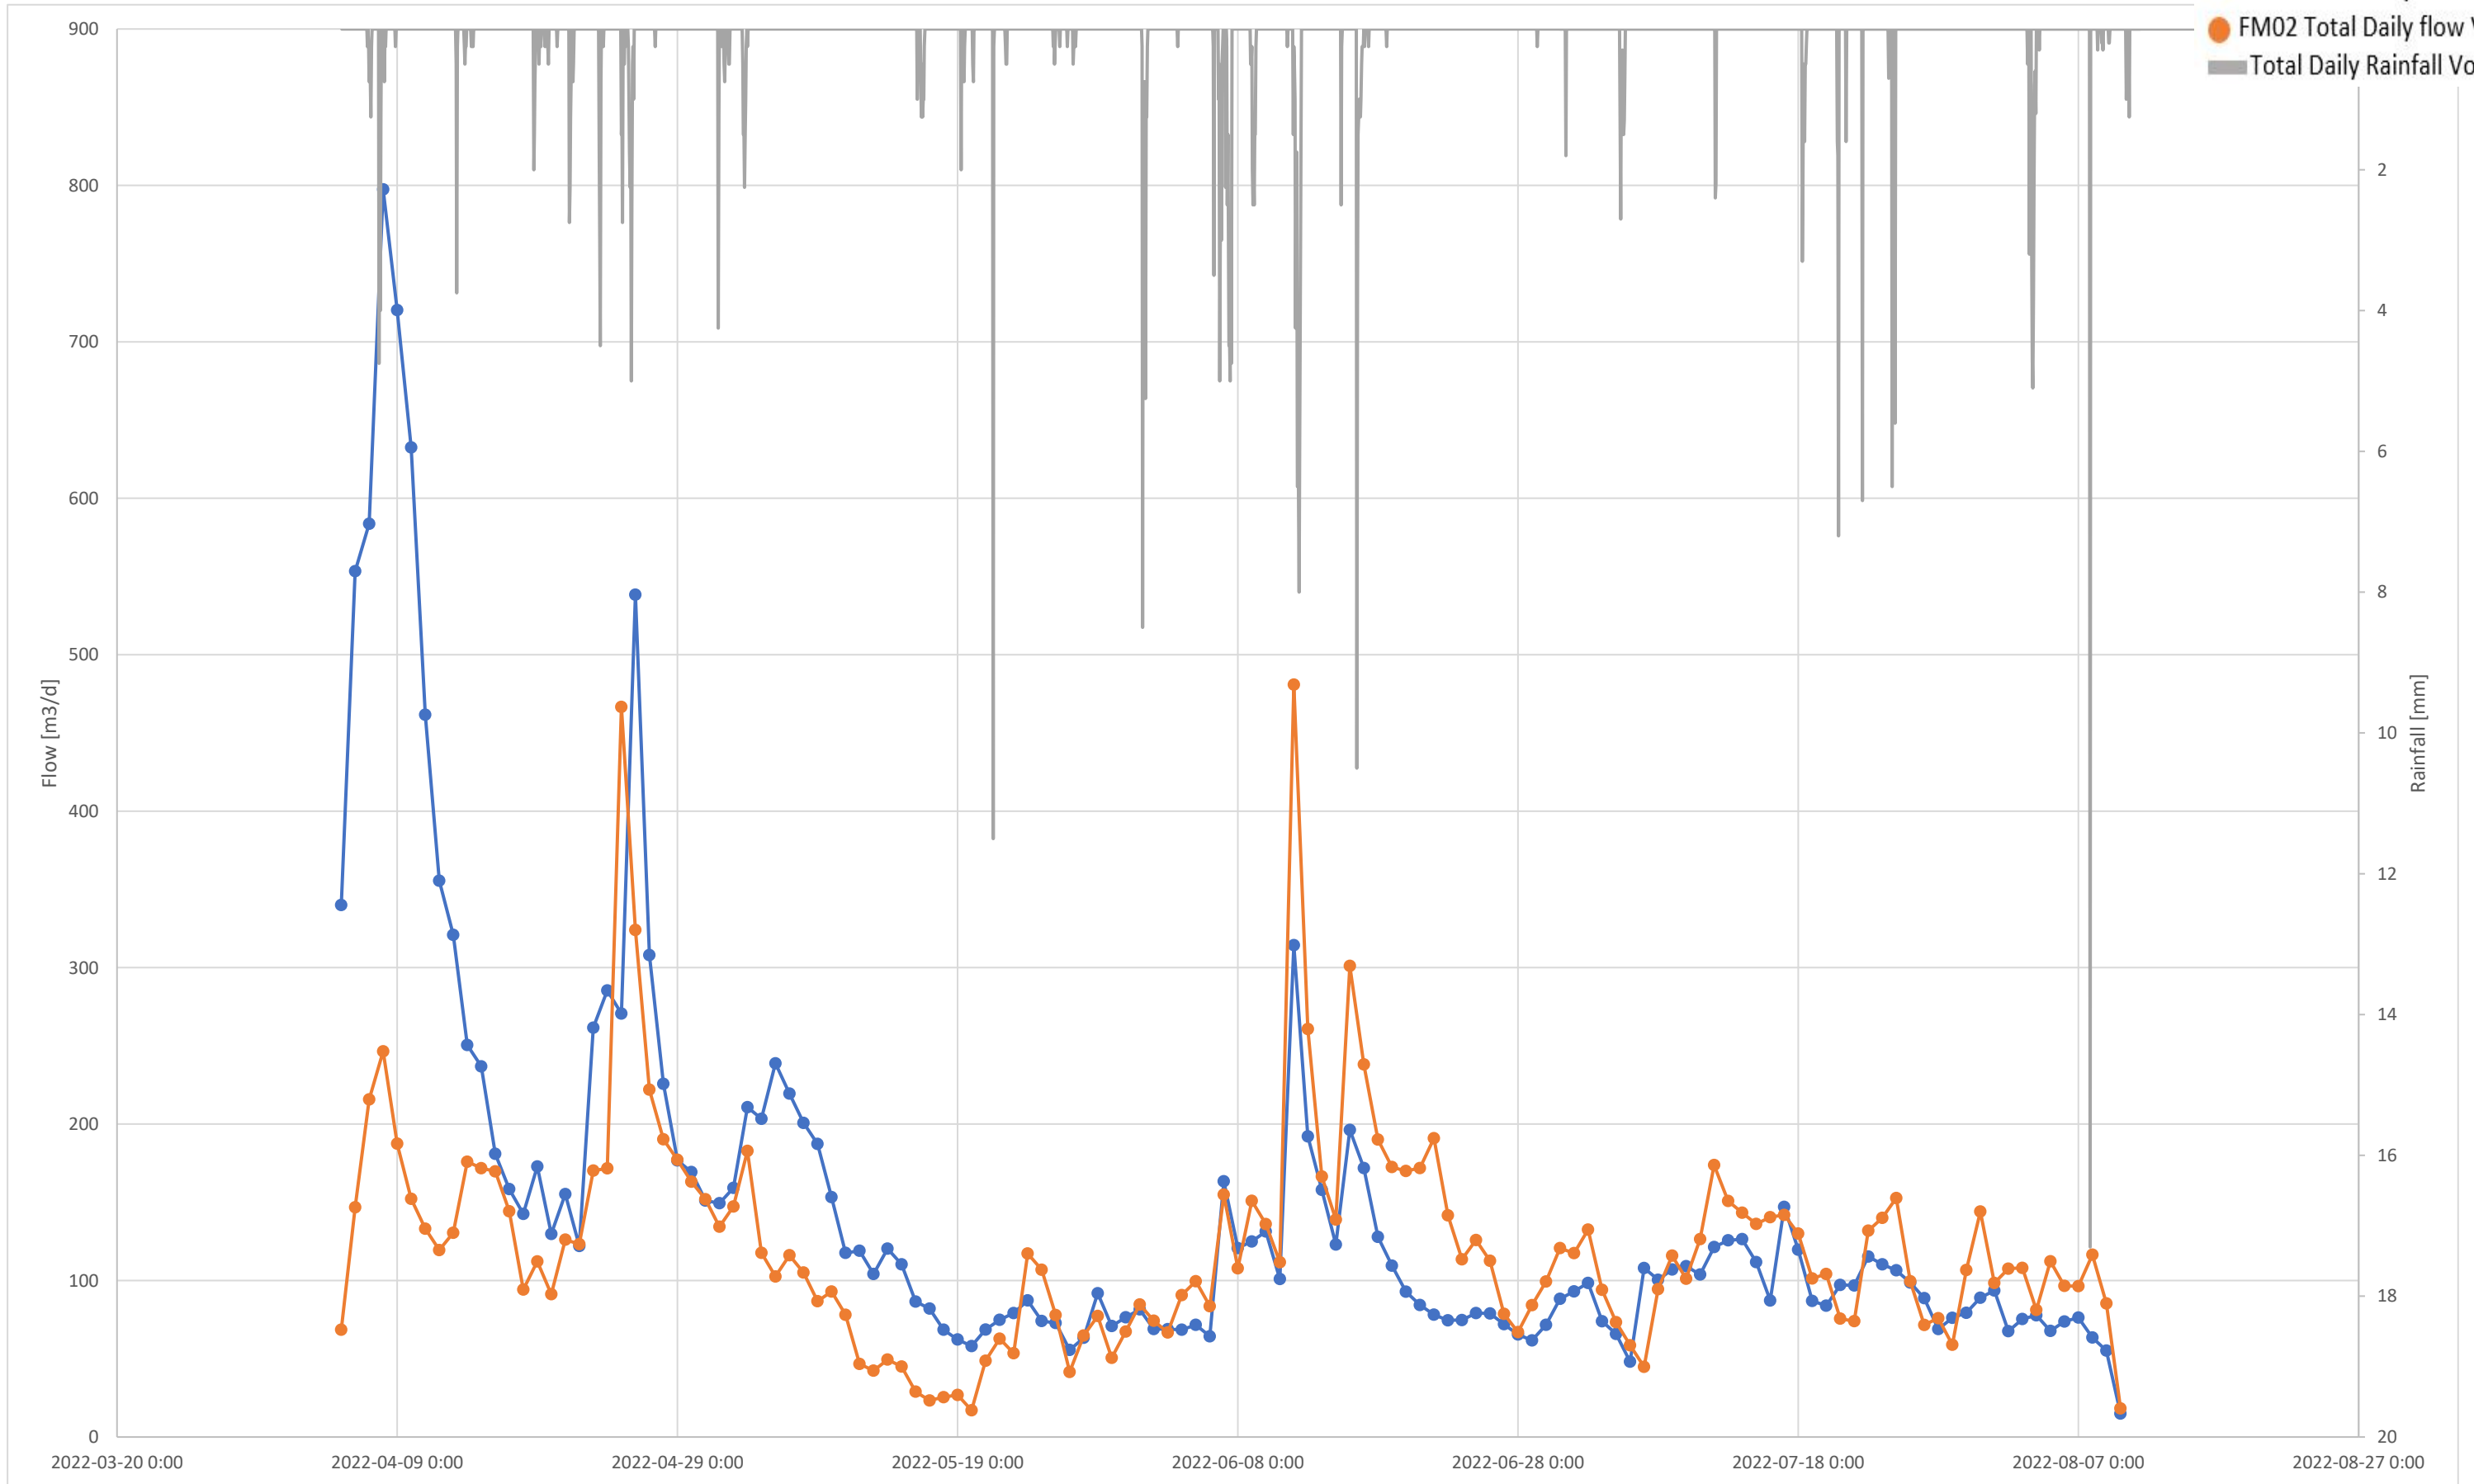
- FM01 Total Daily Flow Volume
- FM02 Total Daily flow Volume
- Total Daily Rainfall Volume

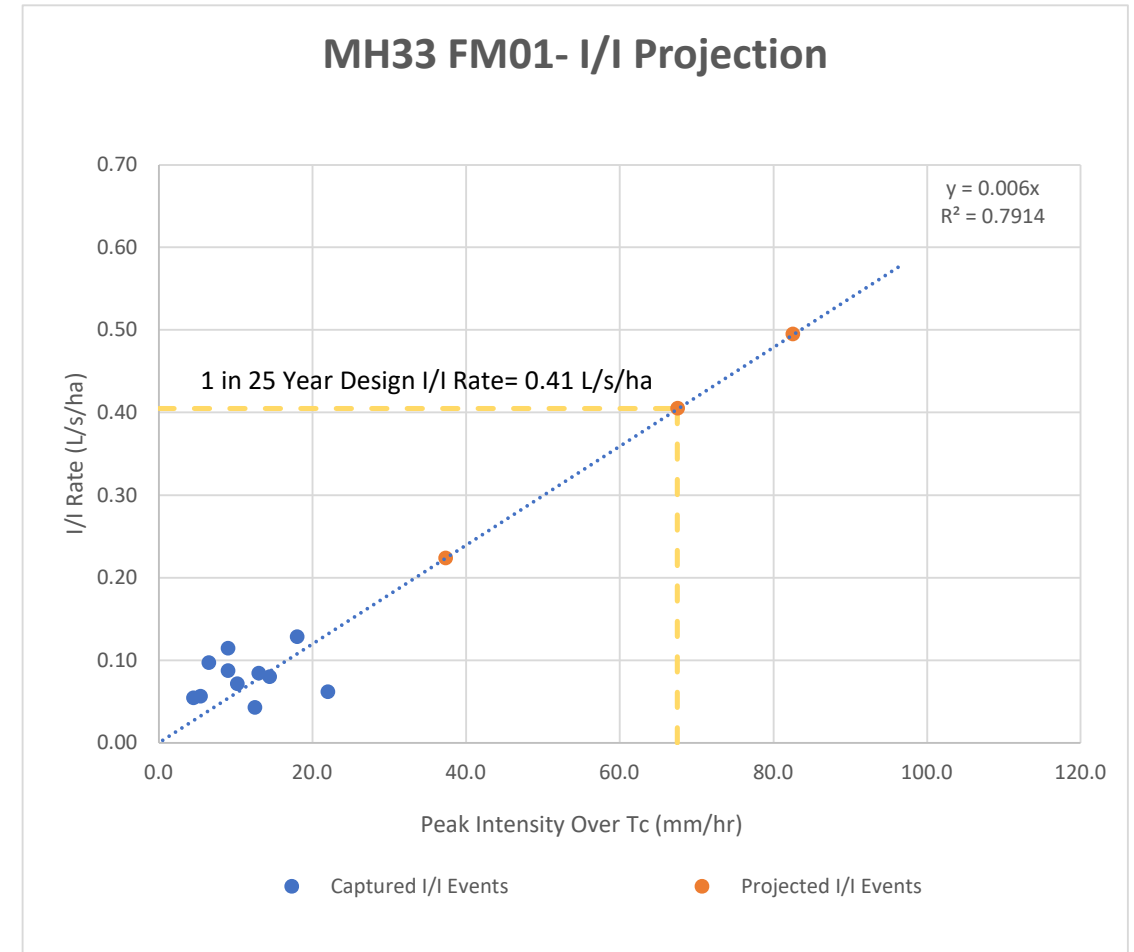
**MH33 FM01 (North)  
Inflow and Infiltration (I/I) Report  
Catchment Area: 47.1 ha**

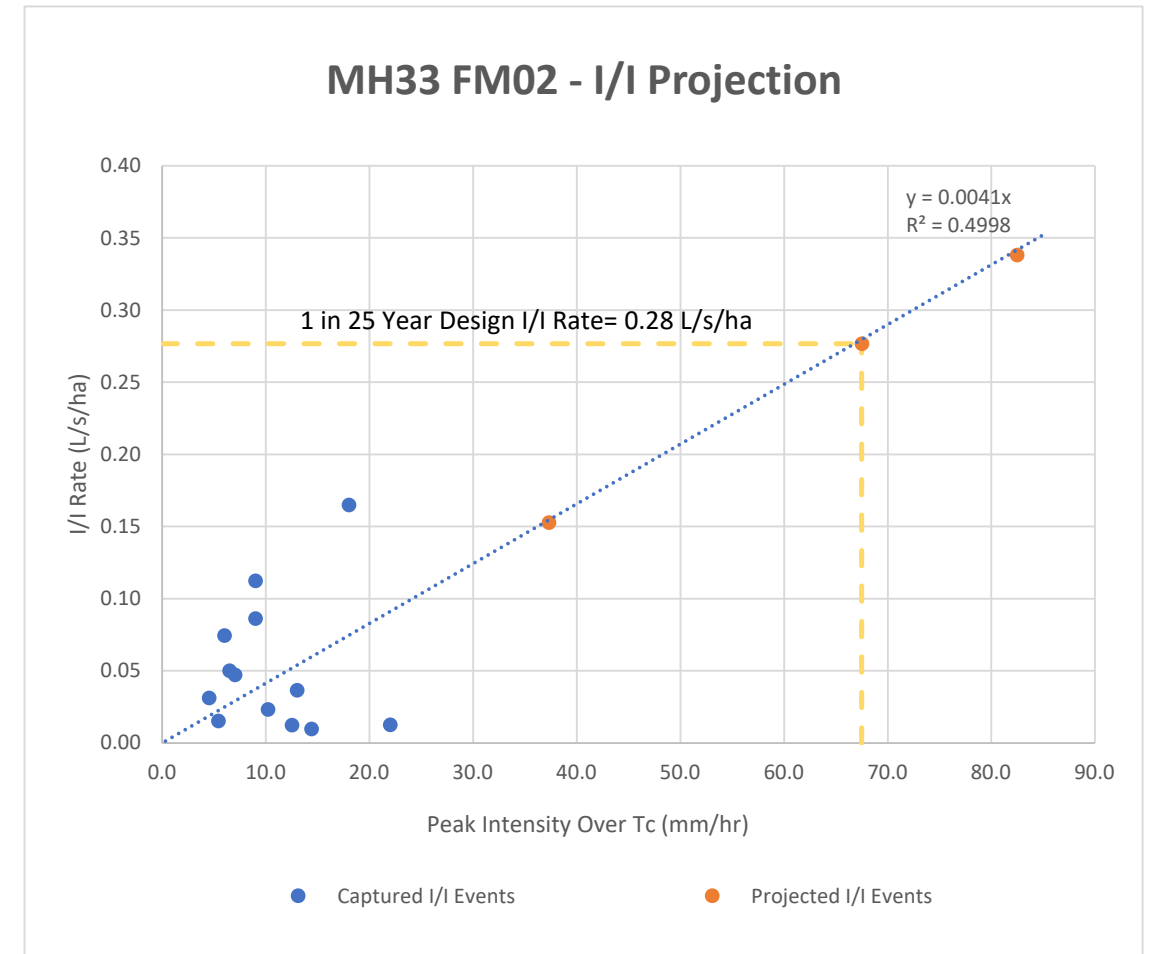
**MH33 FM02 (South)**  
**Inflow and Infiltration (I/I) Report**  
**Catchment Area: 49.82 ha**

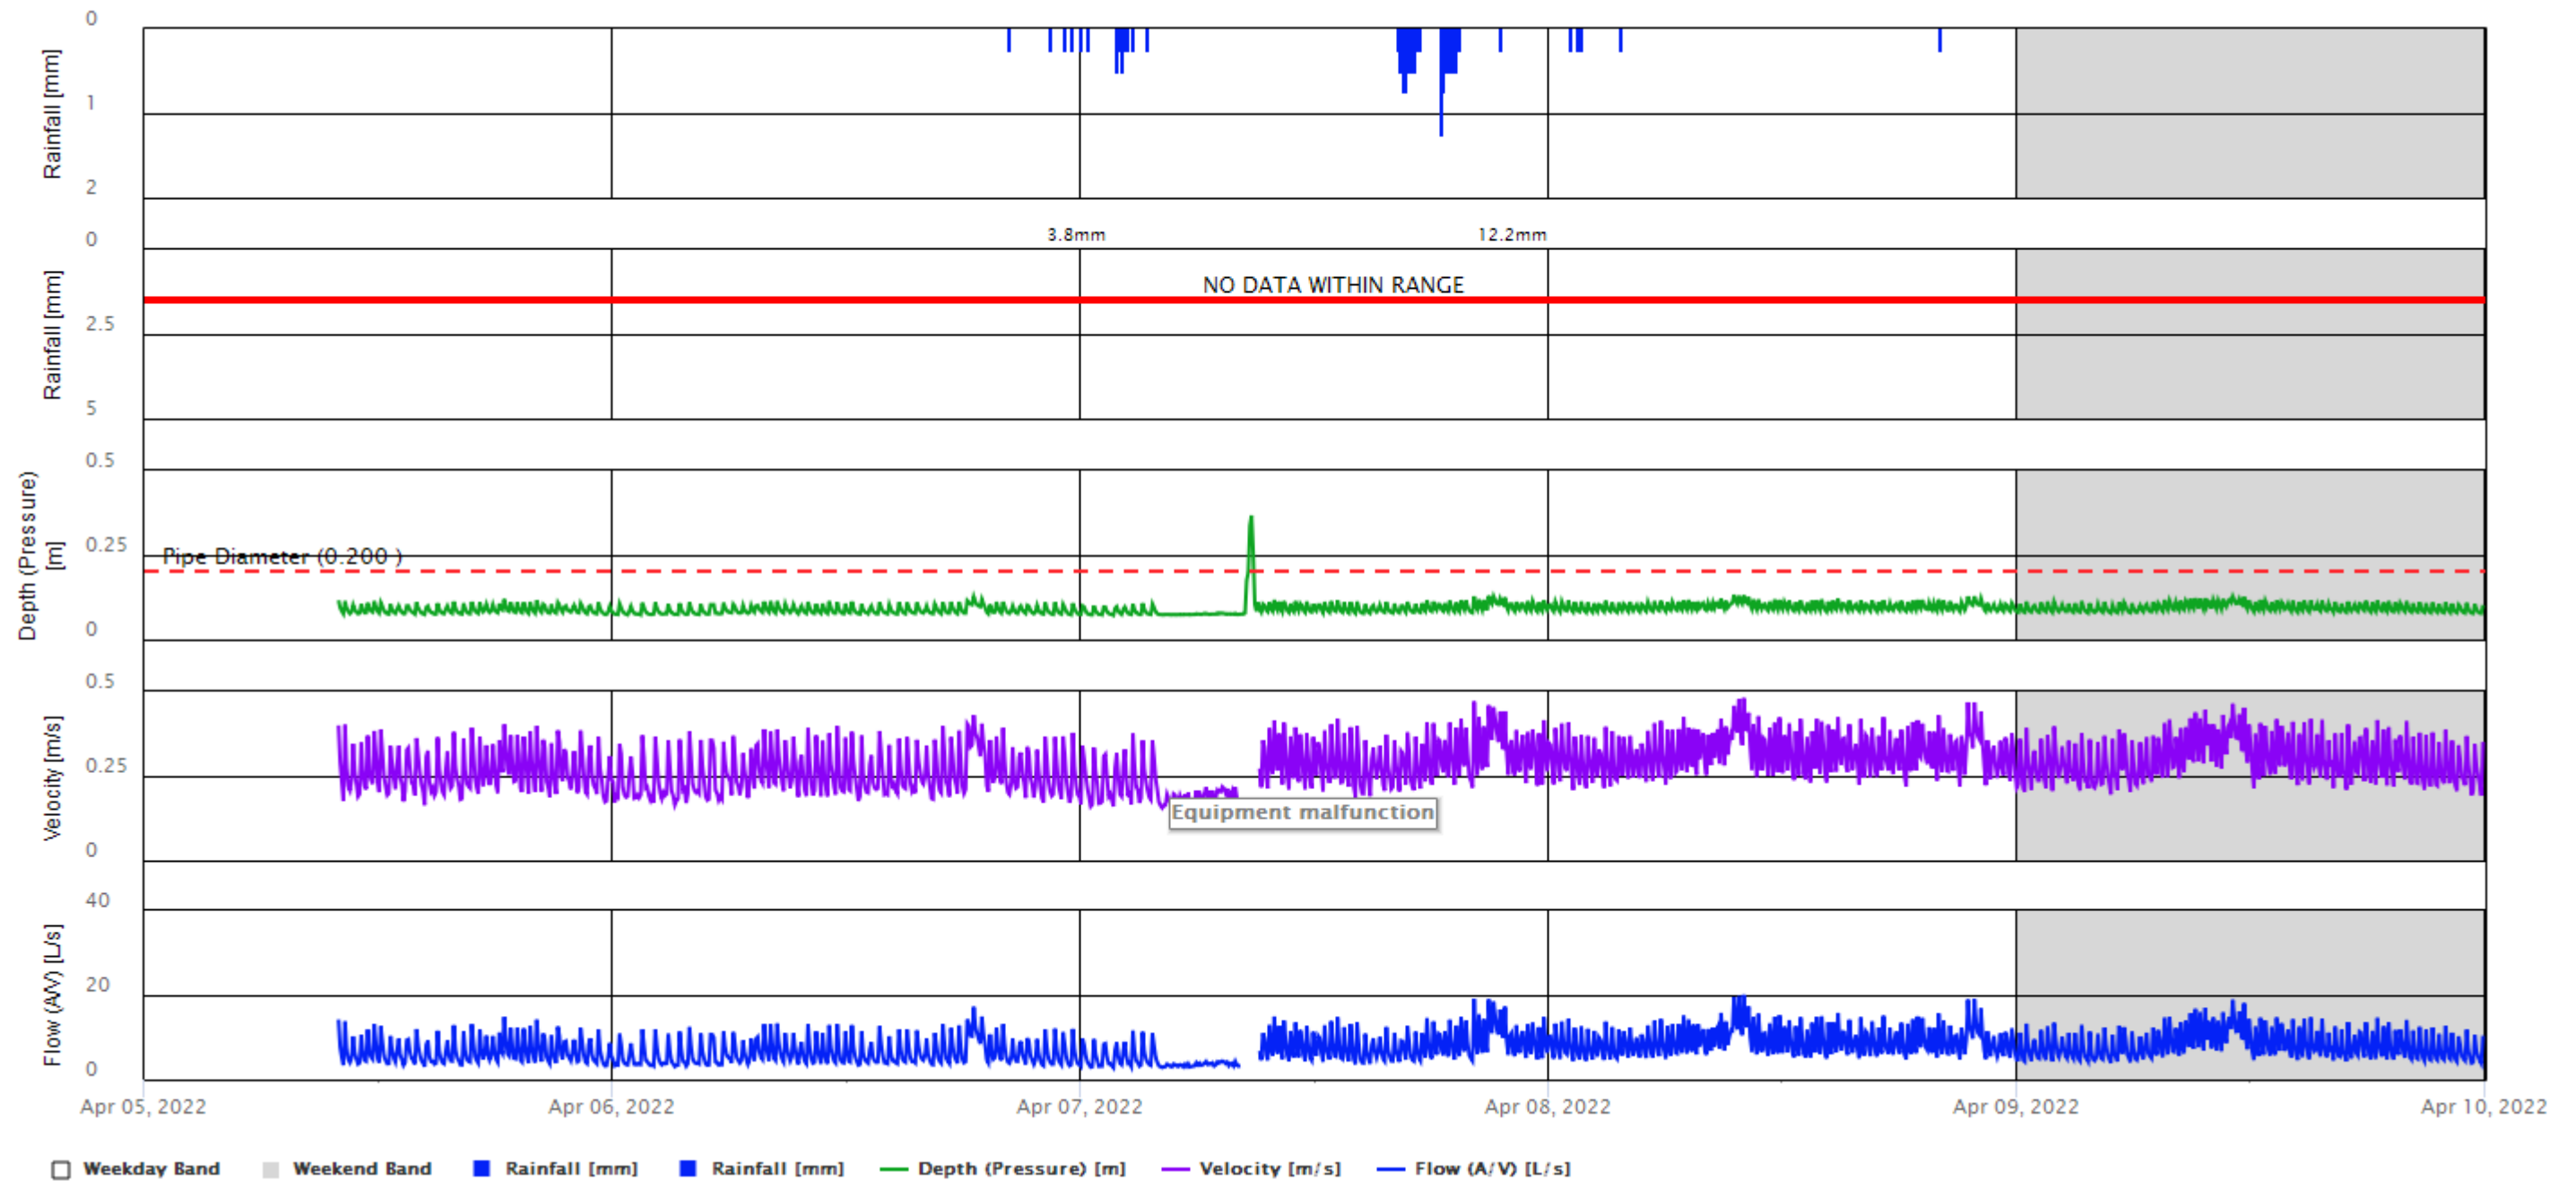
[Apr 05, 2022 – Apr 09, 2022](#)

# Data Chart

Station: MH33\_FM01 (North)

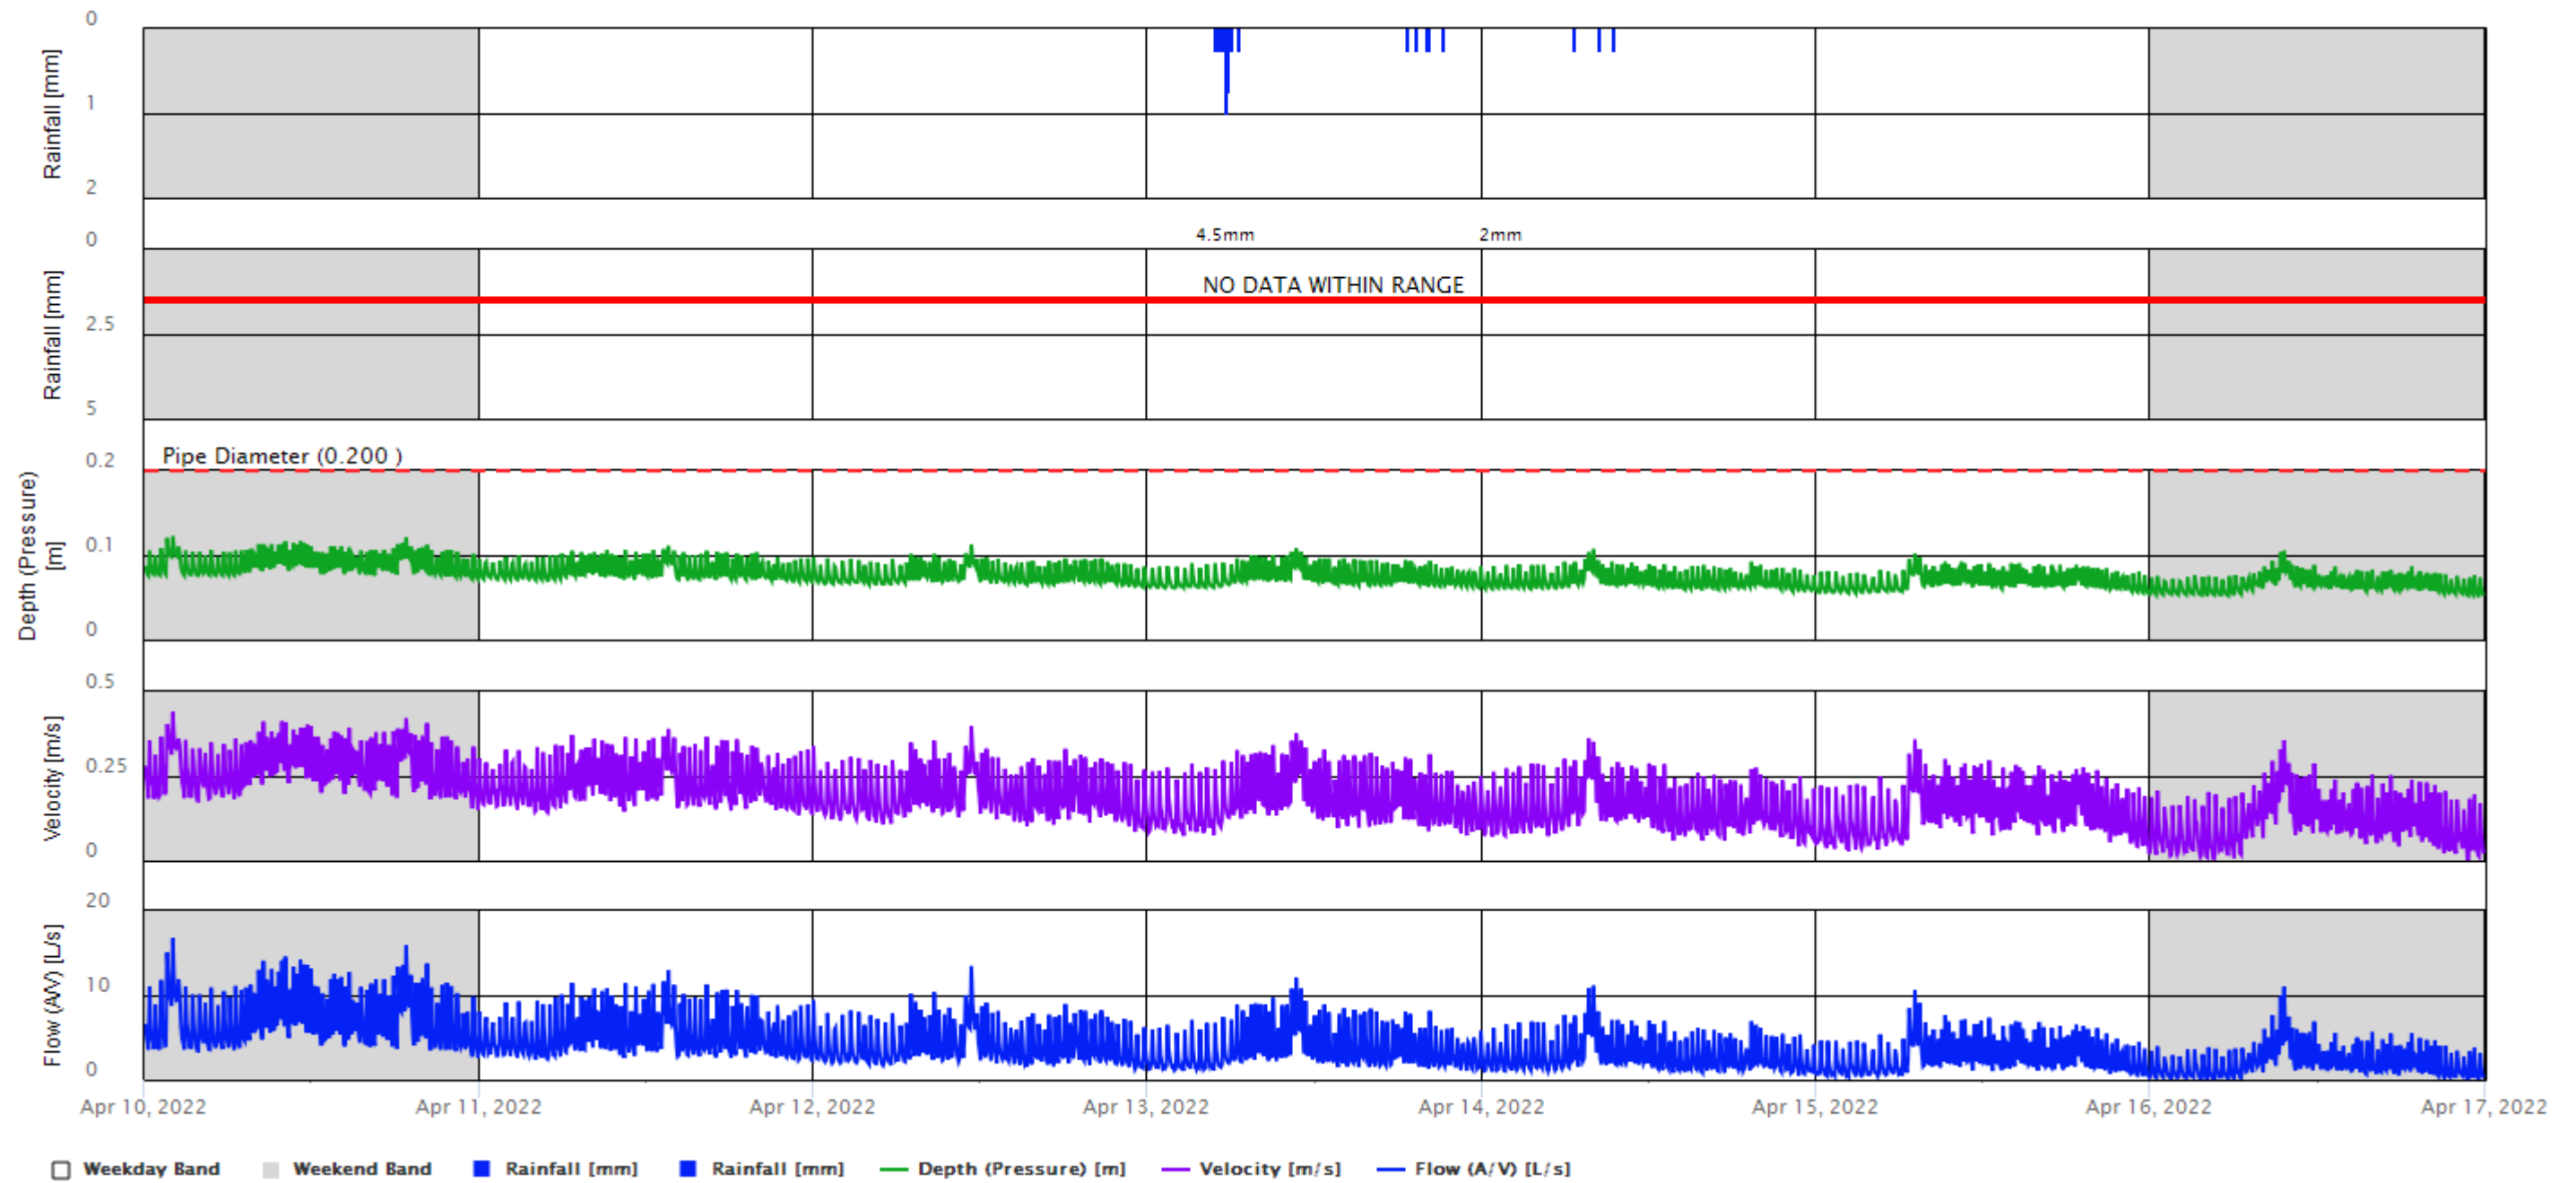
[Apr 10, 2022 – Apr 16, 2022](#)

# Data Chart

Station: MH33\_FM01 (North)

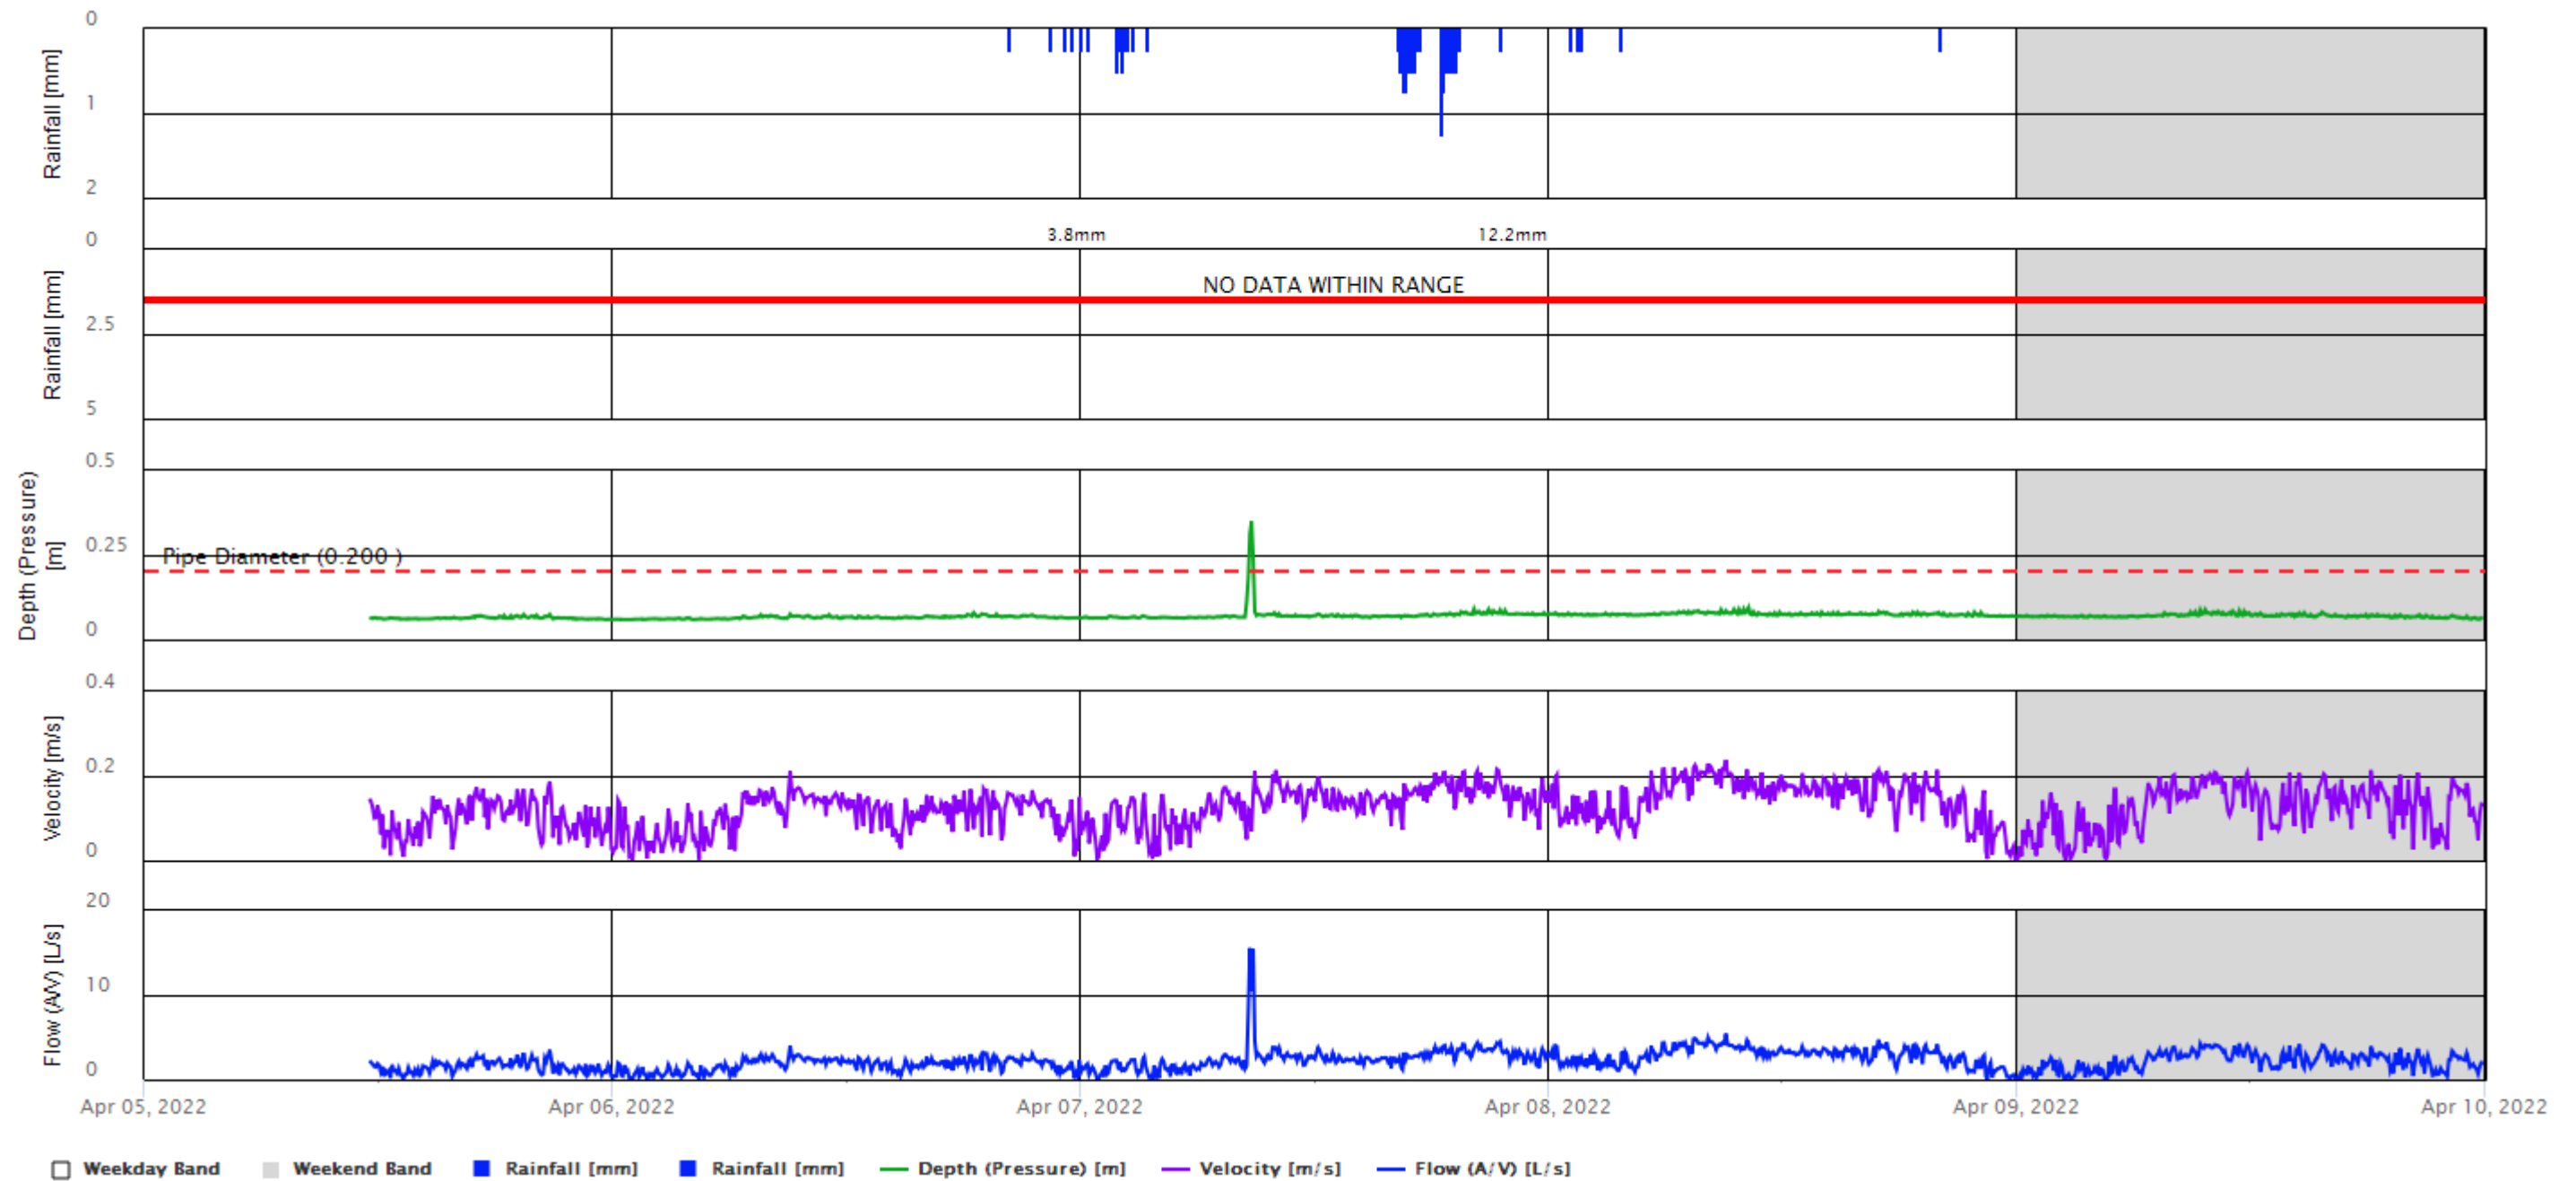
[Apr 05, 2022 – Apr 09, 2022](#)

# Data Chart

Station: MH33\_FM02 (South)
