# **Report to the Township of Ramara for Inflow and Infiltration Study**

Date: April 20, 2023  
Project No: RAMARN1616-2233  
Rev: 2

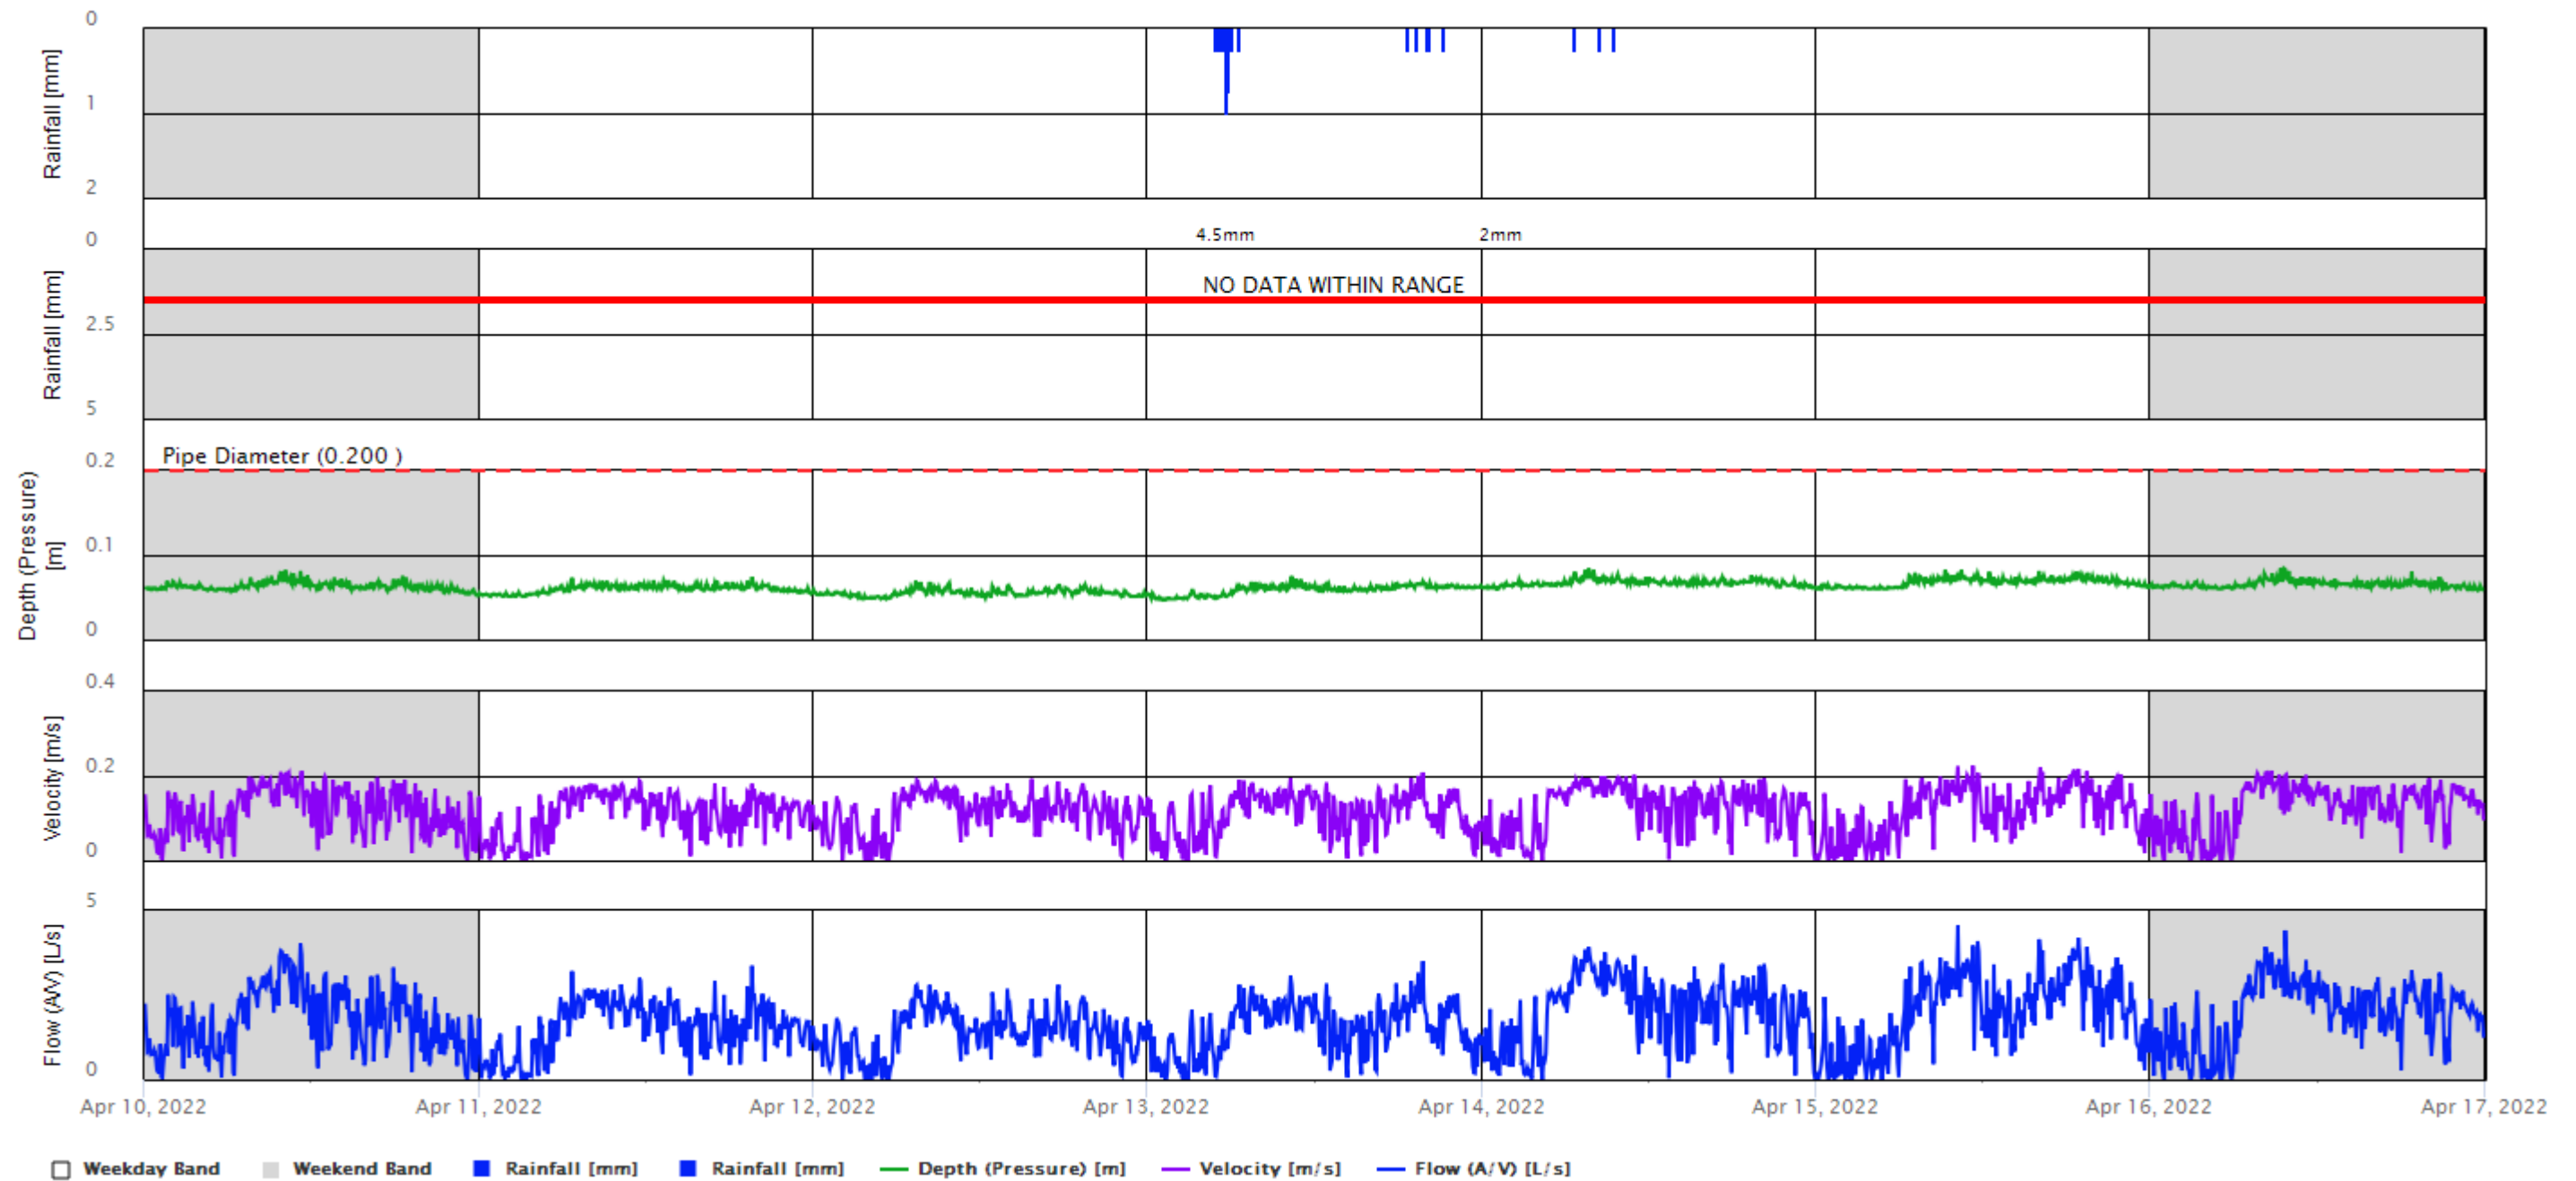
[Apr 10, 2022 – Apr 16, 2022](#)

# Data Chart

Station: MH33\_FM02 (South)

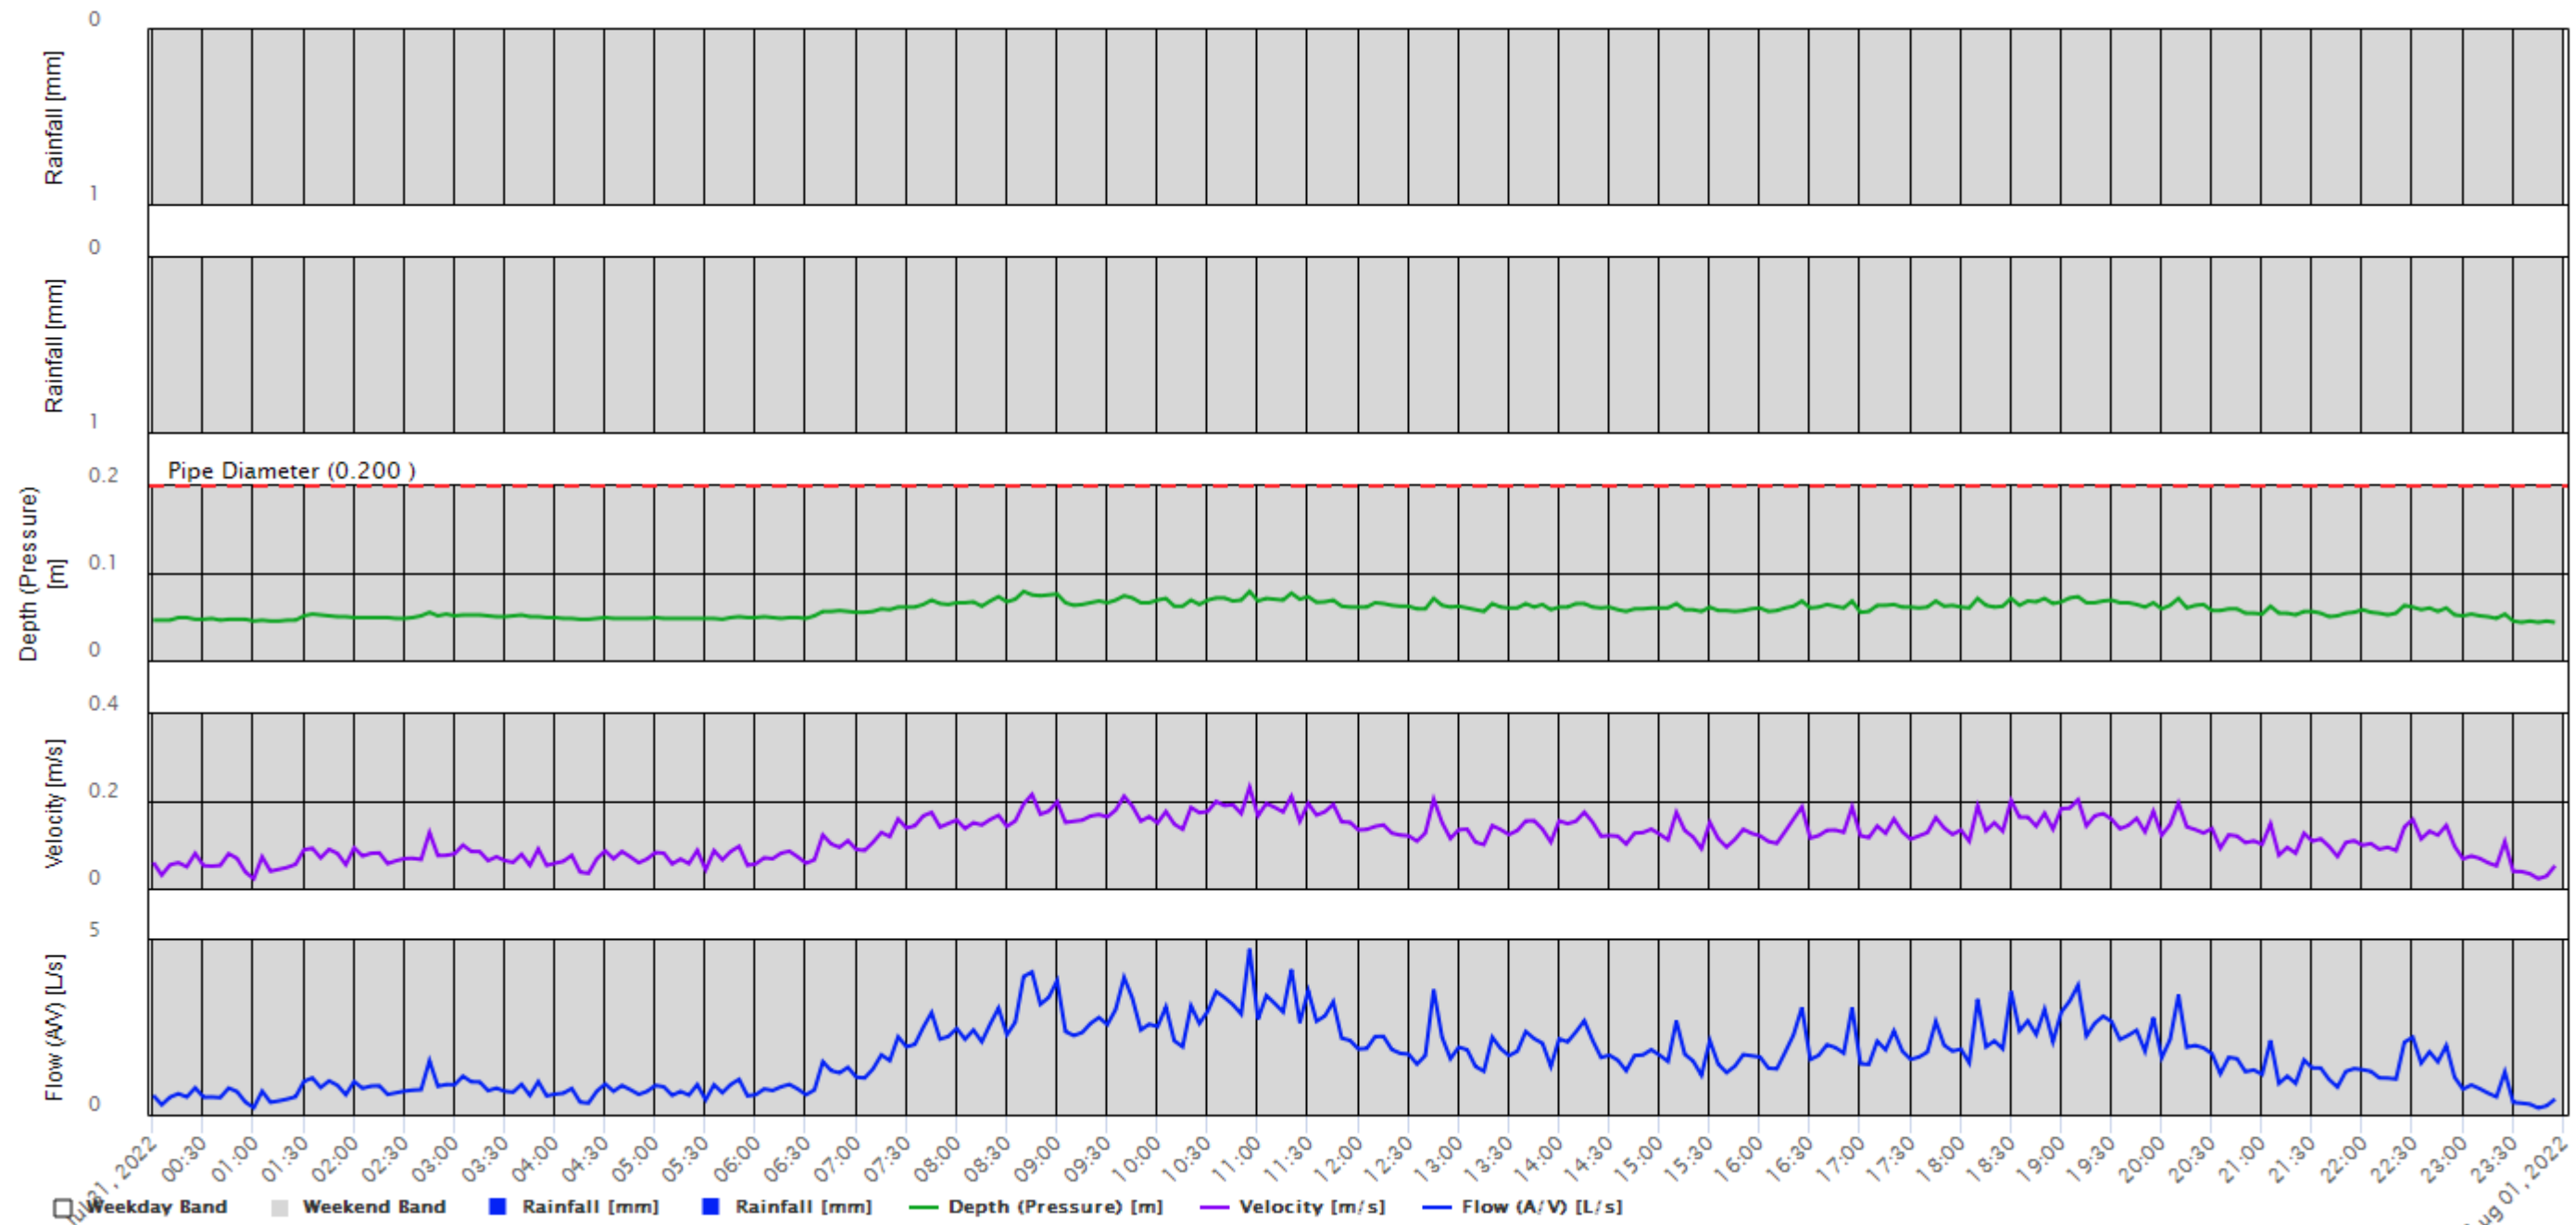
Station: MH33\_FM02 (South)

[Jul 31, 2022 – Jul 31, 2022](#)

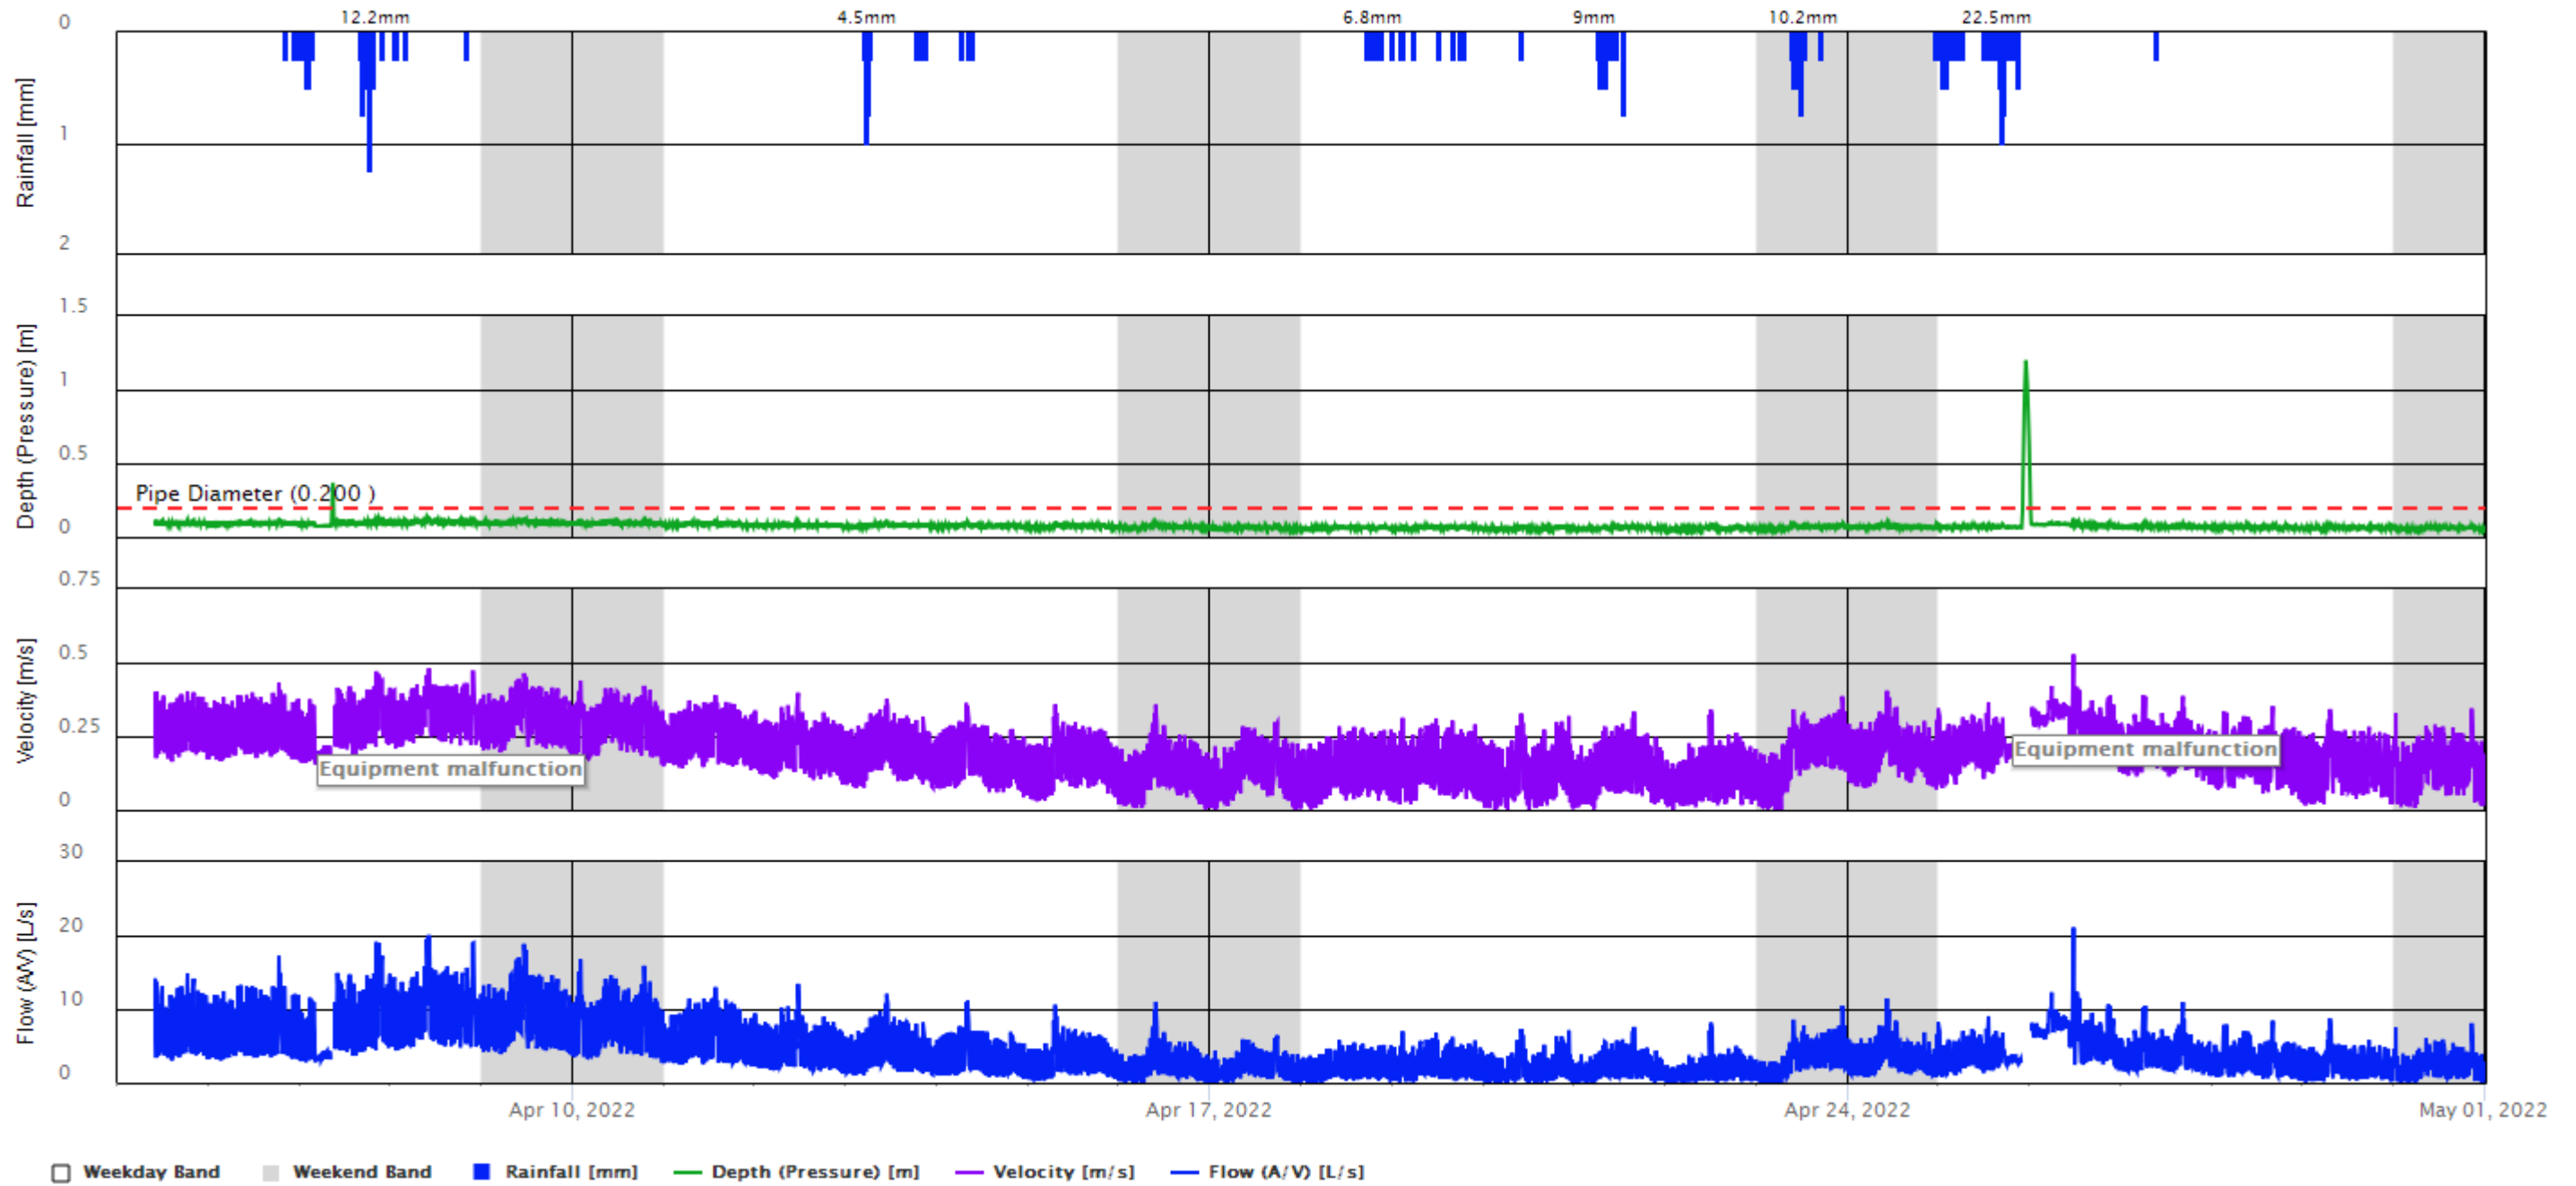
Station: MH33\_FM01 (North)

[Apr 05, 2022 – Apr 30, 2022](#)

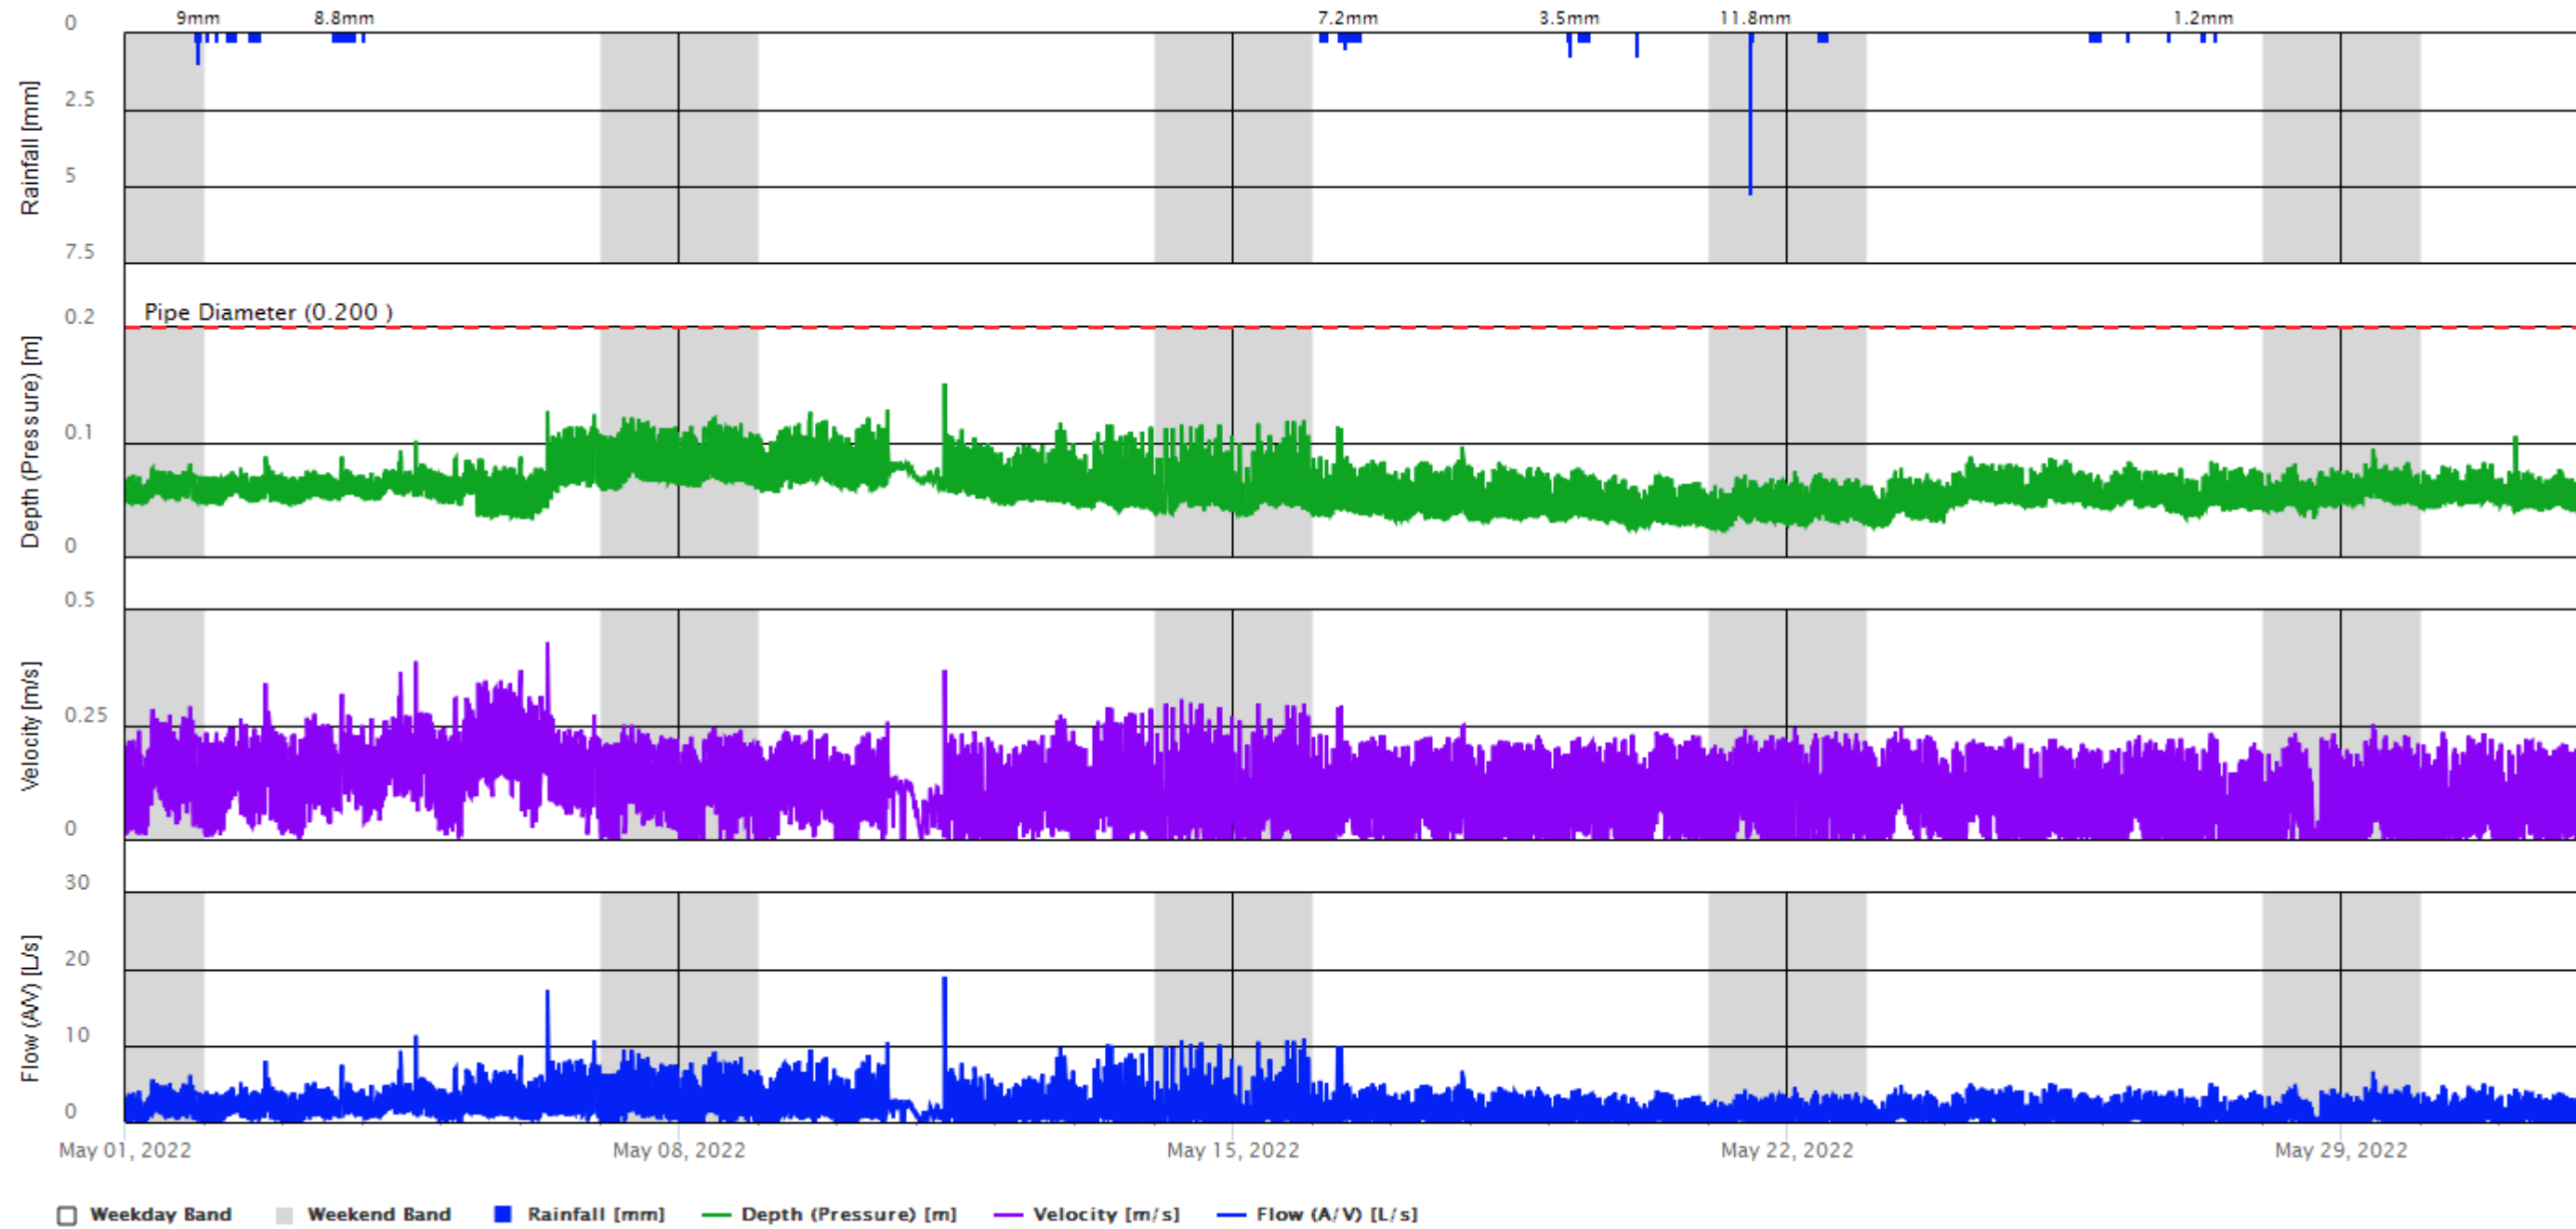
# Data Chart

Station: MH33\_FM01 (North)

[May 01, 2022 – May 31, 2022](#)

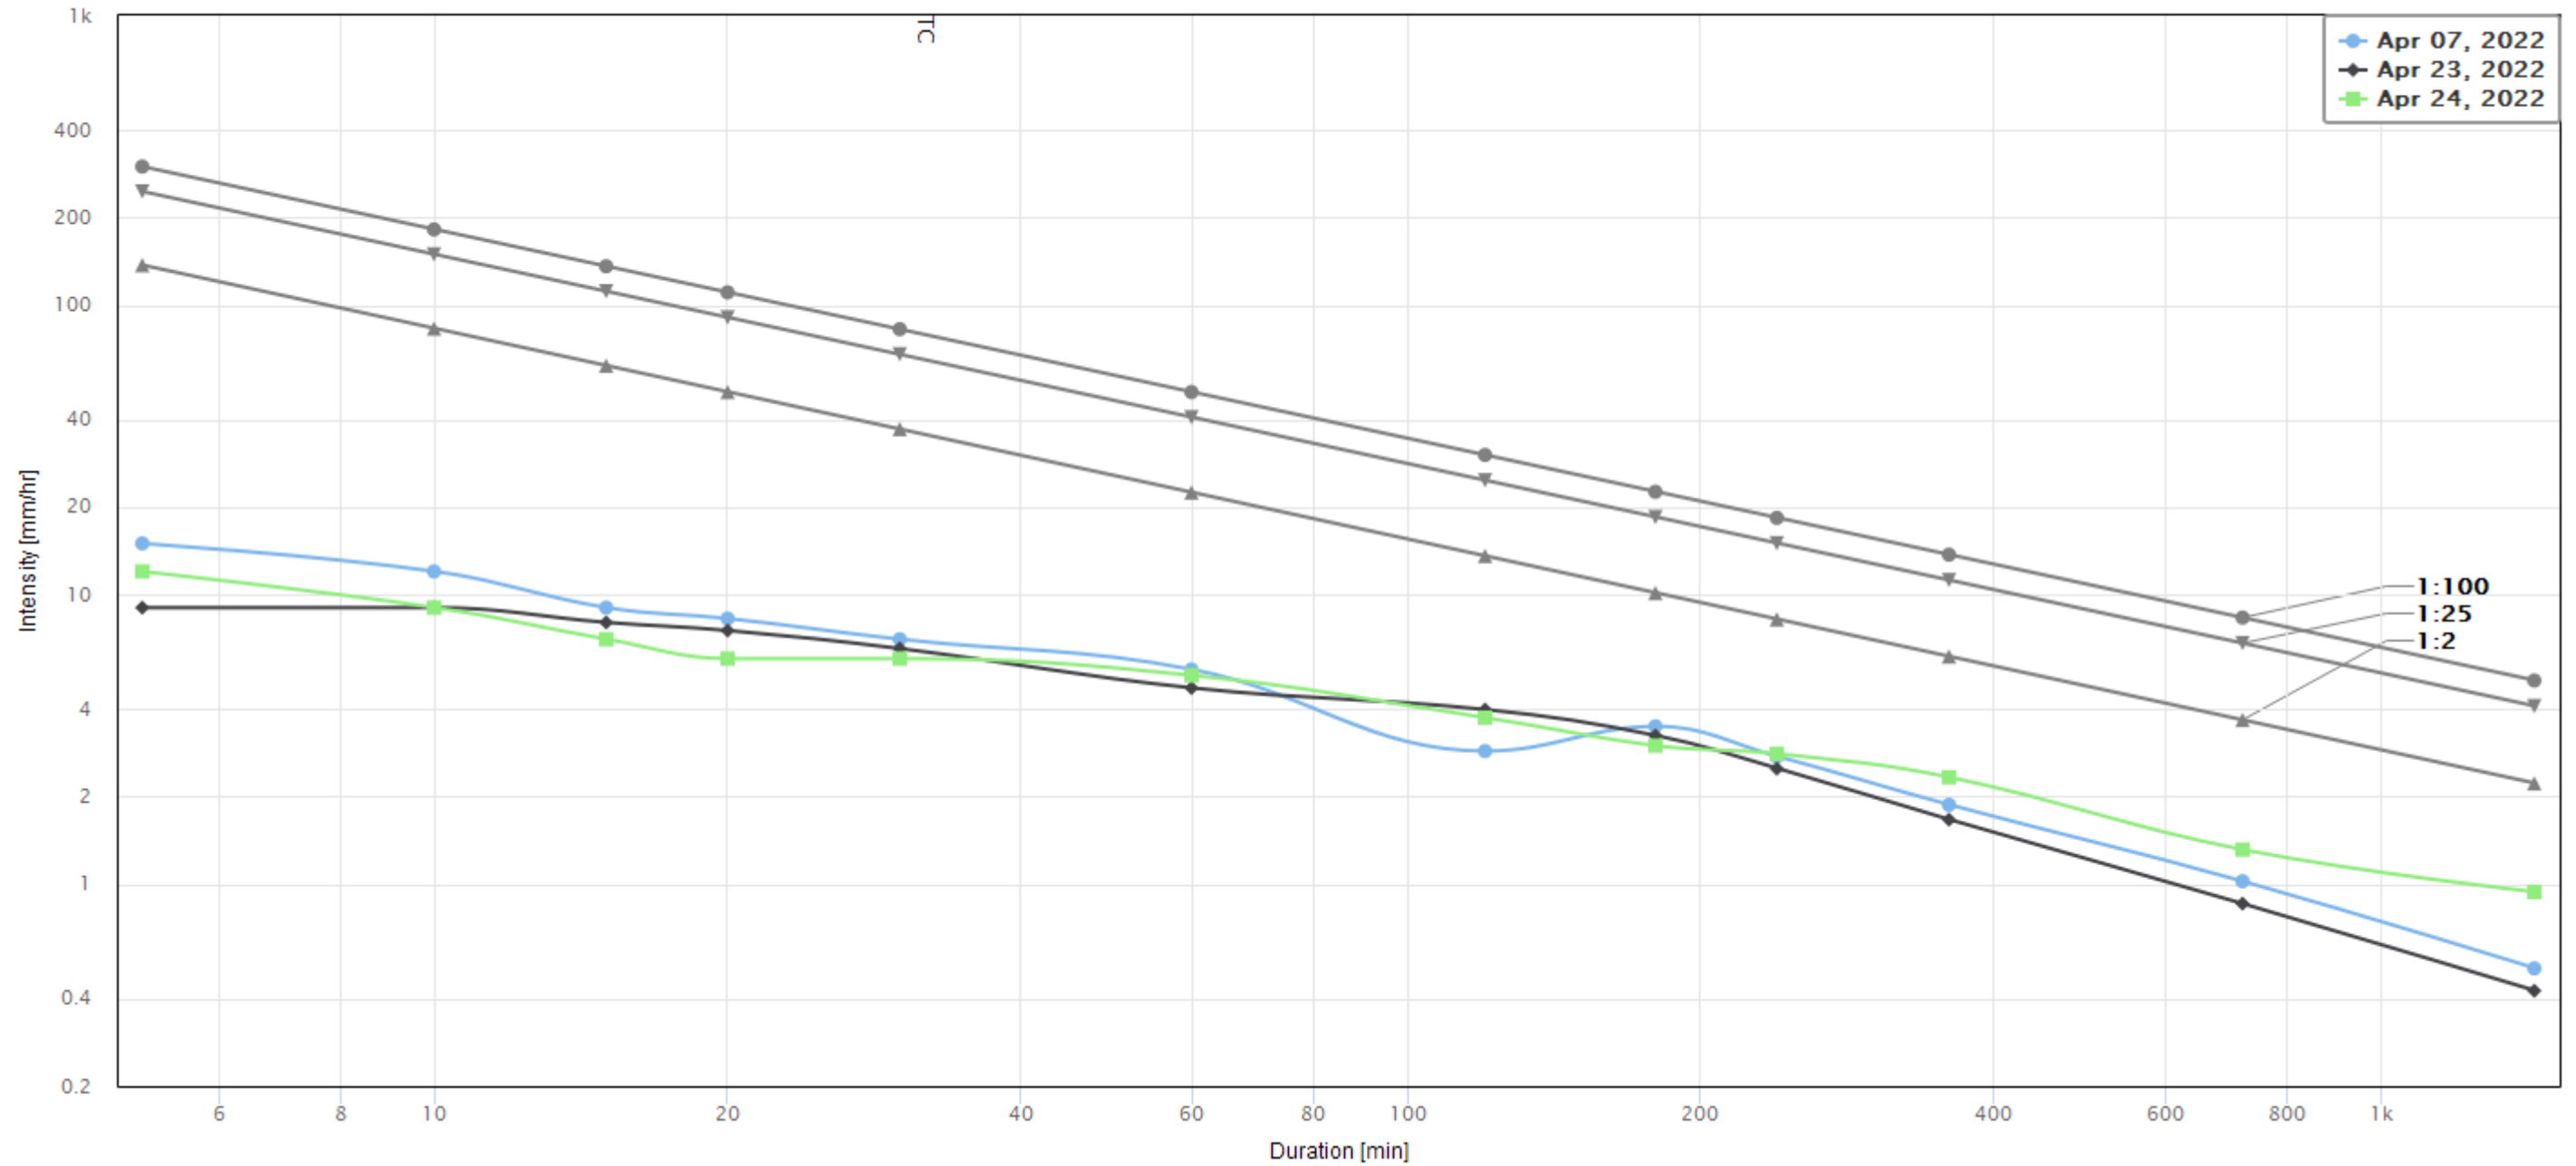
IDF Return Period Analysis MH33\_FM01 (North)

Station: MH33\_FM01 (North) (Apr 05, 2022 – Apr 30, 2022)

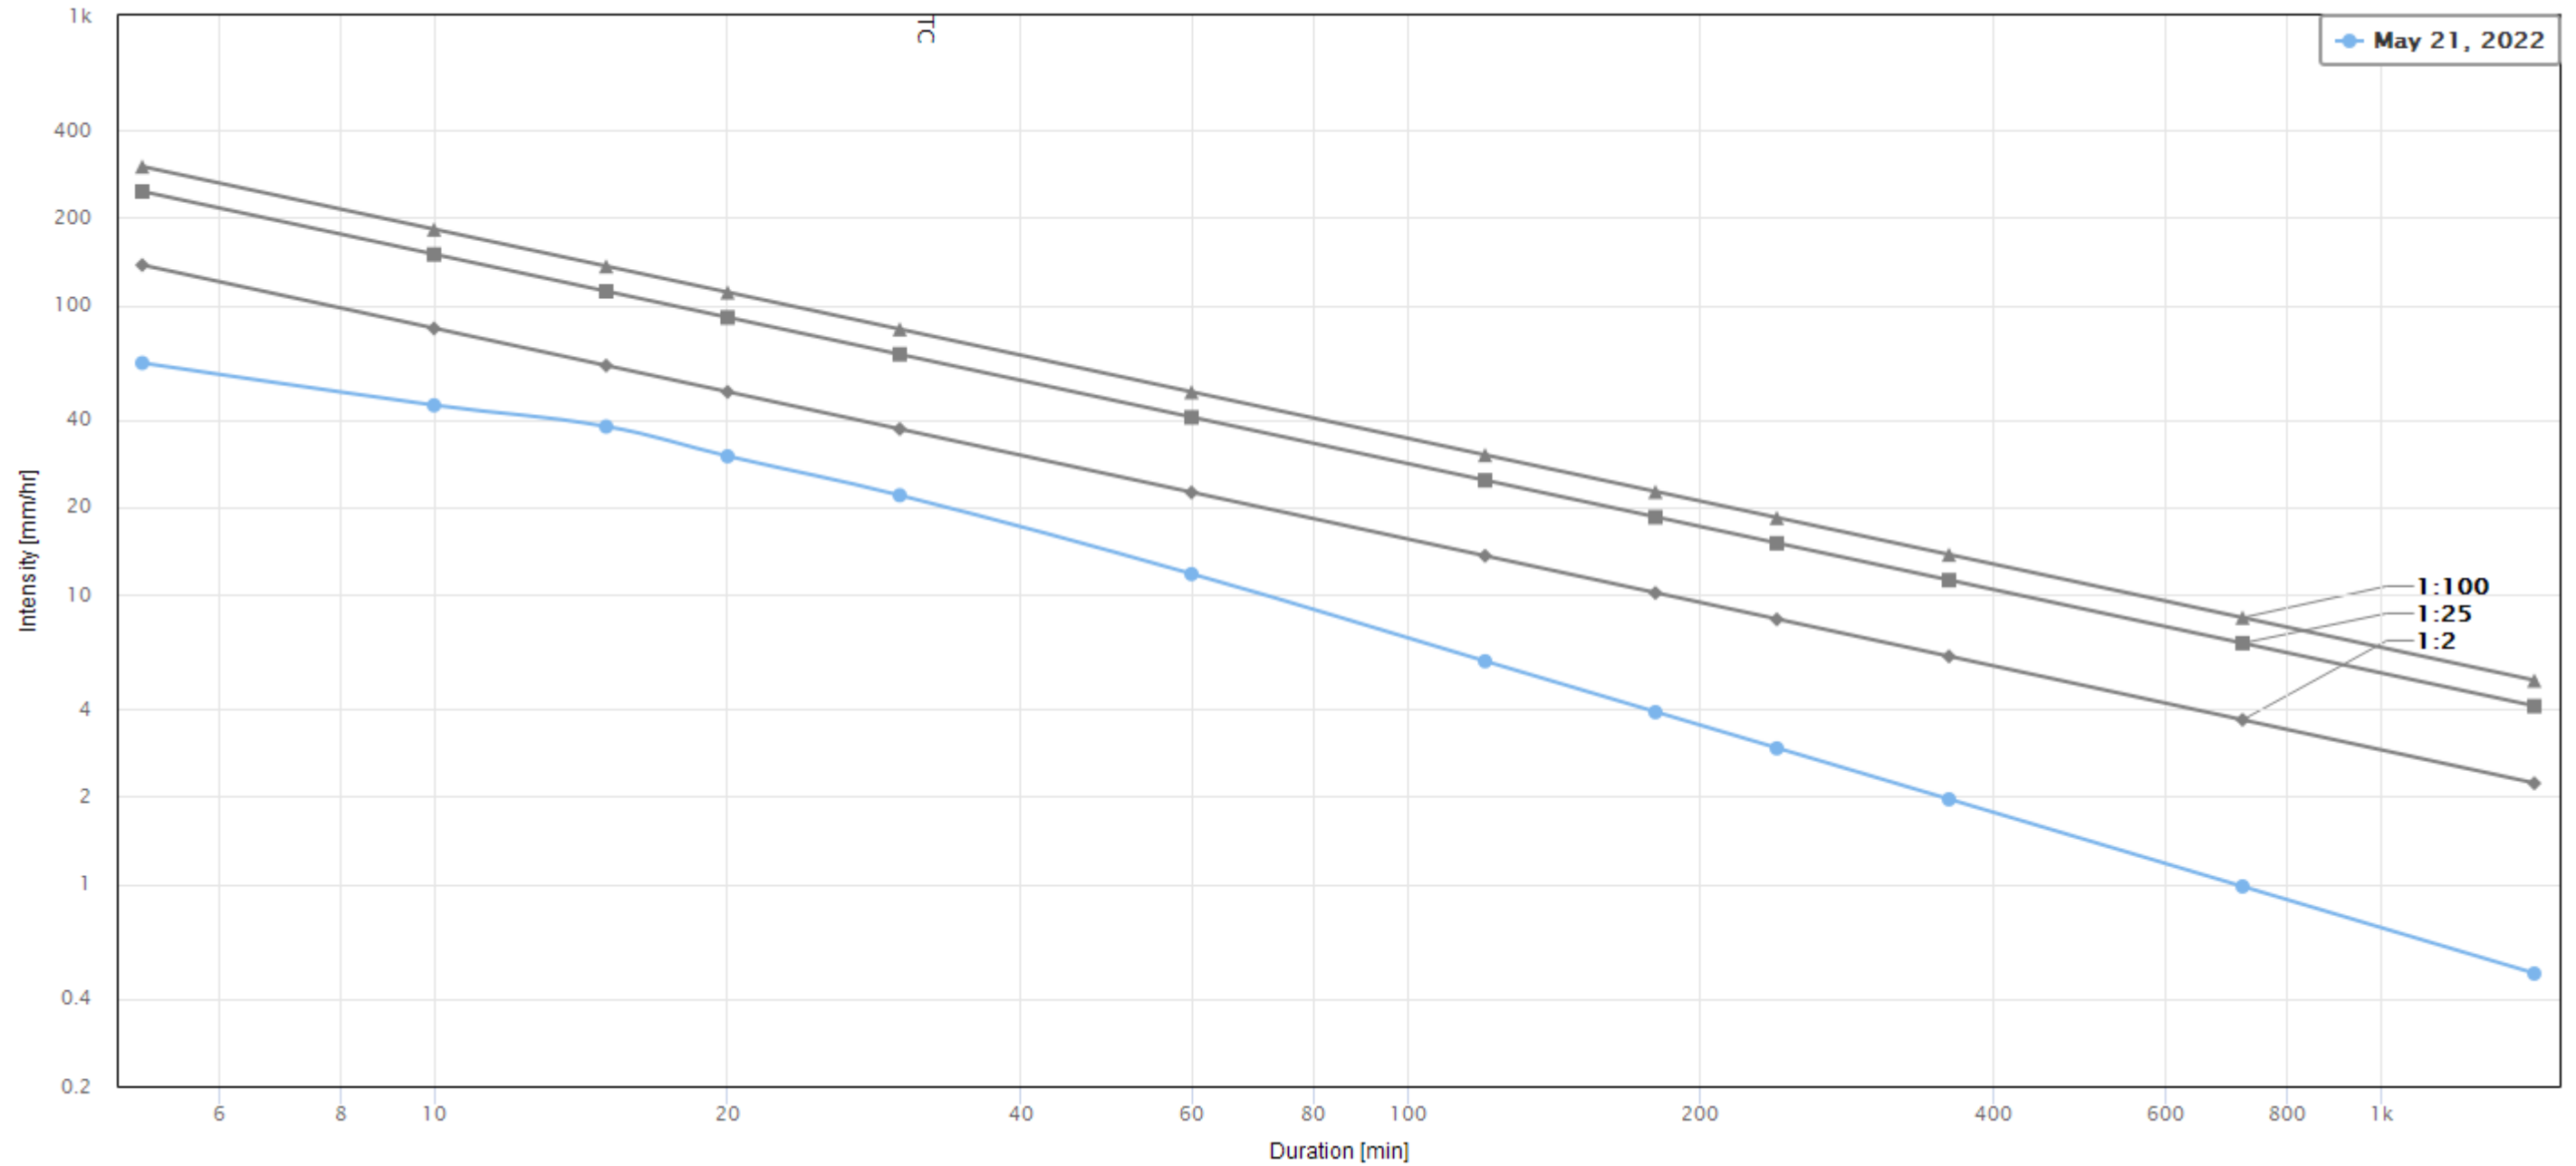
IDF Return Period Analysis MH33\_FM01 (North)

Station: MH33\_FM01 (North) (May 01, 2022 – May 31, 2022)

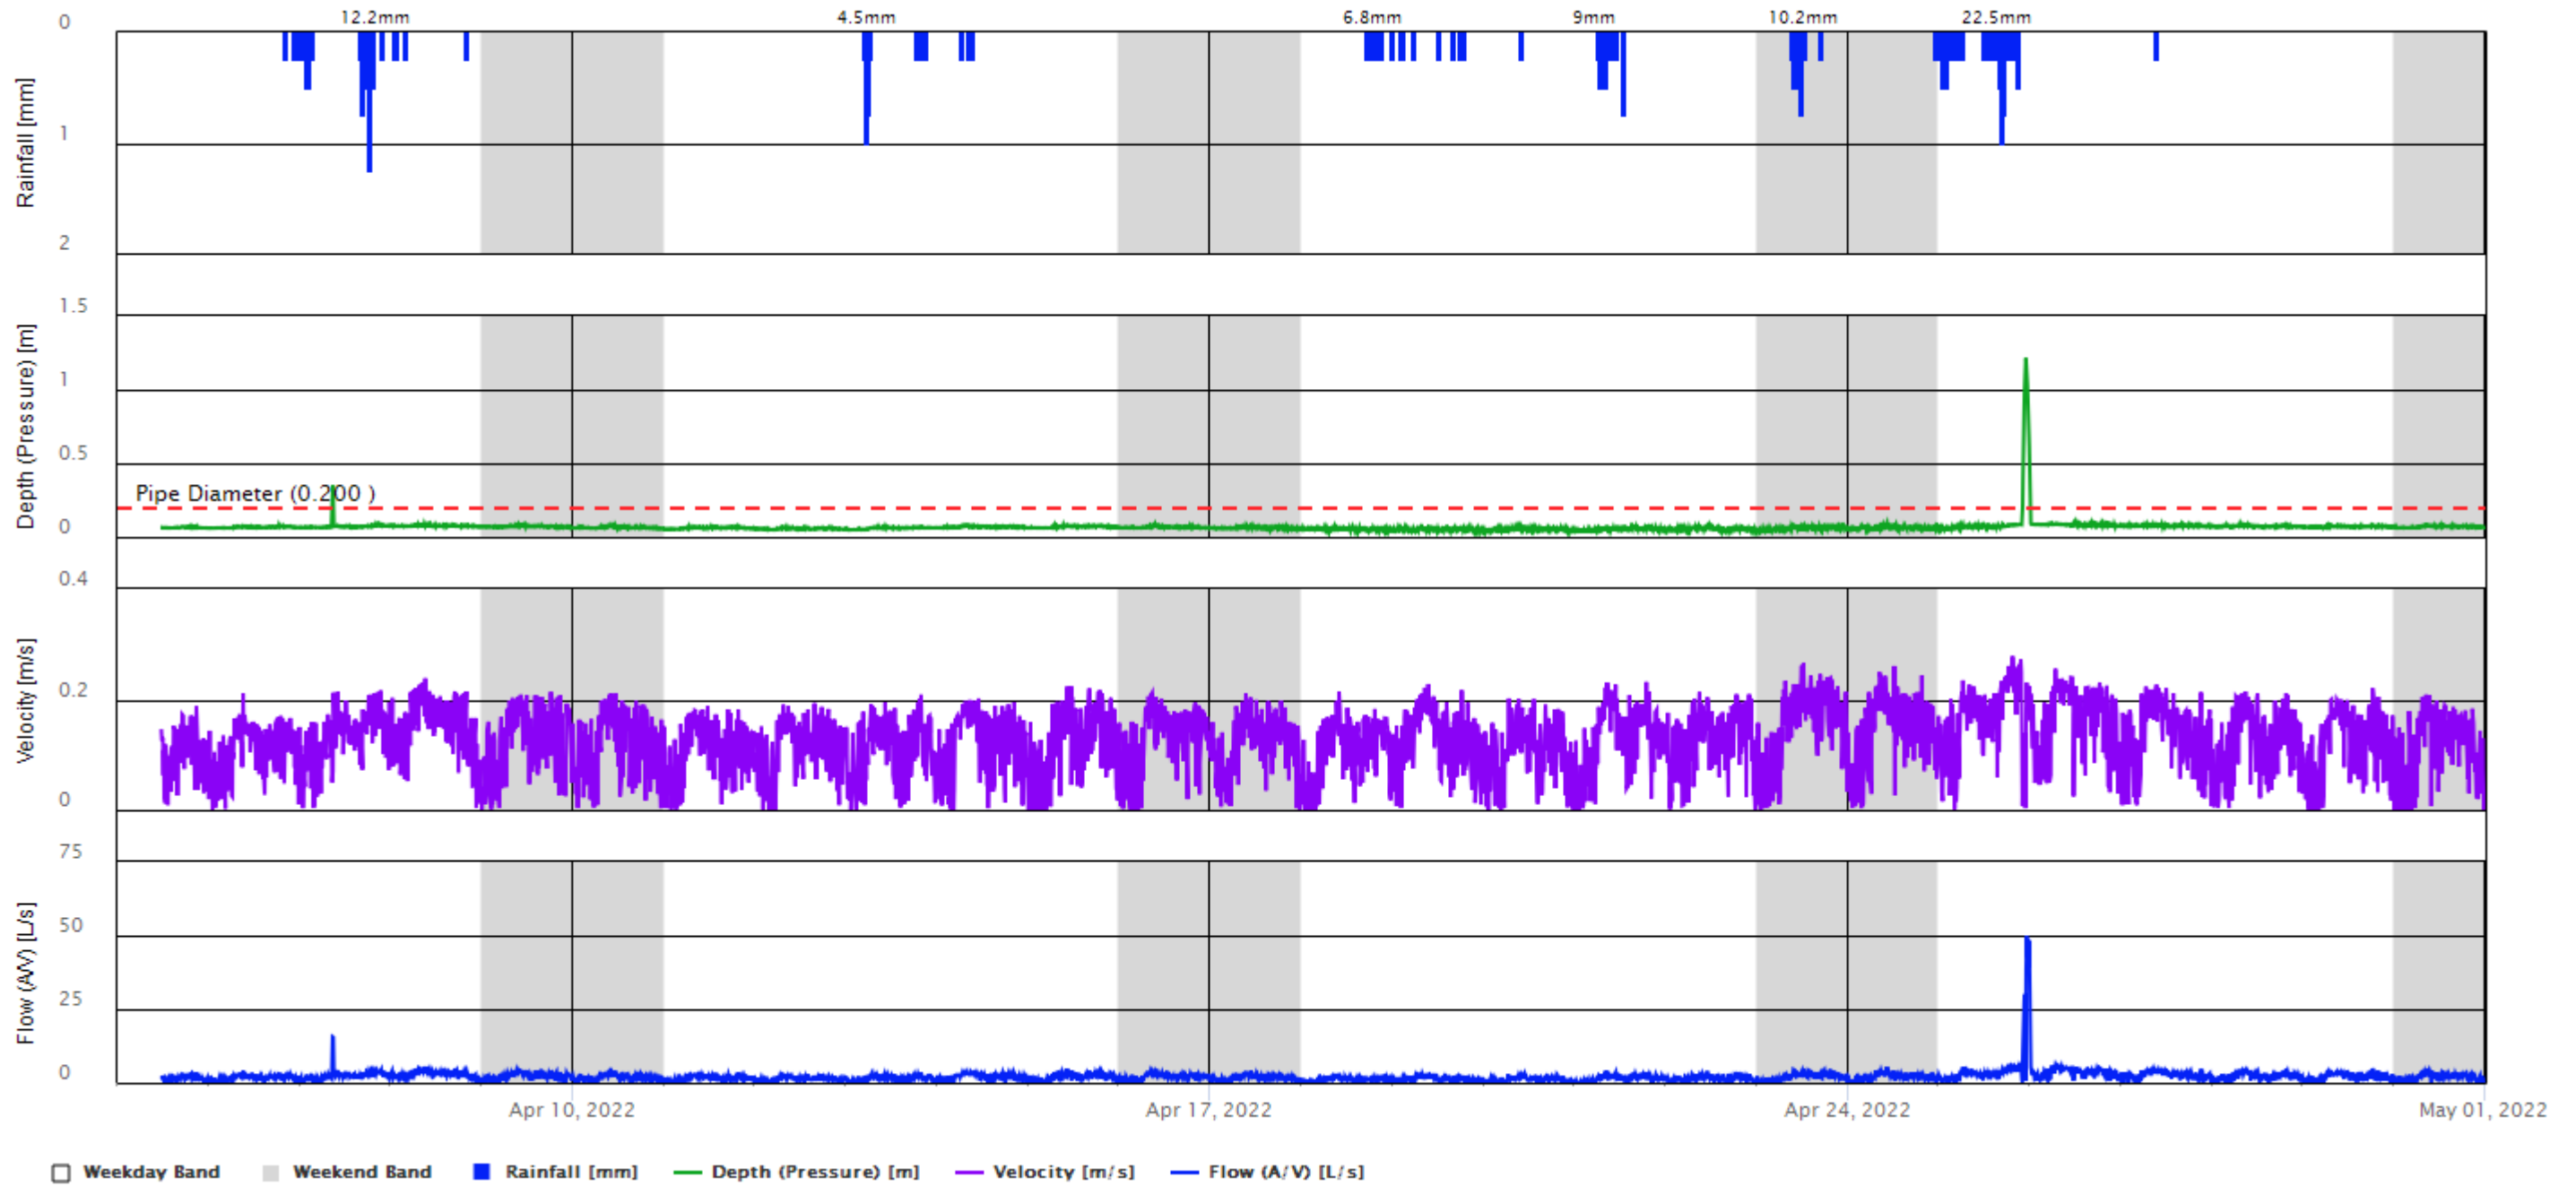
Station: MH33\_FM02 (South)

[Apr 05, 2022 – Apr 30, 2022](#)
