# **Report to the Township of Ramara for Inflow and Infiltration Study**

Date: April 20, 2023  
Project No: RAMARN1616-2233  
Rev: 2

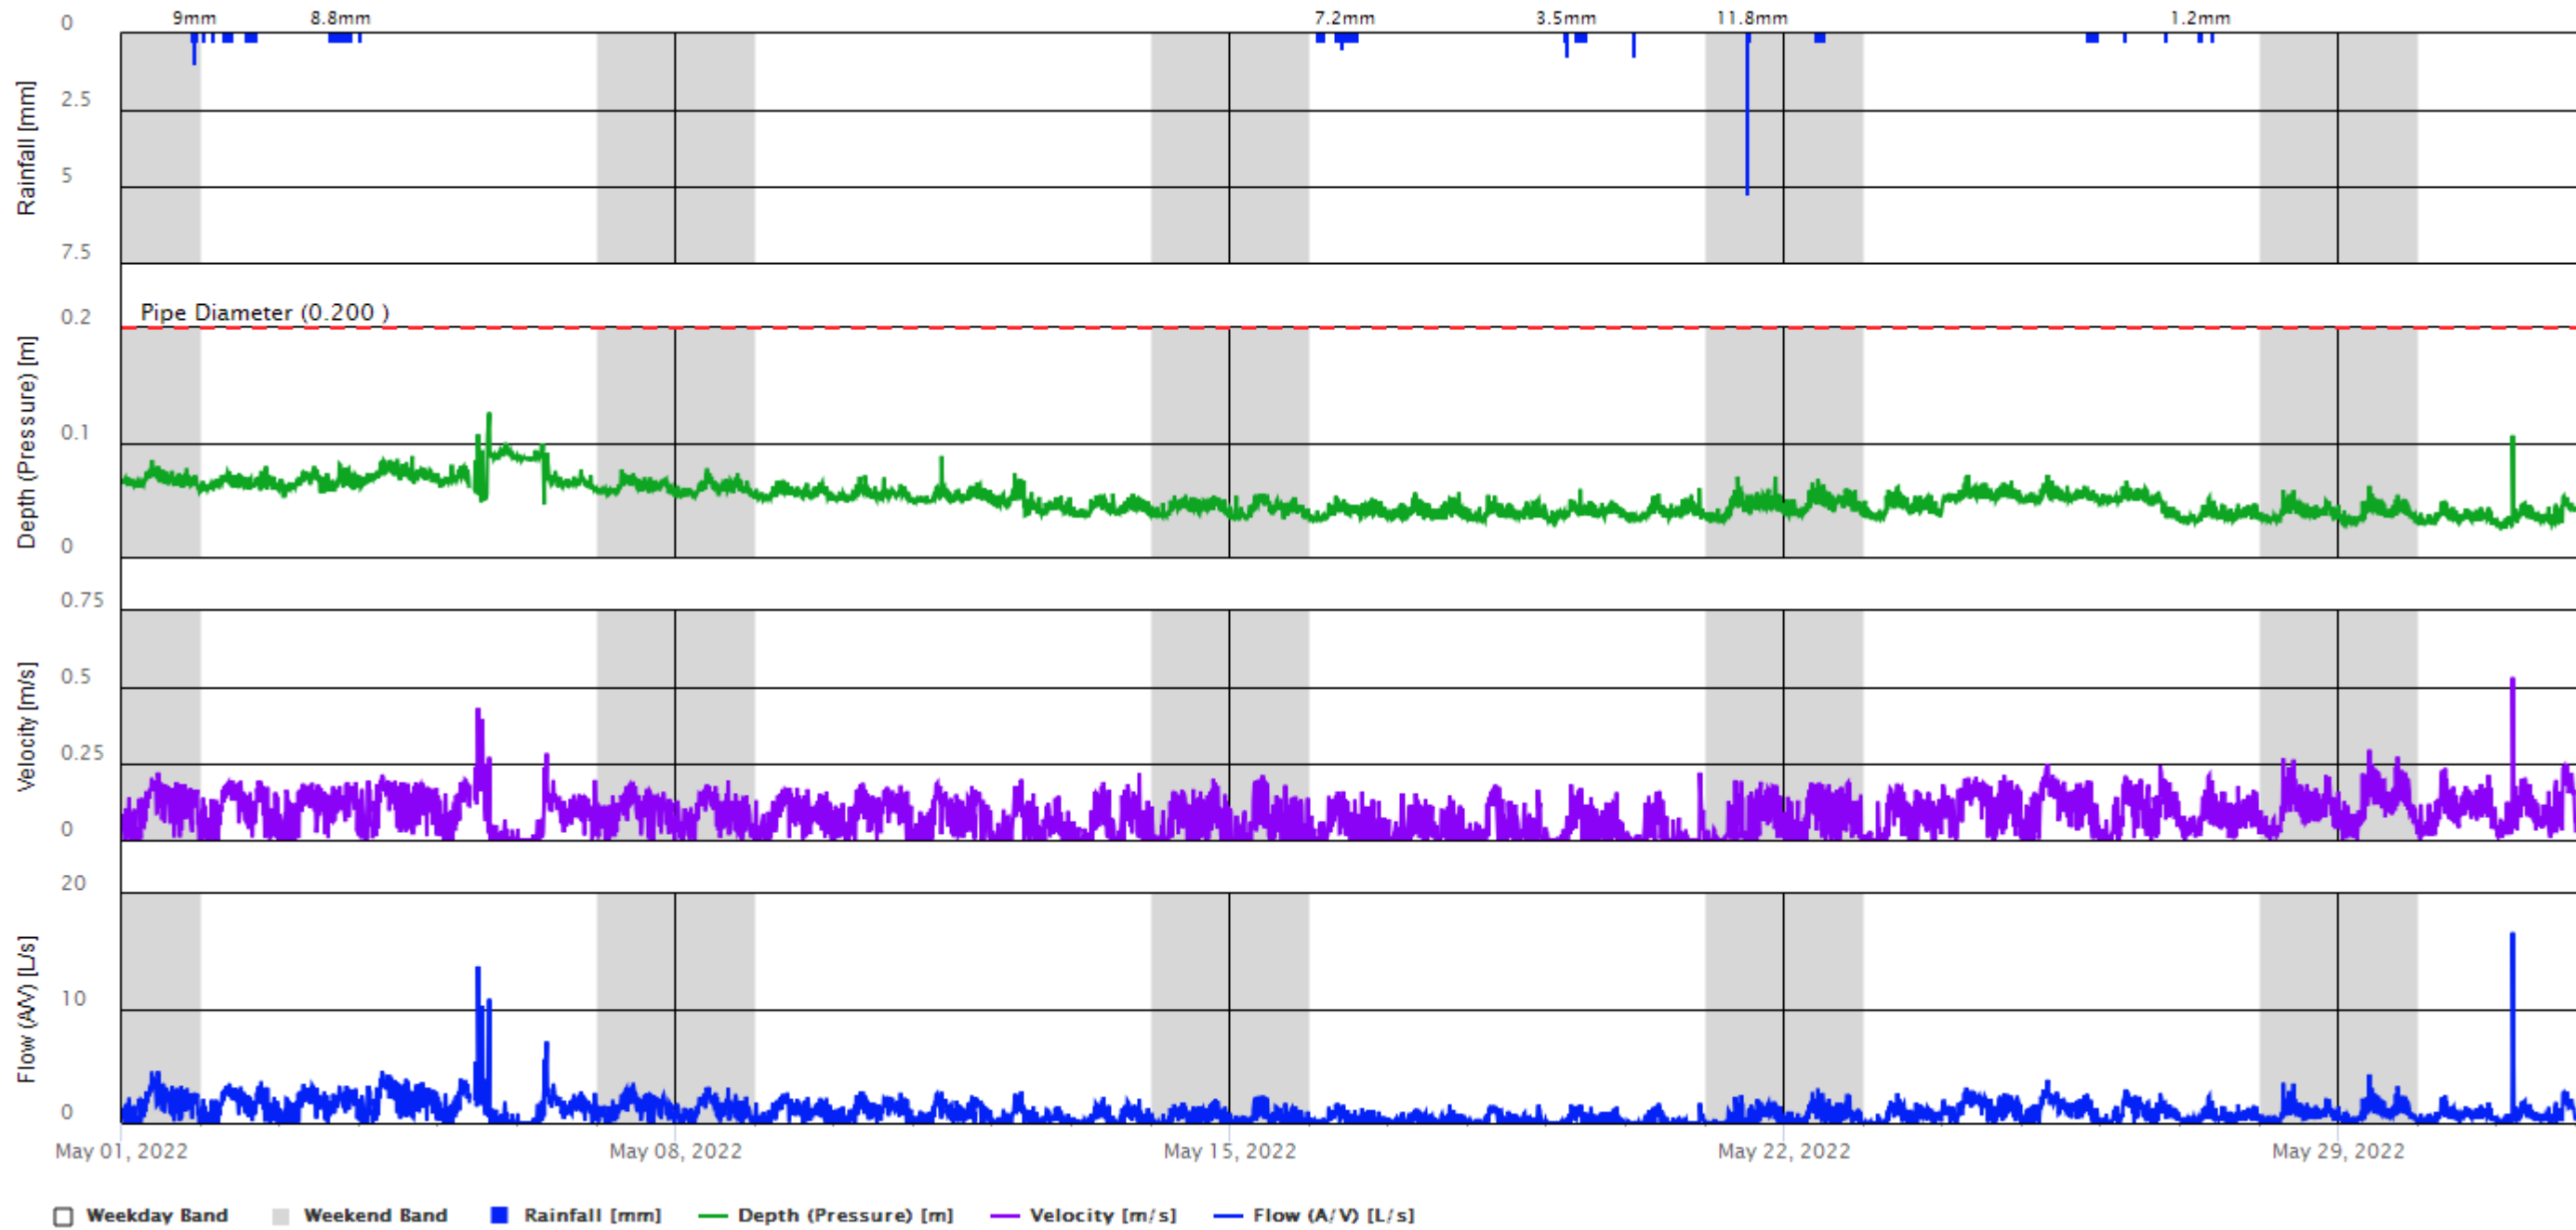
# Data Chart

Station: MH33\_FM02 (South)

[May 01, 2022 – May 31, 2022](#)

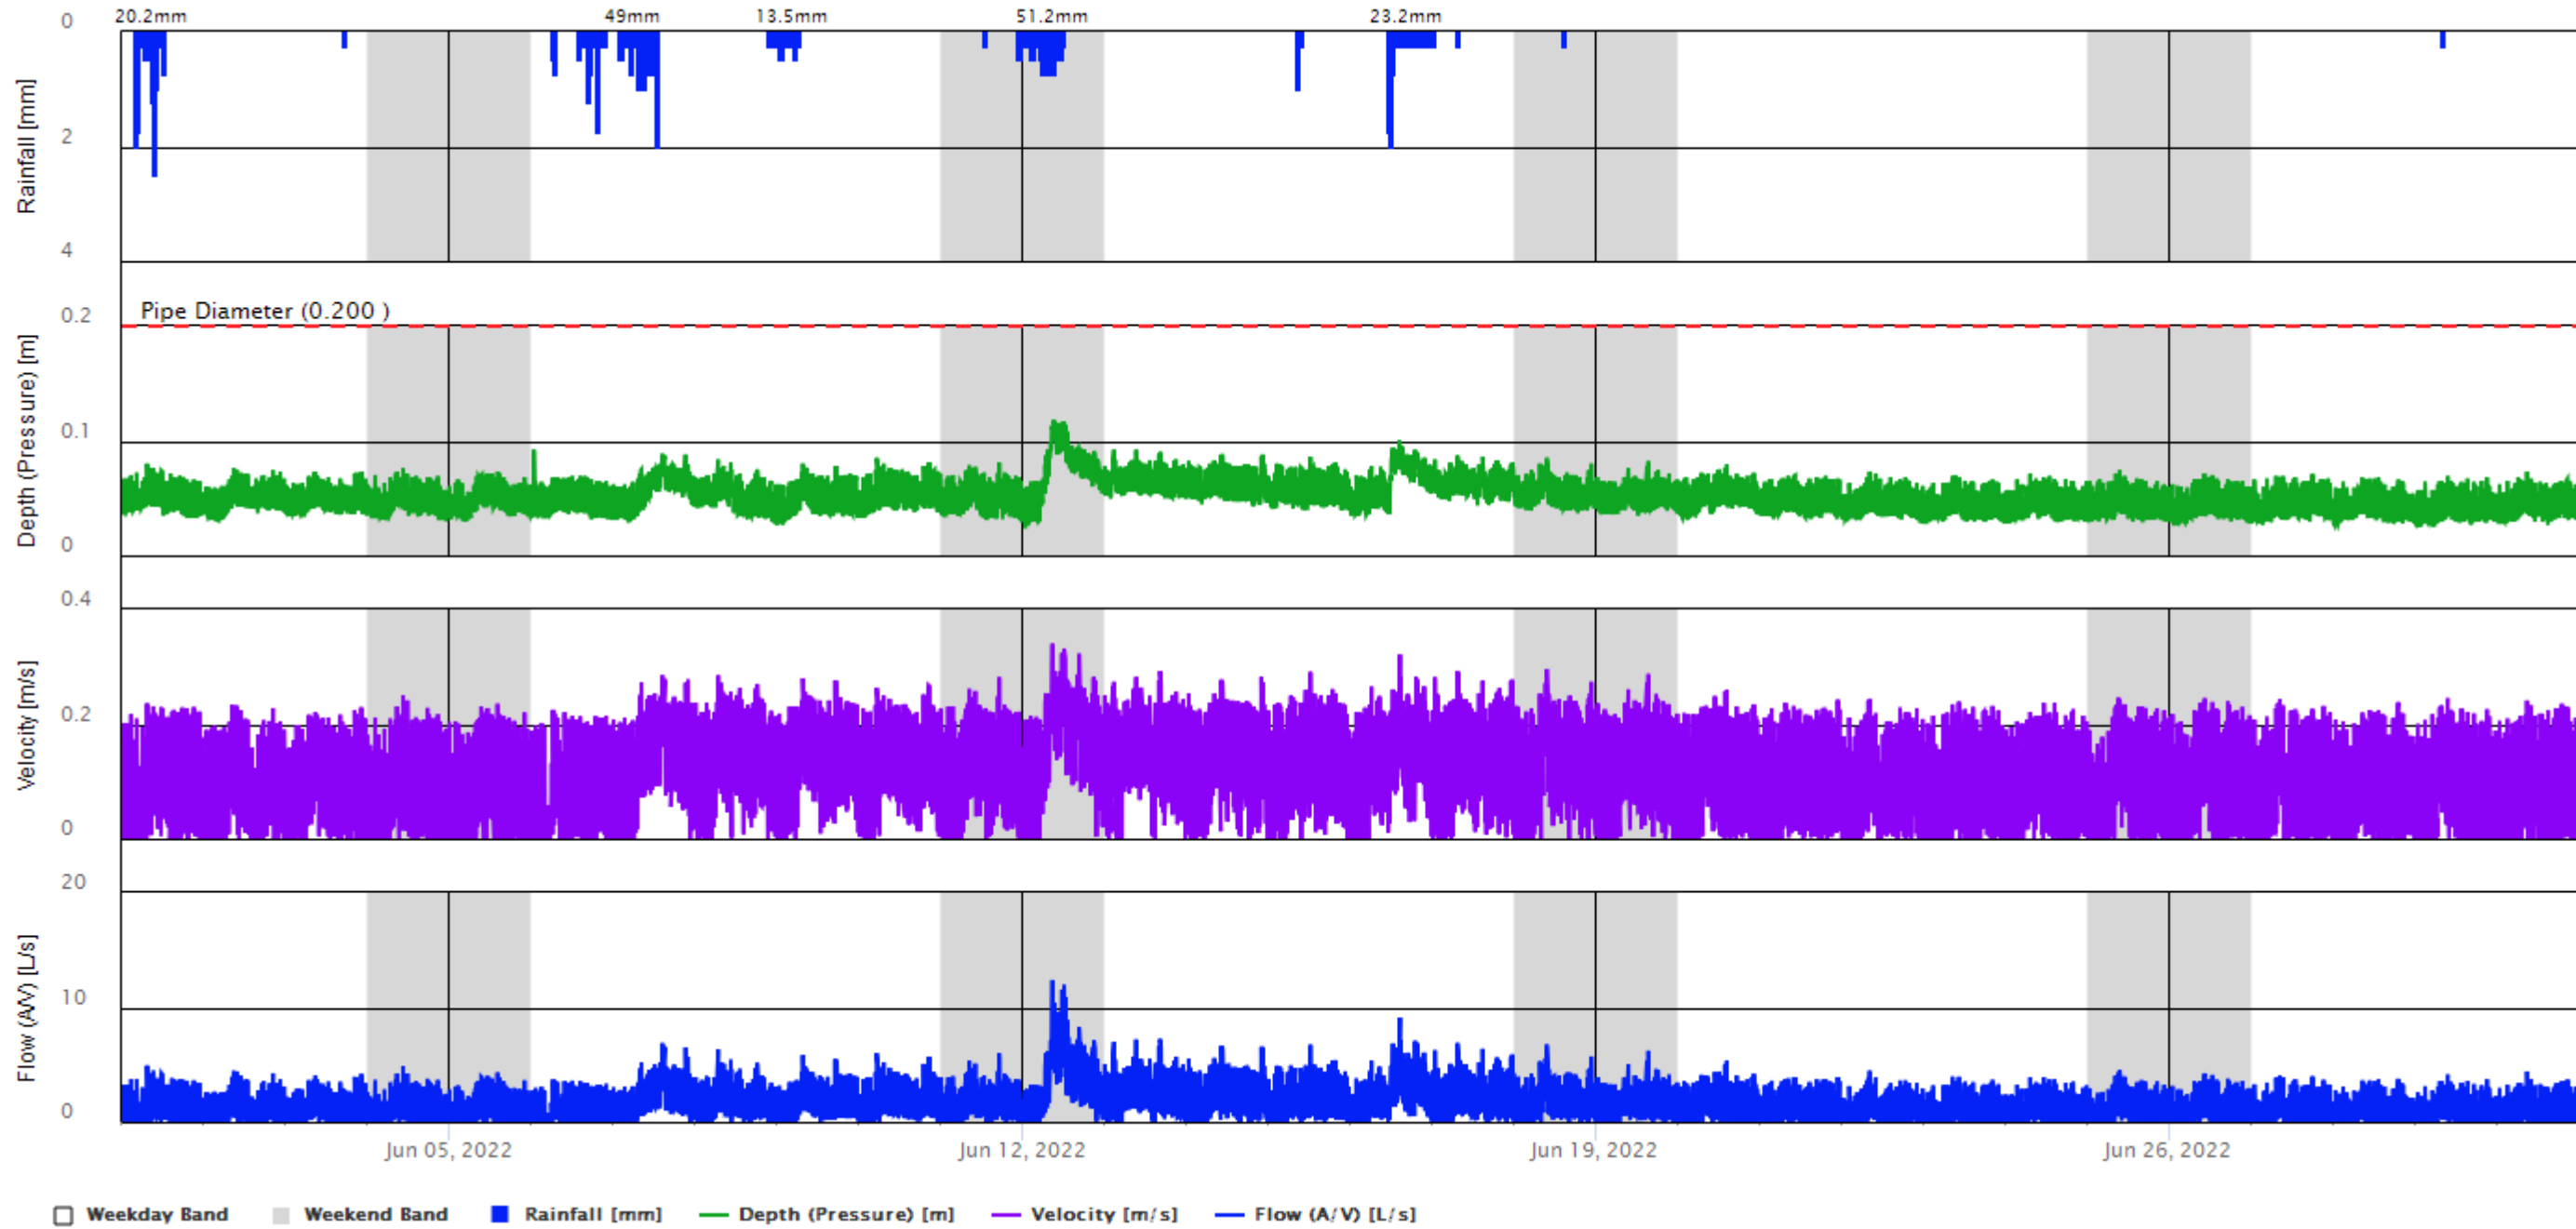
Station: MH33\_FM01 (North)

[Jun 01, 2022 – Jun 30, 2022](#)

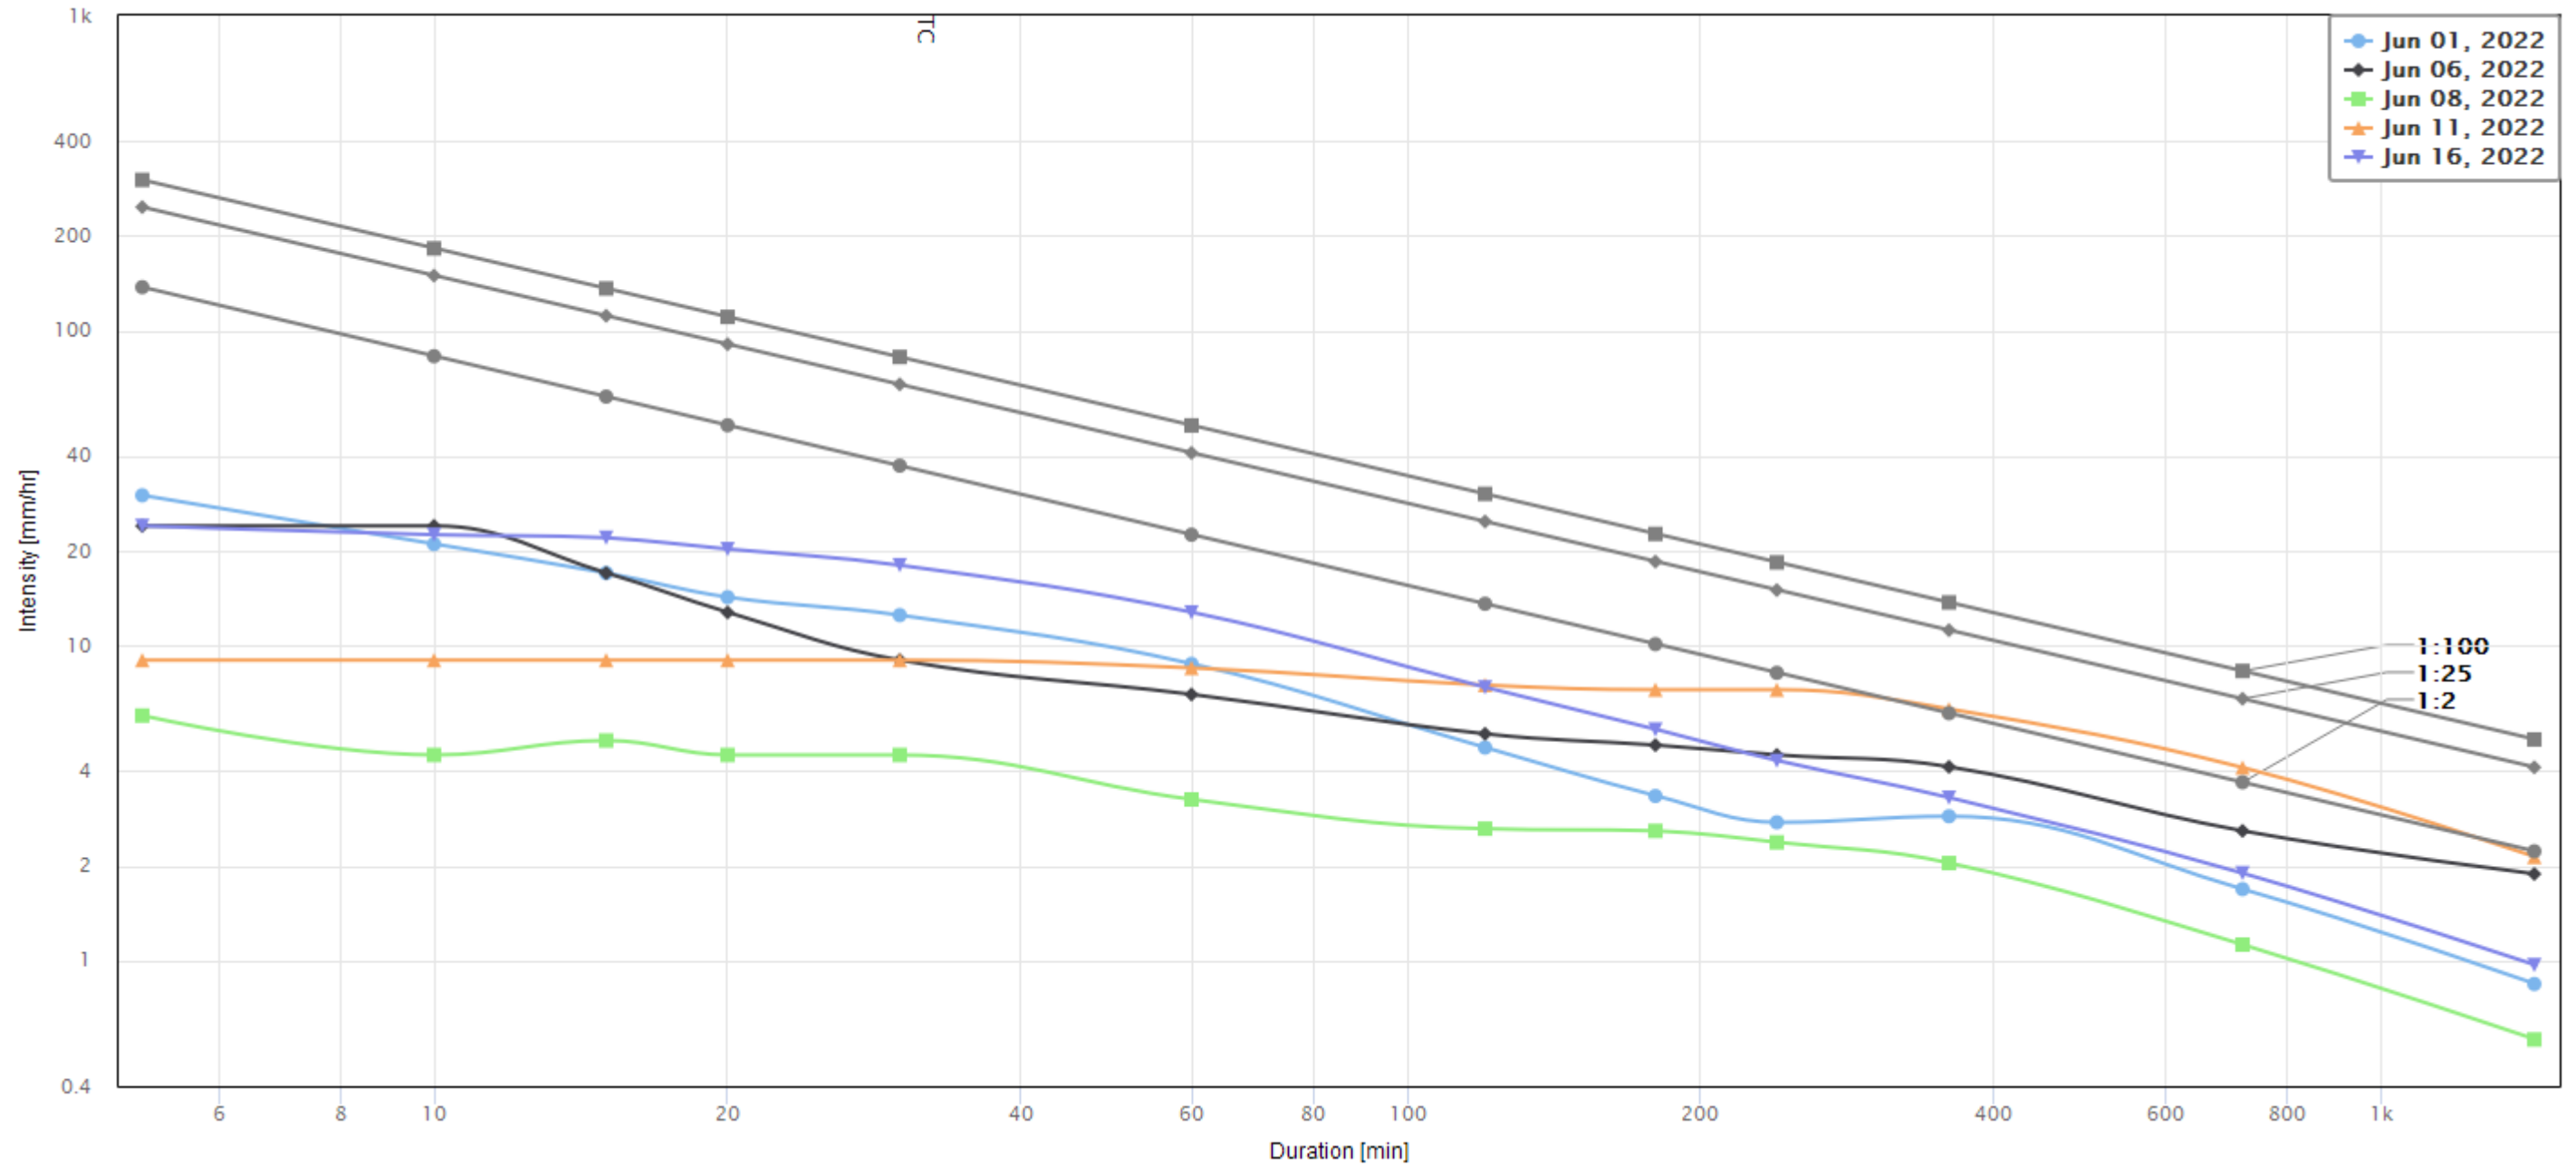
IDF Return Period Analysis MH33\_FM01 (North)

Station: MH33\_FM01 (North)

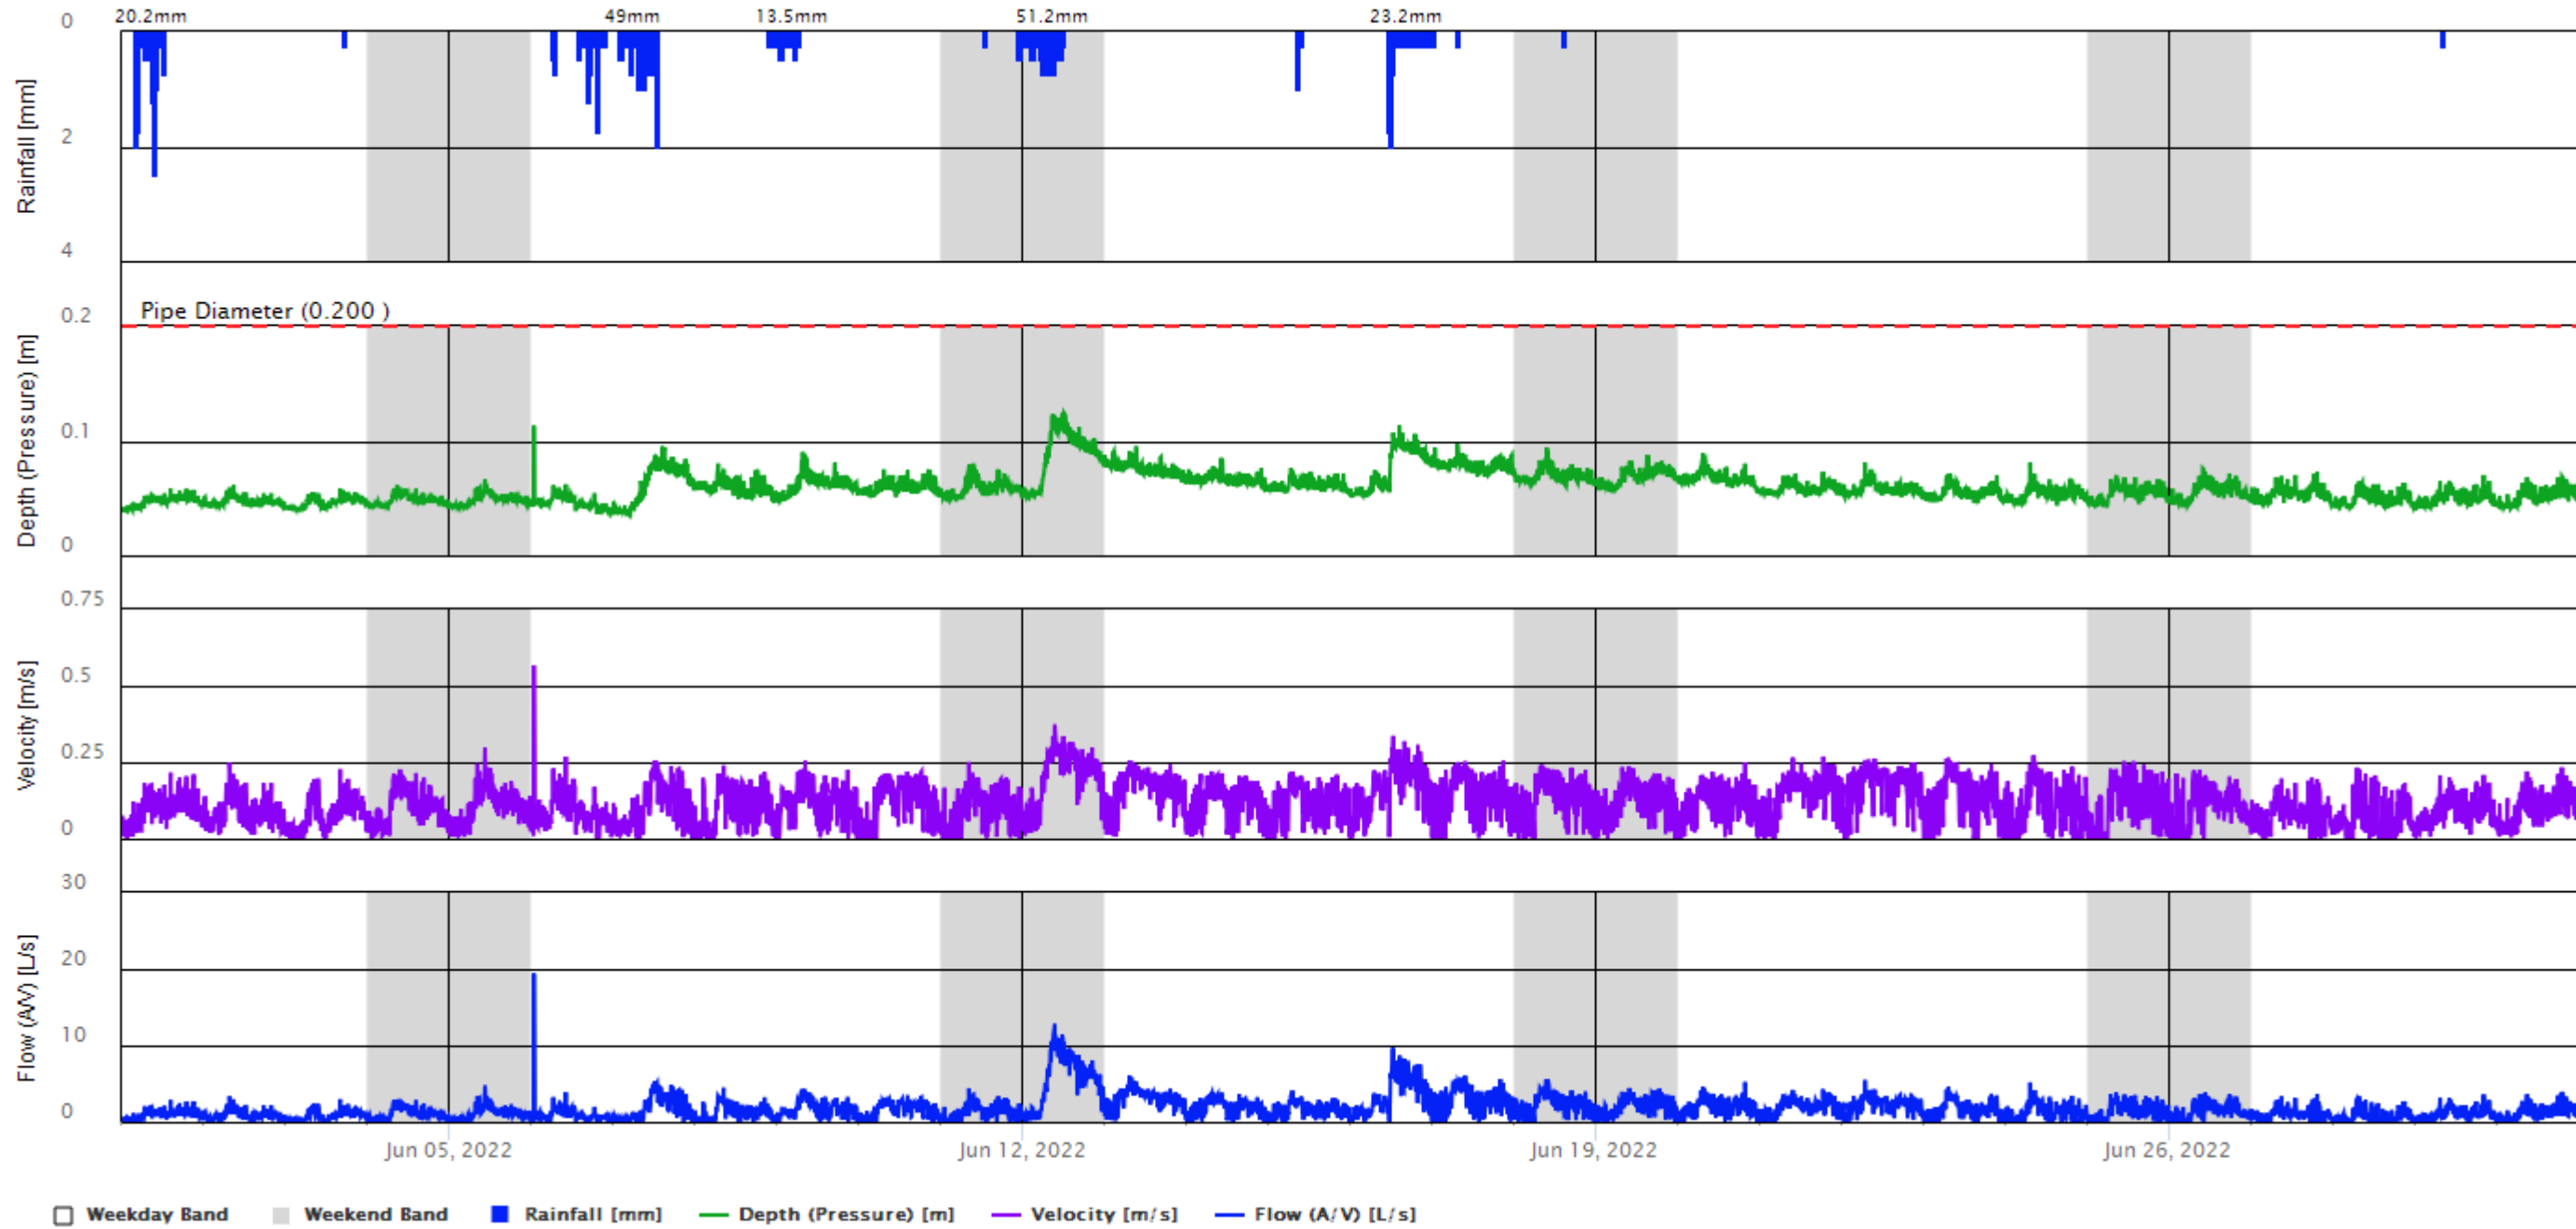
Station: MH33\_FM02 (South)

[Jun 01, 2022 – Jun 30, 2022](#)
