Report to the Township of Ramara for the Bayshore Excess Flow Reduction

Ontario Clean Water Agency
2085 Hurontario Street, Suite 500
Mississauga, ON L5A 4G1

March 7, 2022
RAMARN1614-2141
Rev: 1

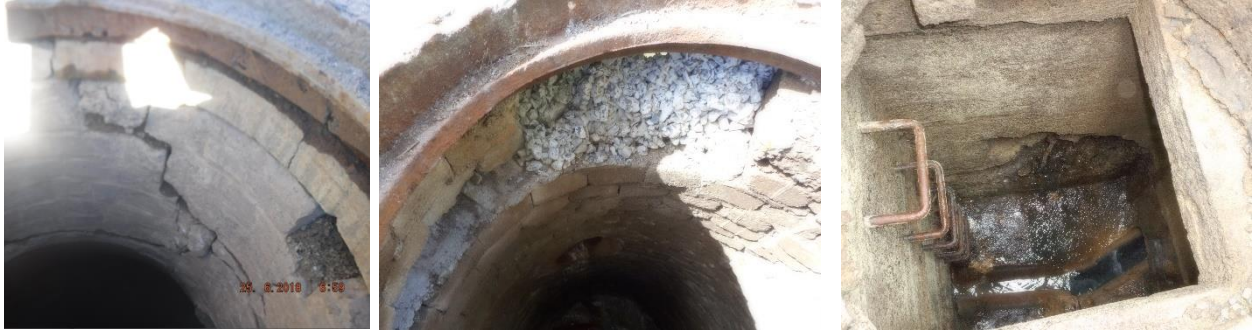
The US EPA⁶ estimates that 30% of I&I enters the system through maintenance holes, which are much more easily repaired than service laterals or the sanitary main. As such, conducting a visual inspection of the maintenance hole may result in some quick wins. Figure 5 provides examples of maintenance hole defects that are a source of excess flows into the system that can be easily repaired.

Figure 5 – Examples of Maintenance Hole Defects
